96-166 Centre Road,
Narre Warren –
Dwarf Galaxias
habitat buffer

Year 3
Vegetation Monitoring

Prepared for
Narre Warren Central Pty Ltd
c/- The Fidus Group

December 2020
Report No. 14090 (15.0)

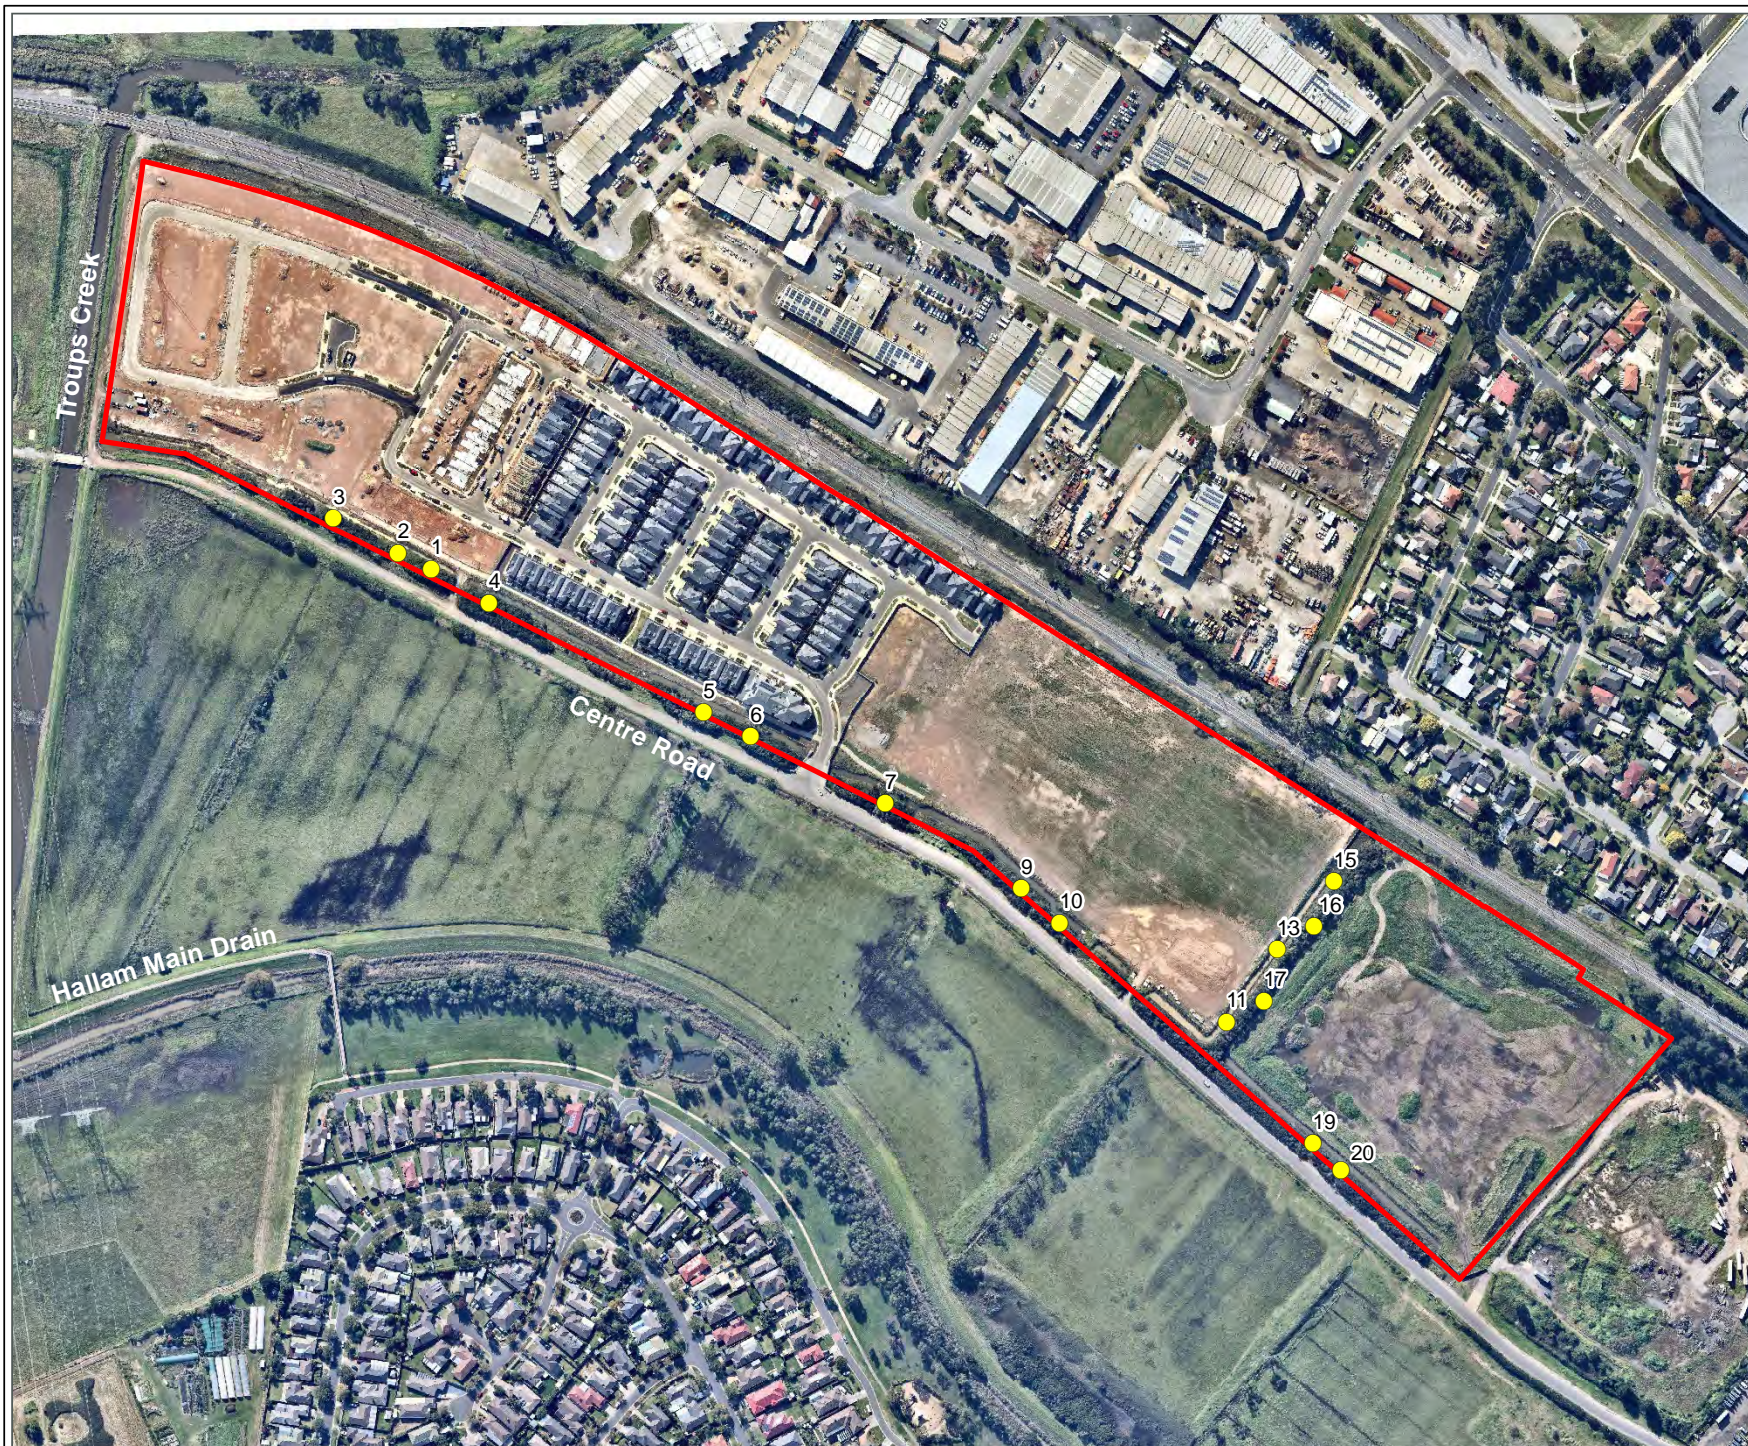
Figure 1: Site and monitoring locations

- Property boundary
- Quadrat locations

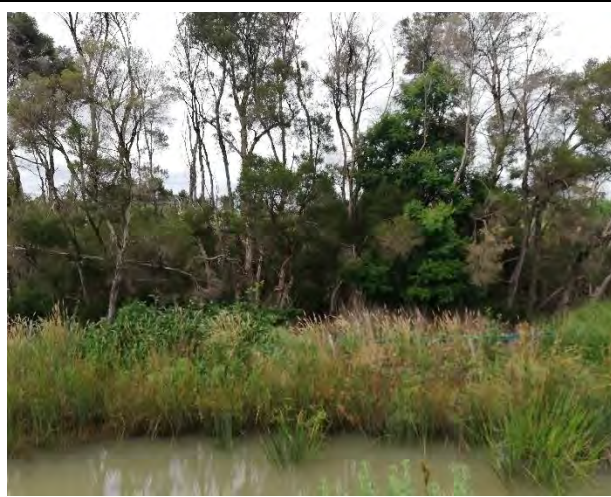
Quadrat 16 (Swamp Scrub)

16	Swamp Scrub	Co-dominated by Swamp Paperbark and Black Wattle, moderate cover of Blackberry	30	70
17	Non-native	Dominated by Swamp Paperbark. Blackberry present	10	90
19	Swamp Scrub	Swamp Paperbark, Common Reed and Blackberry present	30	70
20	Swamp Scrub	Dominated by Swamp Paperbark, with a low cover of Common Reed	10	80

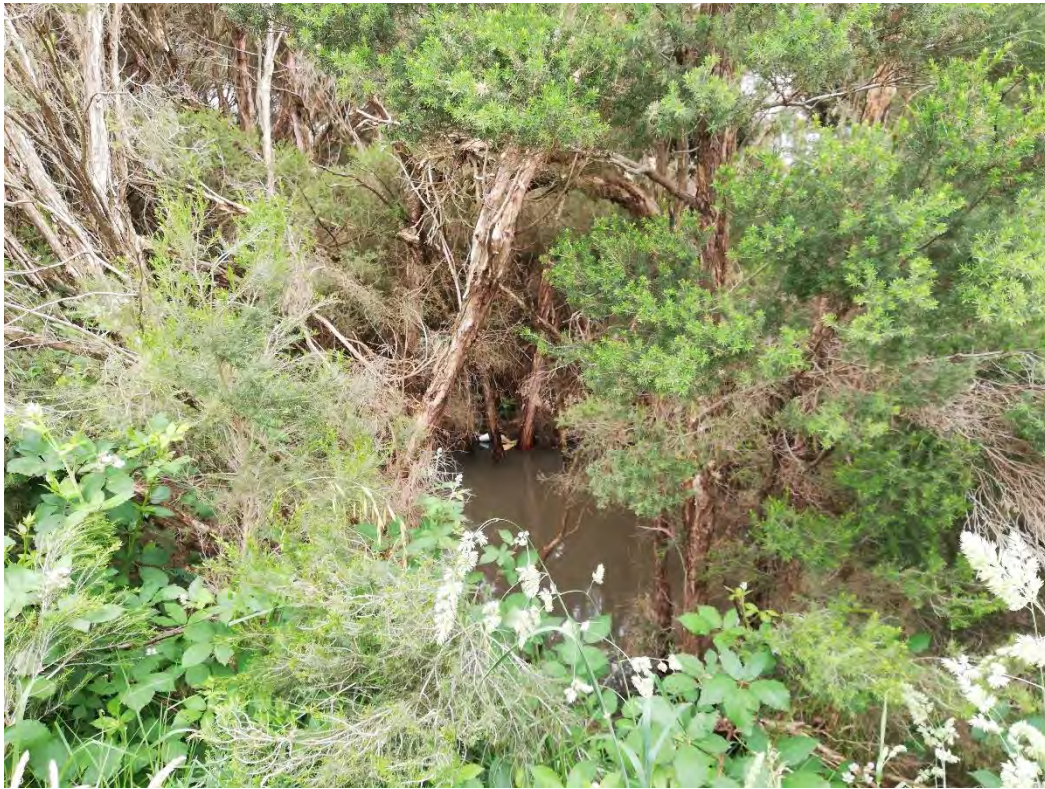
The drainage channel along Centre Road was full of water

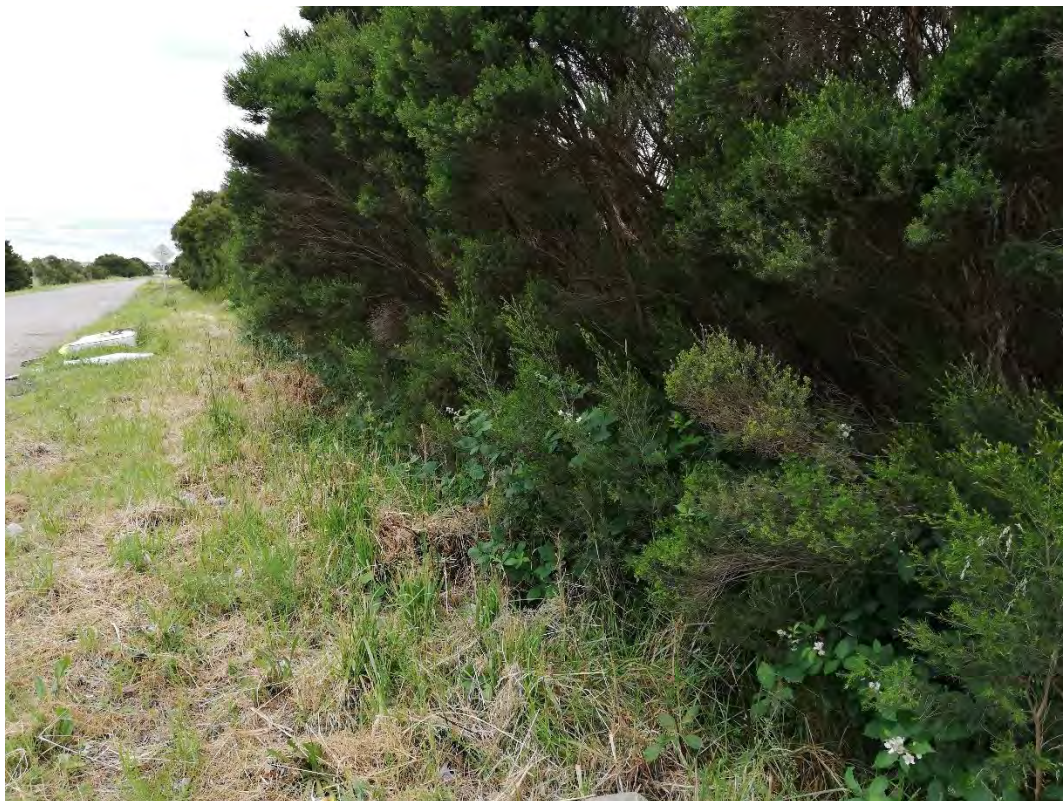
Swamp Scrub vegetation along the southern bank of the drainage channel west of Billy Button Drive

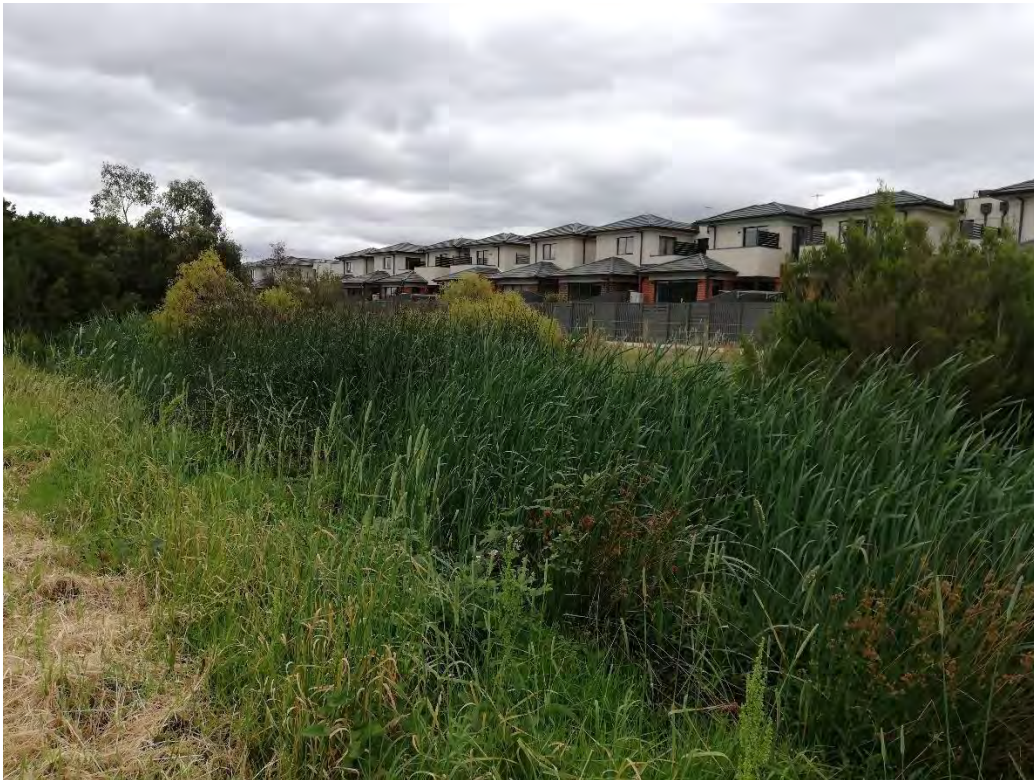
Narrow-leaf Cumbungi and Rush present in the drainage channel

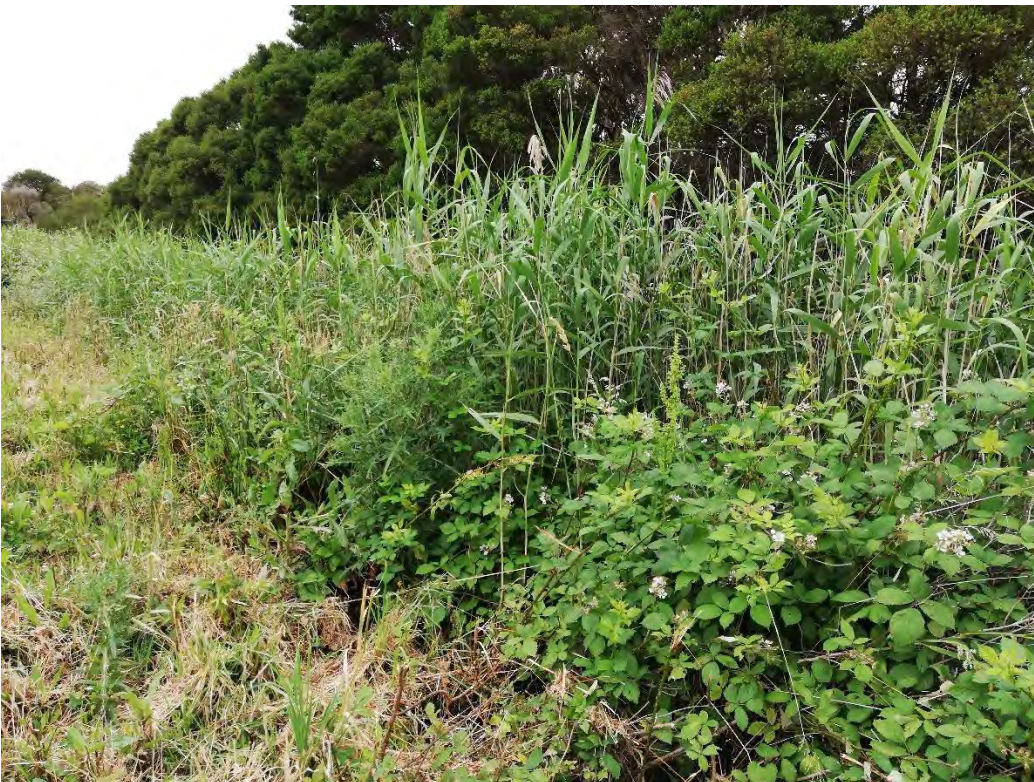
Common Reed dominating large areas along the drainage channel in the west

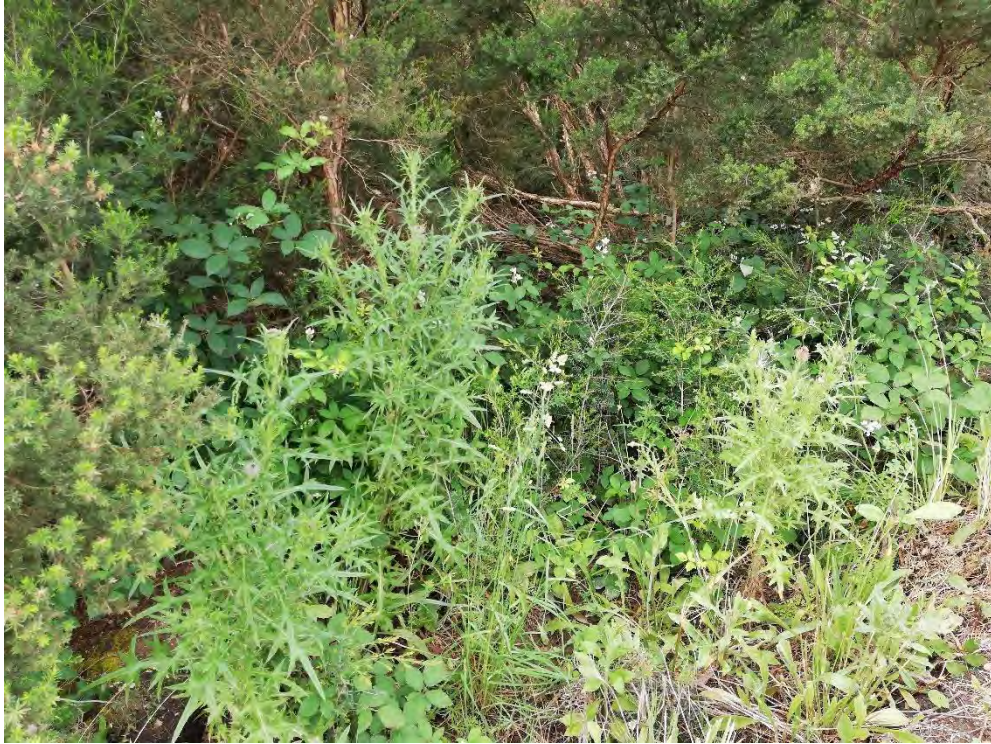
The high-threat weed species Spear Thistle was common along the southern bank of the drainage channel west of Billy Button Drive and must be controlled

accessed. The high-threat herbaceous weed Spear Thistle, common throughout the site, should also be treated via spot-spraying.

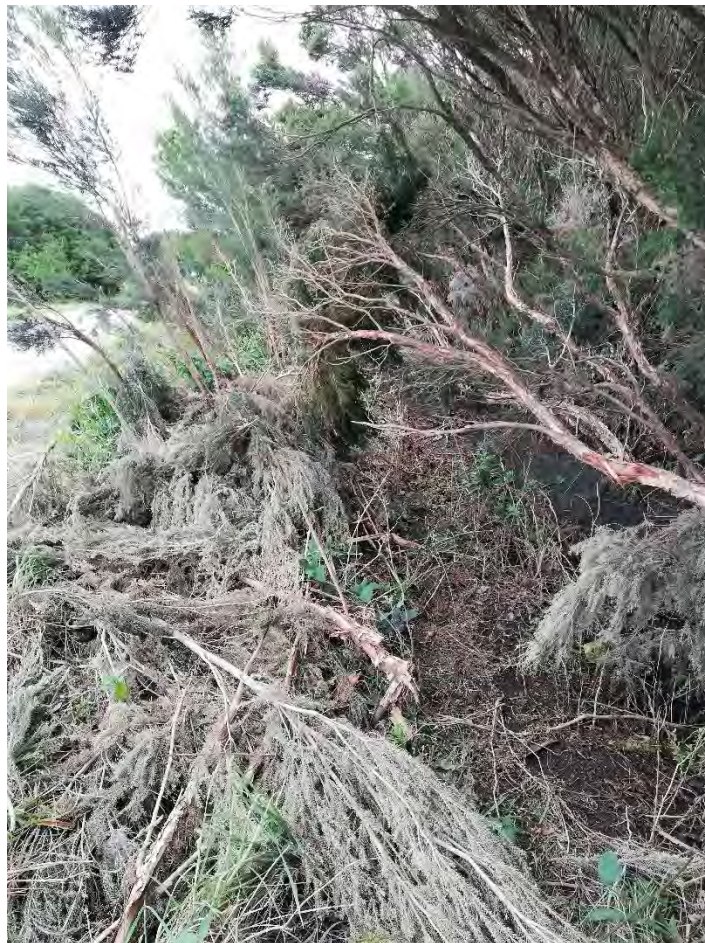
Habitat destruction where Swamp Paperbark plants have been knocked over

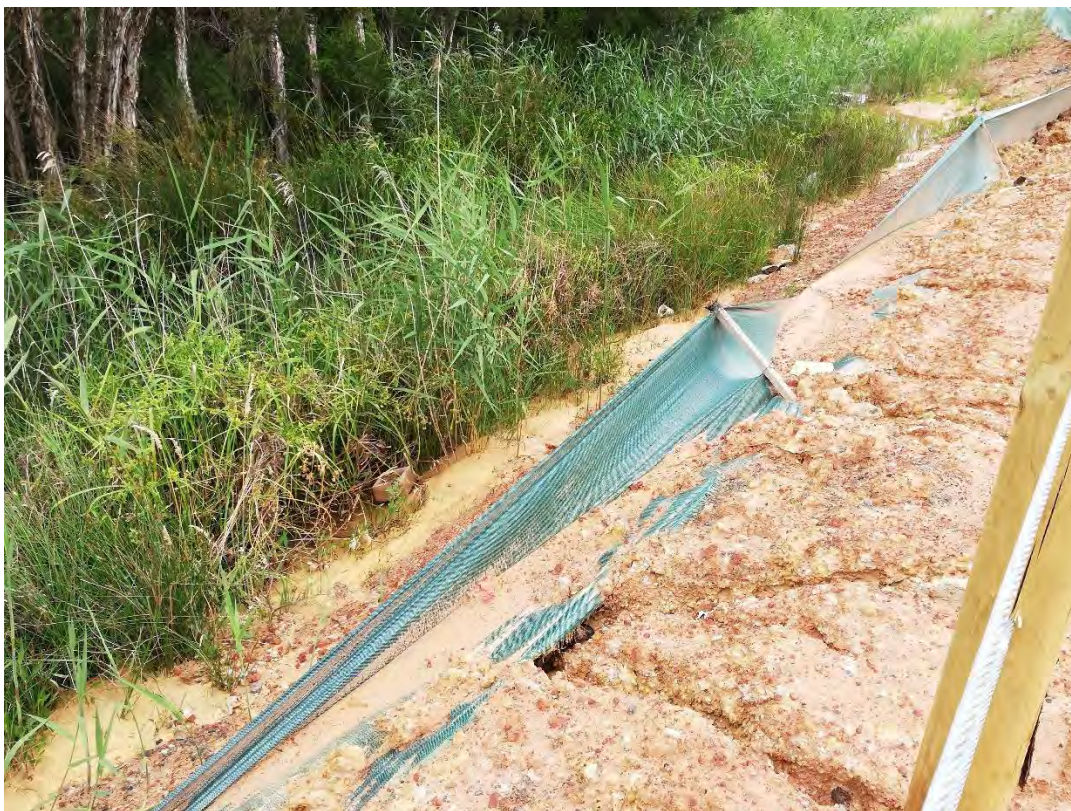
Sediment fencing has collapsed, with erosion channels running beneath the fencing, along the northern edge of the swale in the west of the site. Sedimentation of the water can be seen.

Collapsed sediment fencing along the northern edge of the swale drain in the west of the site is to be repaired to prevent further sedimentation into the drains. Where required, sediment fencing must be replaced before construction begins. Any sediment fencing that is no longer serving its purpose it to be removed to avoid it becoming litter.

This fencing must be rectified as soon as possible

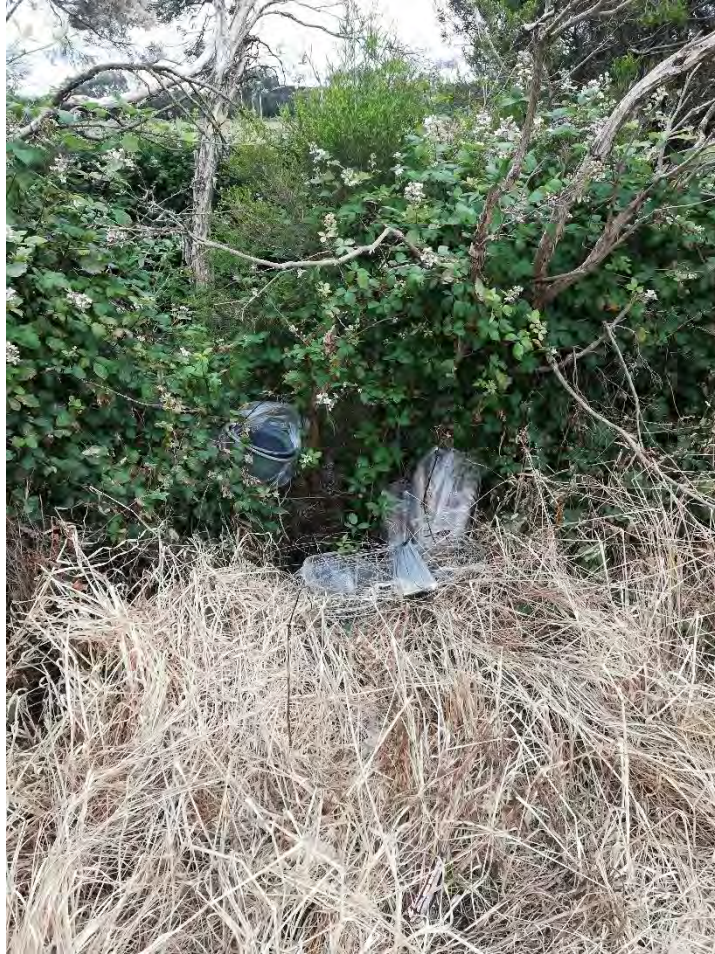
A significant amount of hard rubbish was observed within or close to the buffer areas, including polystyrene, dumped timber, car tyres, general construction refuse and plastic bottles. This was both from construction within the site as well as from the public using the road to the south of the site. Habitat destruction was present in one location to the west of Billy Button Drive where several Swamp Paperbark plants had been knocked over. In addition, sediment fencing between the habitat buffers and swales had collapsed and fallen, and in many cases, was breaking up. In particular, where construction was currently occurring in the very west of the site, sediment fencing had collapsed under the weight of recent sediment runoff, and erosion channels had occurred underneath the existing sediment fence. This has resulted in sediment build-up in the water near the edge of the drain and amongst the native Common Reed.

Excessive amounts of hard rubbish were present throughout the survey site and is to be removed

All rubbish should be removed from the site as soon as possible. This is to be undertaken by the proponent within private land and by Council along Centre Road. Signage should be employed along the drainage channels to deter rubbish dumping.

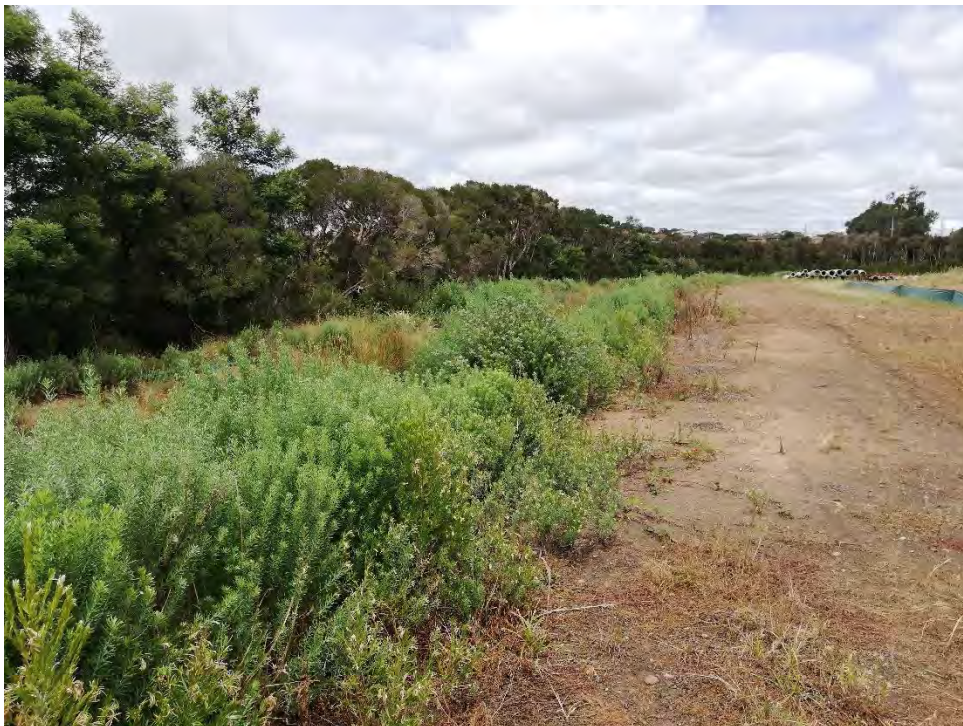
Flax-leaf Broom was abundant along the western edge of the drainage channel running from Centre Road to the Pakenham Railway line. This is to be removed.

Alternatively, Nature Advisory recommend that weed control efforts should focus on the other woody weeds on the site, namely Montpelier Broom, Flax-leaf Broom, Hawthorn and Desert Ash, that can be easily treated via the cut and paint method, providing they can be
