96-166 Centre Road,
Narre Warren

Offset Site Monitoring for Revegetation and Weeds – 12 Months Post-construction

December 2024
Report No. 14090.7 (3.0)

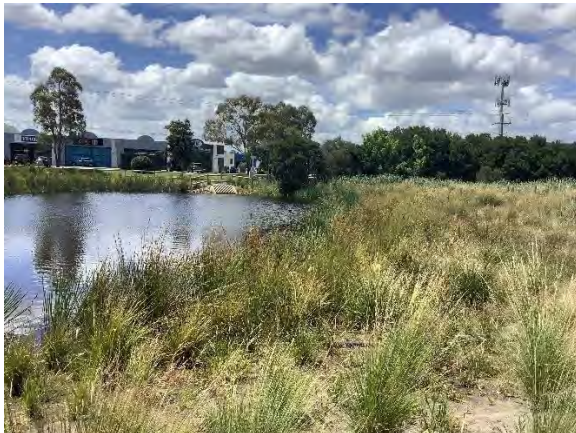
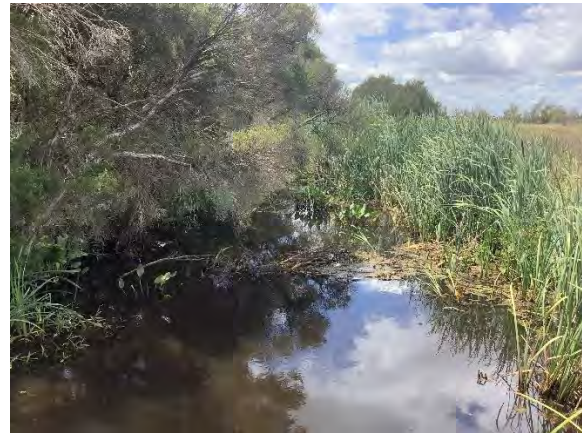
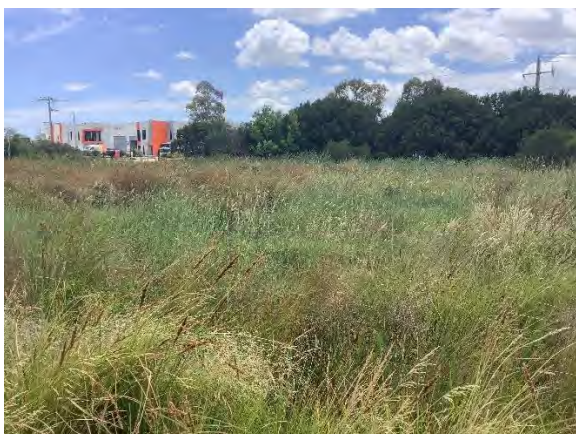
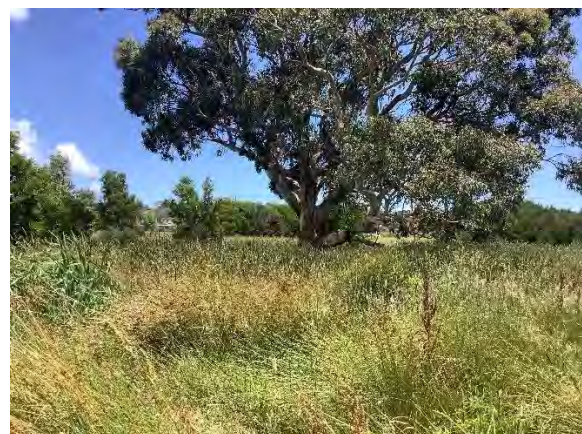
Photos 1-4. Native wetland vegetation in the offset site, including open wetlands and dense Common Reed (top and bottom left), with Swamp Scrub along the northern and western boundaries (top and bottom right).

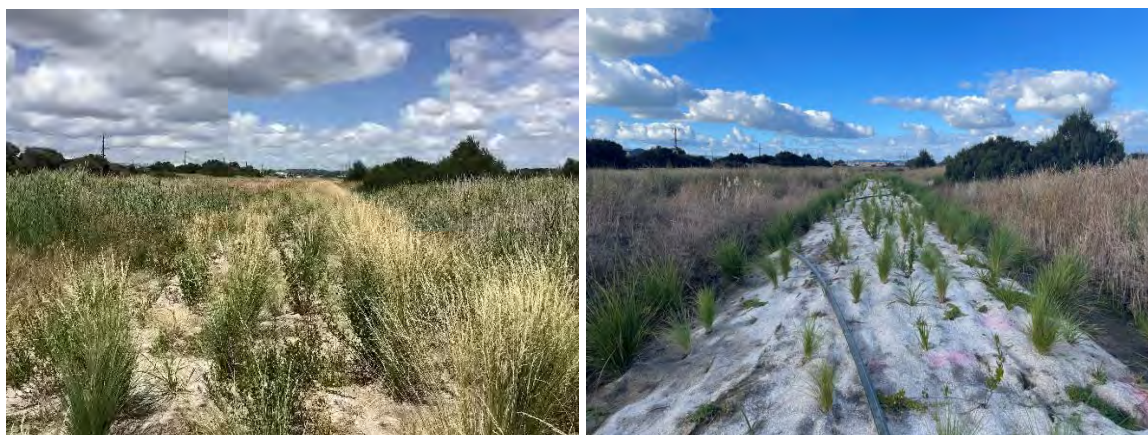
Total mortality of plantings within the matting was estimated to be about 5-10% overall. Biomass from the revegetation works has increased dramatically from the previous monitoring assessment in June. Hop Goodenia, Mat Rushes, Spear Grass and Common Blown Grass remained successful in establishment. Furthermore, planted Flax Lilies, Goodenia and Wallaby Grasses were observed to be flowering.

Photo 5 & 6. A comparison between December 2024 (left) and June 2024 (right) surveys to show a clear increase in revegetation biomass

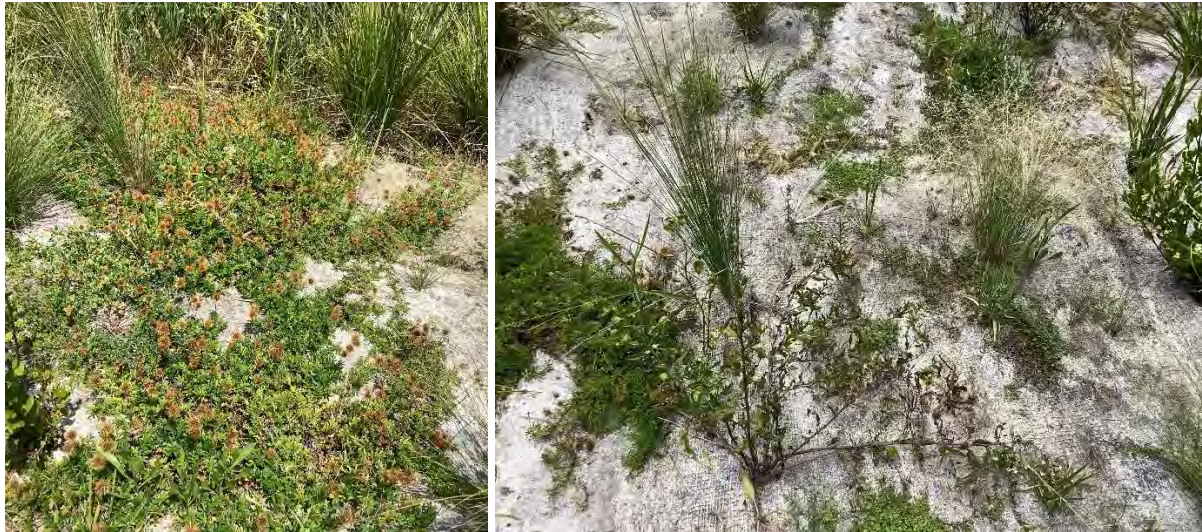
The planted species that appeared to be struggling the most is the herbaceous Kidneyweed. Its patchy establishment is limited to moist areas (wet depressions and/or path edges) and struggling individuals on the edges of the revegetation path. This accounted for most of the revegetation plant mortality.

Photo 7 & 8. Bidgee-widgee forming mats in open space of the jut matting (left) and Kidneyweed under stress in drier areas of the revegetation path (right)

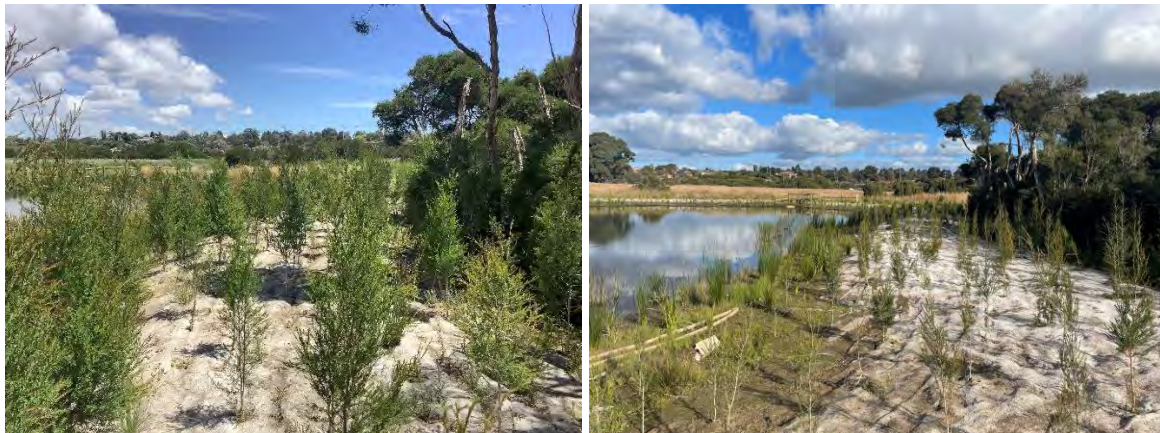
Planted Swamp Paperbark and Woolly Tea-tree in the western and northern entrance have mostly survived and grown considerably (see photos below), except the fallen individuals in the western entrance noted in the last survey which have since died.

Photos 9 & 10. Increase in biomass of planted Woolly Tea-tree and Swamp Paperbark in December 2024 (left) to June 2024 (Right).

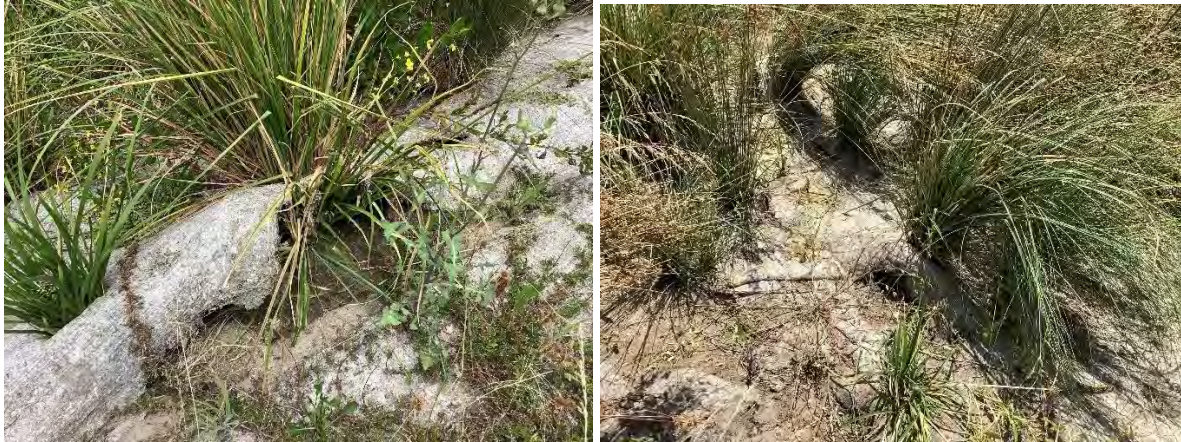
Some areas of the erosion matting had become unpinned and damaged (see photo below). The damage is most likely due to erosion over time and plants outgrowing the holes in the matting. Locations of the most damaged mat areas are shown in Figure 1.

Photo 11 & 12. Representative unpinning of matting caused by plants outgrowing the holes

- Damaged areas of erosion matting will require repair and the plantings in these areas that died as a result will need to be replaced (see below). We recommend re-planting with Hop Goodenia, Mat-rushes, and Spear and Wallaby Grasses. We do not recommend any more plantings with Kidneyweed due to lack of previous success – alternative herbaceous plants to consider instead would be Centella (*Centella cordifolia*) or Hairy Willow-herb (*Epilobium hirtigerum*).

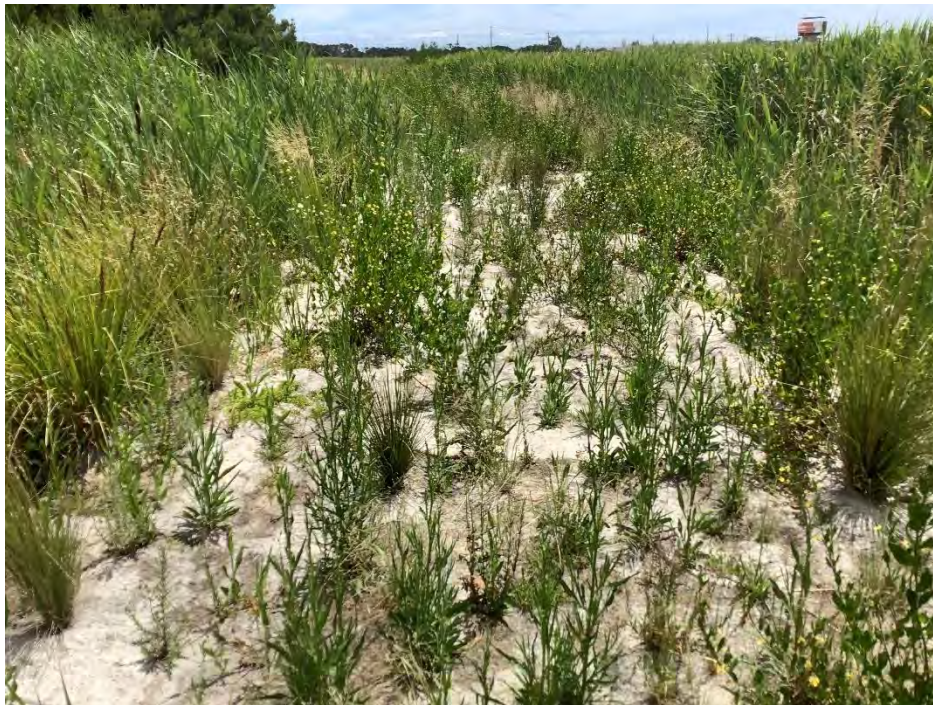
Photo 13. Fleabane and Common Sow Thistle in Figure 1. Photo shows lack of success of planted vegetation and the potential for fleabane to outgrow remaining native vegetation

- Although a high percentage of the revegetation works has been successful, one particular area has been identified in Figure 1 (photo below) which will require further weed management and replanting with similar plants used in the rest of the revegetation path. It is likely that planted individuals have not been as successful in establishing, hence weeds like Fleabane have established instead and the Fleabane could become a high threat weed if left unmanaged.

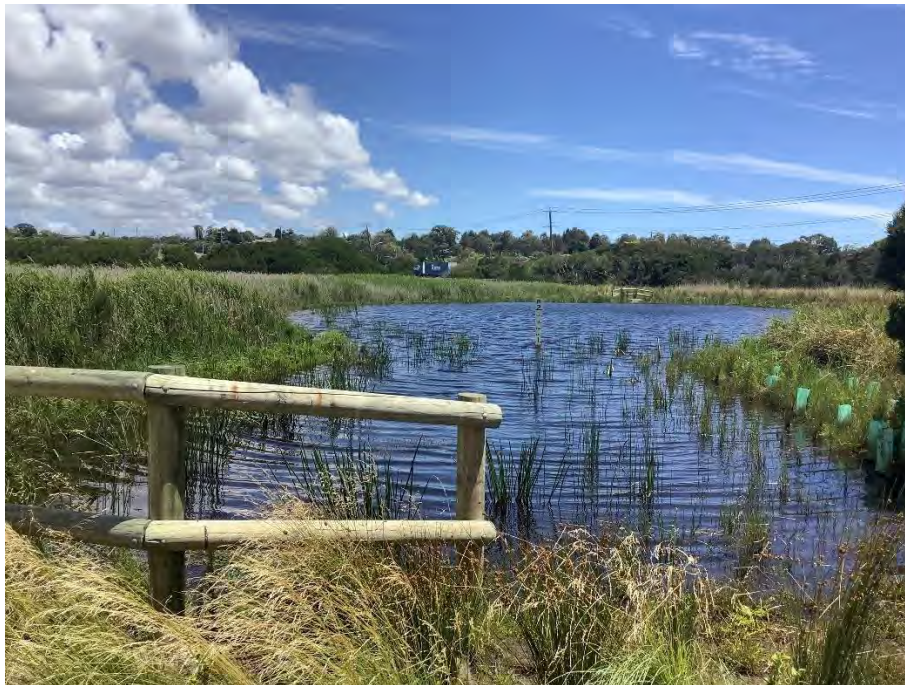
Photo 16. Tree guards surrounding the southern dam to the right of the photo

- The planted Swamp Paperbark and Woolly Tea-trees that have fallen over and died will need to be replaced.
- Most of the tree guards have been removed from site. A small collection of planted shrubs along the border of the southern dam still have tree guards. These will need to be removed and disposed of appropriately (offsite), when no longer required.

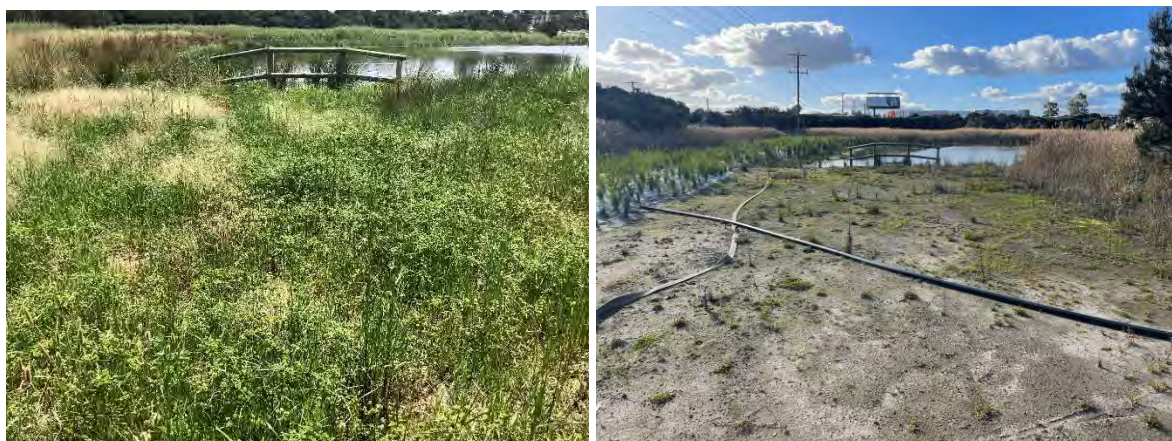
The previous survey identified an area in the southwest of the offset site that was generally devoid of vegetation. It was noted that the purpose of this area was unknown, but the current survey found weeds are colonising that area. This area is now densely dominated by Drain Flat-sedge, Couch Grass, and Fleabane (see photos below and Figure 1). These weeds are likely to invade the adjacent native wetland and revegetation works if left managed, therefore these weeds should be removed and it is recommended that native species be seeded or planted here.

Photo 22. Southwest of the offset site, previously non-vegetated (right) is now dominated by Fleabane, Couch grass, and Drain Flat-sedge (left).

- Future use of the non-revegetated area (now colonised by dense weeds) is yet to be confirmed. If this area is to be a permanent area set aside for maintenance and access, the area will require works to provide proper foundation. If this area will not serve as a maintenance purpose and has another intended purpose, it needs to be managed as to limit the continued establishment of high threat weeds. It is recommended that this area undergoes a revegetation treatment and done so rapidly as to provide additional native vegetation, mitigate weed establishment and soil erosion.

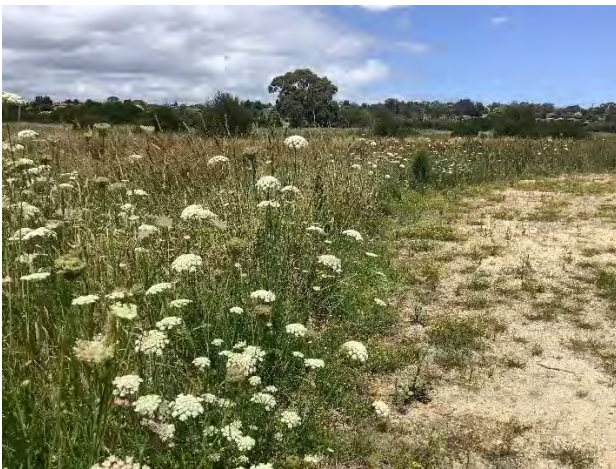
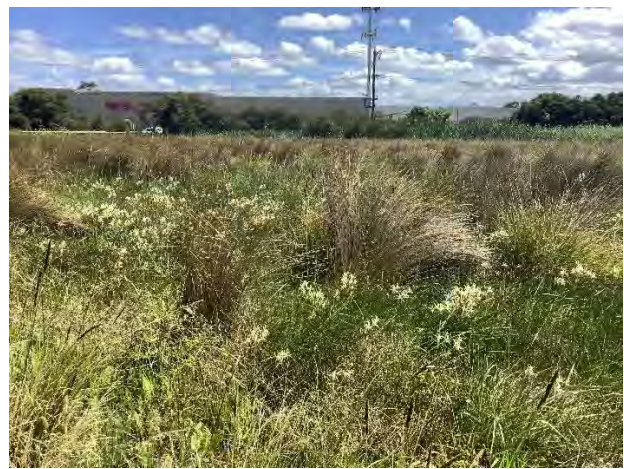
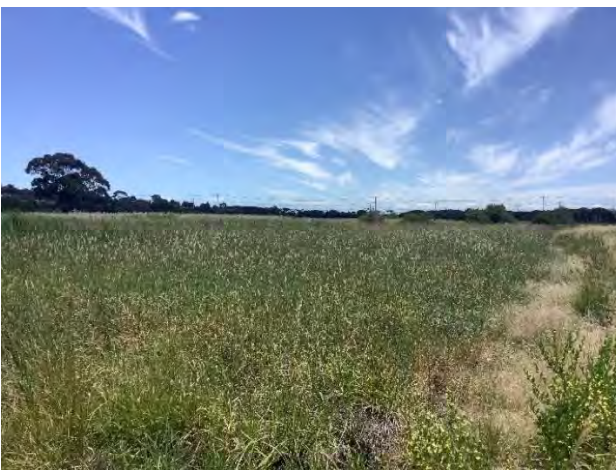
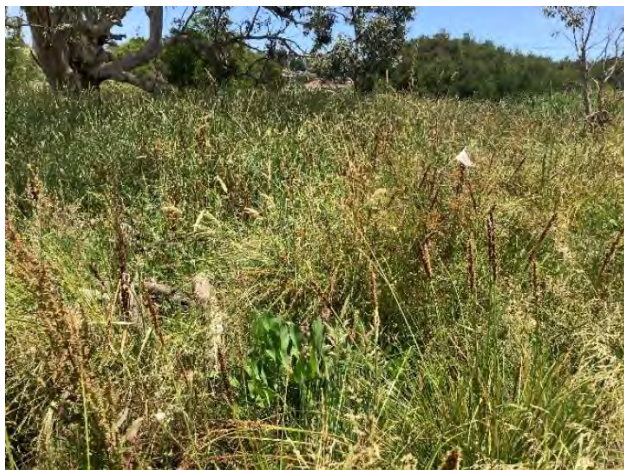
Photos 19-23. Top left – Weedy area along the dirt track. Top right – Wild Gladiolus in the northeast of the offset site. Bottom left – example of Toowoomba Canary-grass dominated area. Bottom right – weeds along the revegetation track in the southern part of the site.

- Continued weed control should aim for the following:
 - While all weeds should be removed or reduced as much as possible, the high-threat weed species (listed above) are to be prioritised.
 - Reduce weed cover in the Weed Areas mapped on Figure 1.
 - Reduce weed cover along the dirt track in the northern part of the site and in the areas of Swamp Scrub. All woody weeds (Blackberry, Gorse, Sweet Briar, Sweet Pittosporum and Yucca) are to be completely removed.
- Continued weed control actions should include the following:
 - Weed control should mostly occur during the times of the year when herbaceous and grassy weeds are actively growing and prior to flowering/seed set (generally in late spring), so treatment is most effective.

- Spot-spray using a herbicide that is appropriate for use in environmentally sensitive areas, such as Roundup Biactive® (Glyphosate). Spot-spray on target grassy and herbaceous weeds, with care to avoid off-target damage to revegetation works and native plants in the existing wetland vegetation.
- For areas containing significant infestations of Toowoomba Canary-grass (as shown in Figure 1), it is strongly recommended that the Toowoomba Canary-grass be regularly slashed every 3 months, including in late spring. Slashing prior to seed set in late spring will help prevent their spread and recruitment. Slashing also reduces biomass, enhancing visibility for weed treatment.
- Woody weeds can be removed using the cut-and-paint method, at any time of the year.
- Spot-spraying of Wild Gladiolus should occur in summer when it is flowering and therefore easily visible.

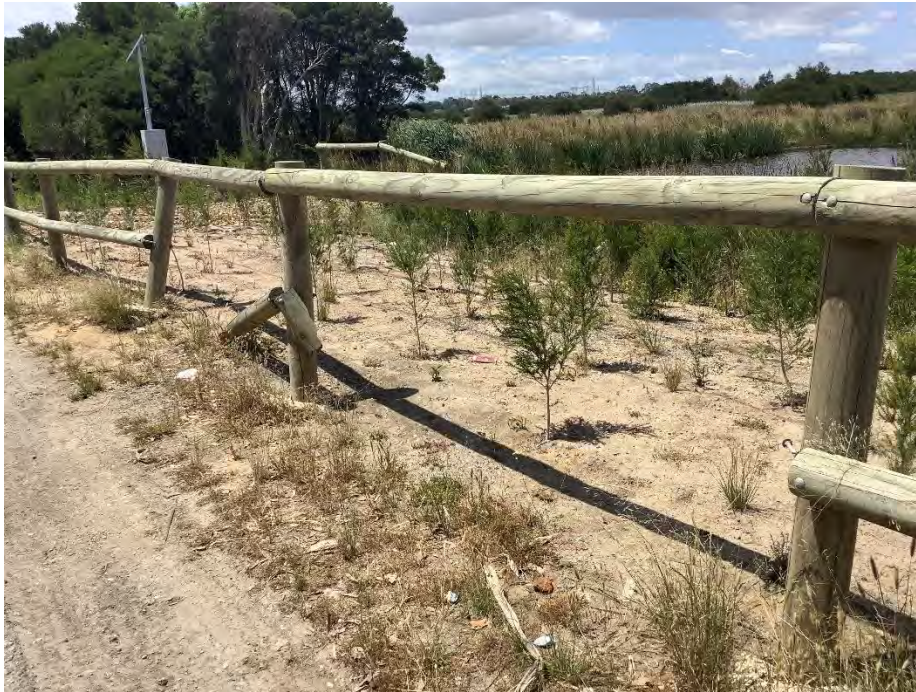
Permanent fencing was installed at the two refuge pools as indicated on Figure 1. The current perimeter fencing along the northern boundary does not prevent members of the public from accessing the offset site (this appears to be intentional as there is an open entryway incorporated into the fence). However, this leaves the revegetation works vulnerable to vandalism and damage as shown by the dumping of rubbish within the offset site. This survey found that the northern fencing remains damaged (see photo below).

Photos 24. Damaged perimeter fencing next to the entryway at the northern boundary.

- The damaged section of the northern fencing will require repair.
- Although the intention may be to enable public access to the offset site in the long-term, it is recommended that the fencing along Centre Road include wire mesh (Image 1 below) and that the entry ways be locked off outside of maintenance activities, to limit revegetation works from damage. Revegetation sites and reserves tend to be vulnerable to vandalism and other disturbances like dumping of garden waste as shown by the continued presence of rubbish 12-months post construction.

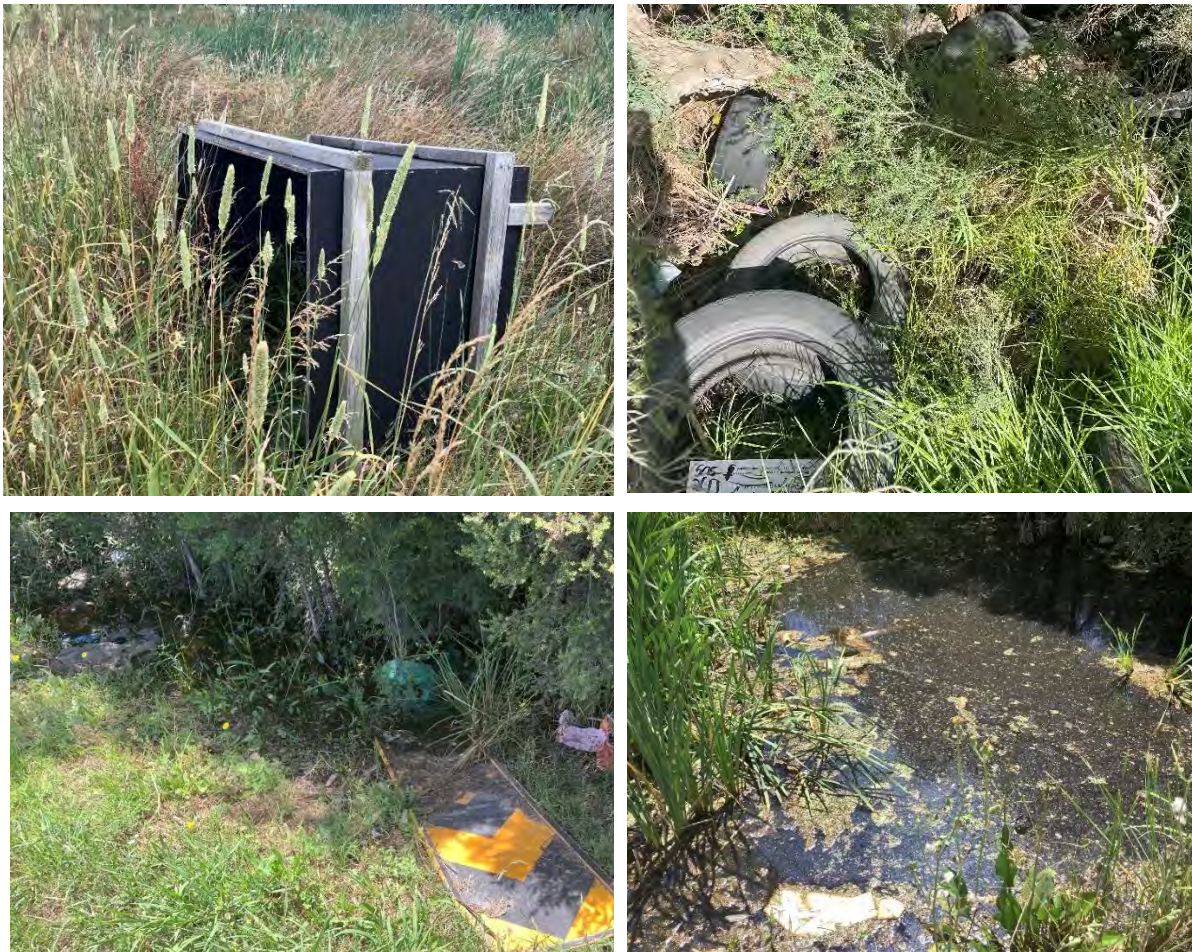
There was rubbish present in the offset site during this survey, including along the edge of the wetland pools (Figure 1). Swamp Scrub along Centre Road also still contains some rubbish dumping. Unfortunately, this Swamp Scrub can be easily accessed by members of the public from Centre Road. Clean up of litter or dumped waste within the site is the responsibility of the proponent. but not along roadsides which is required to be addressed by council.

Photos 25-29. Litter inside the offset site and dumped tyres in the Swamp Scrub along Centre Road.

- Remove litter and dumped rubbish inside the offset site. (Note: It is the council's responsibility to address littering and illegal waste dumping on public land, such as the roadsides of Centre Road and Hallam Road.)

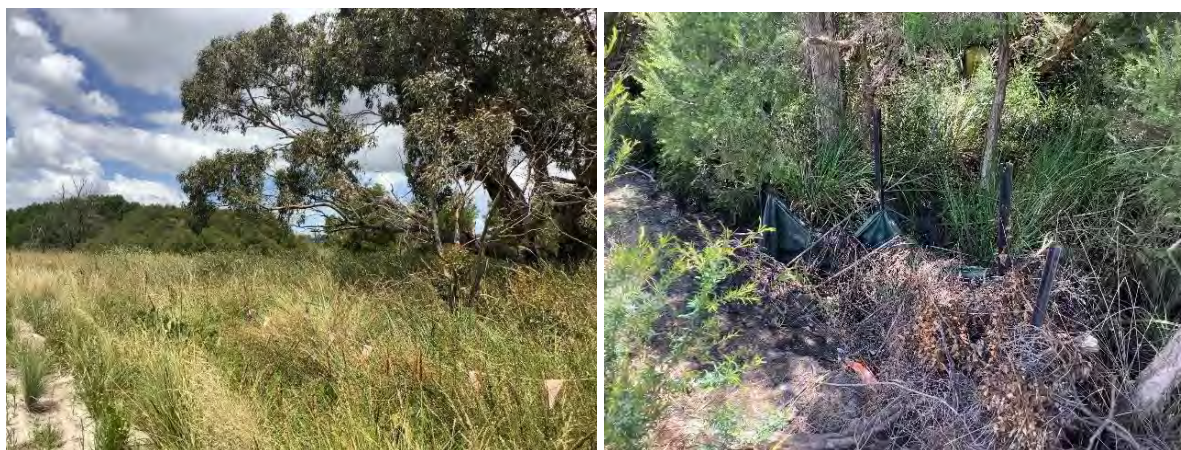
Rope bunting was observed along the interface of the existing wetland vegetation and the revegetation track, in the southern part of the offset site (Figure 1). This was evidently used to prevent accidental encroachment into the vegetation during construction of the revegetation track, however it currently does not serve a purpose and most of it has fallen. Similarly, broken sediment fencing was identified to the west of the most northern dam (Figure 1). The majority of the revegetation efforts have finished, and it is unlikely needed for sediment protection purposes, as such it and the rope bunting should now become part of the rubbish removal effort.

Photo 30-31. Rope bunting along the southern portion of the revegetation track (left) and broken sediment fencing (right).

- Remove all roped bunting (and stakes) at the southern part of the offset site as they have become rubbish in the site. Vegetation in these areas is becoming overgrown and if delayed it will become harder to be removed.

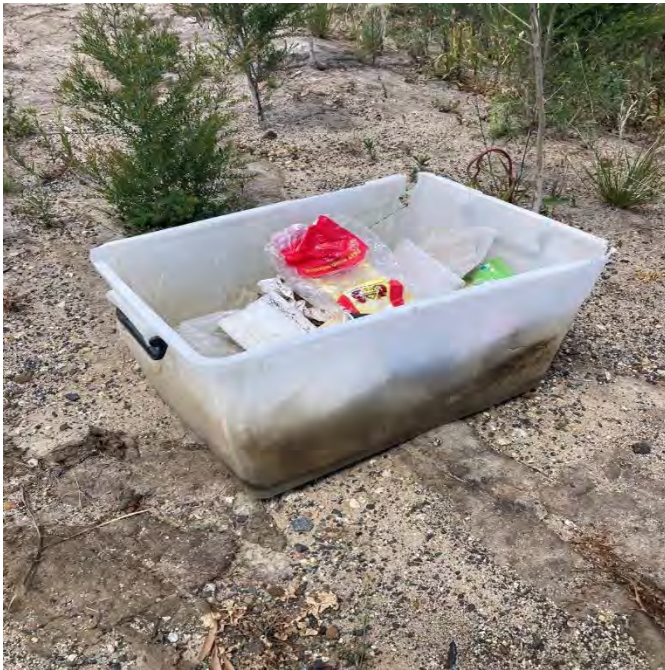
Rubbish collected

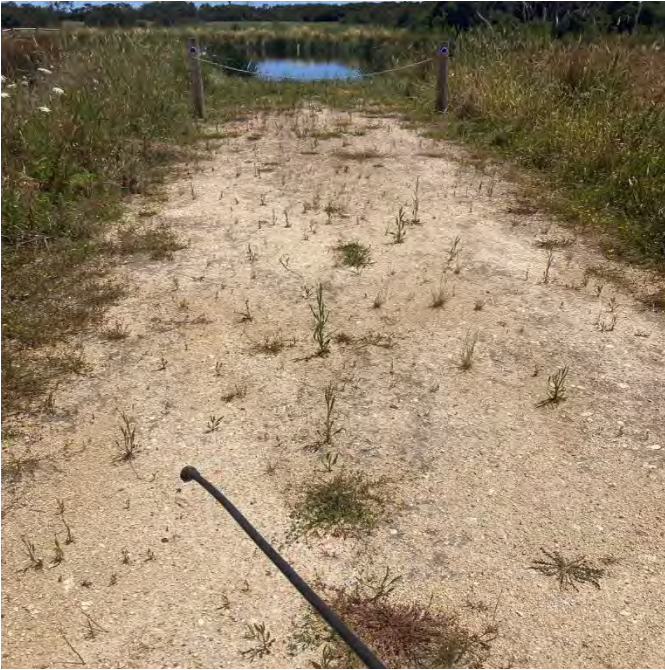
Track sprayed out
