96-166 Centre Road,  
Narre Warren –  
Dwarf Galaxias  
habitat buffer

Year 5  
Vegetation Monitoring

Prepared for  
Narre Warren Central Pty Ltd  
c/- The Fidus Group

December 2022  
Report No. 14090.8 (17.0)

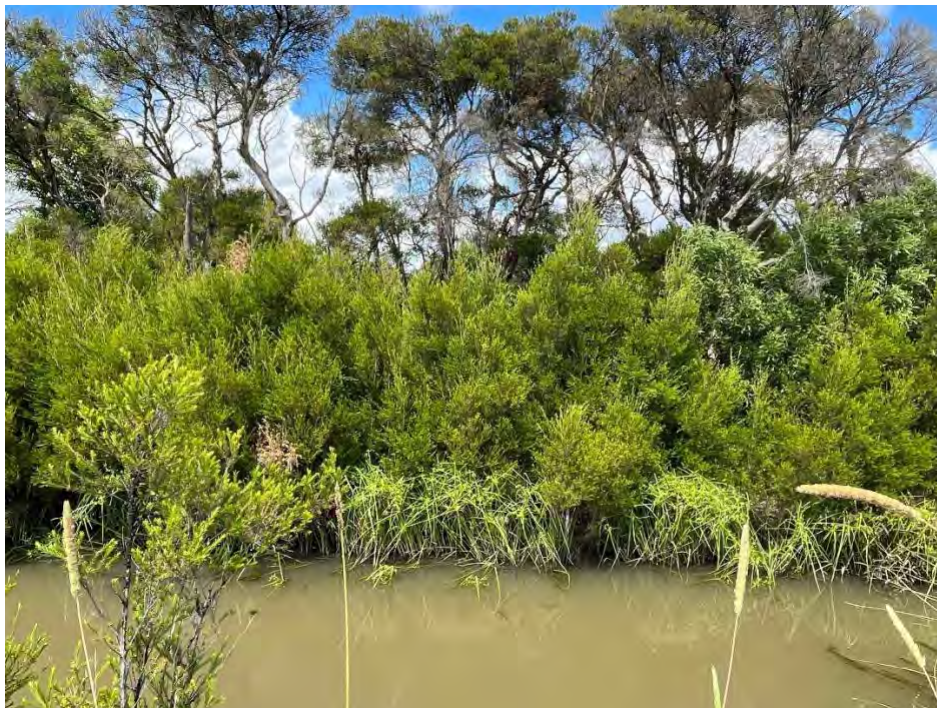
The habitat buffer which ran between Centre Road and the Pakenham Railway line – which supported quadrats 11, 13, 15, 16 & 17 – was unable to be accessed due to the large swale drains containing deep water along both the eastern and western sides (Photo 1). Access at the entry from the Centre Road onto Billy Button Drive and the crossing between quadrat 1 and 4 were attempted, however there was still deep water and/or impenetrable vegetation at those locations, and the habitat buffers could not be accessed safely.

**Photo 1.** Swale drain with deep water (foreground) preventing access to the habitat buffer between Centre Road and the Pakenham Railway line, which supported quadrats 11, 13, 15, 16 & 17.

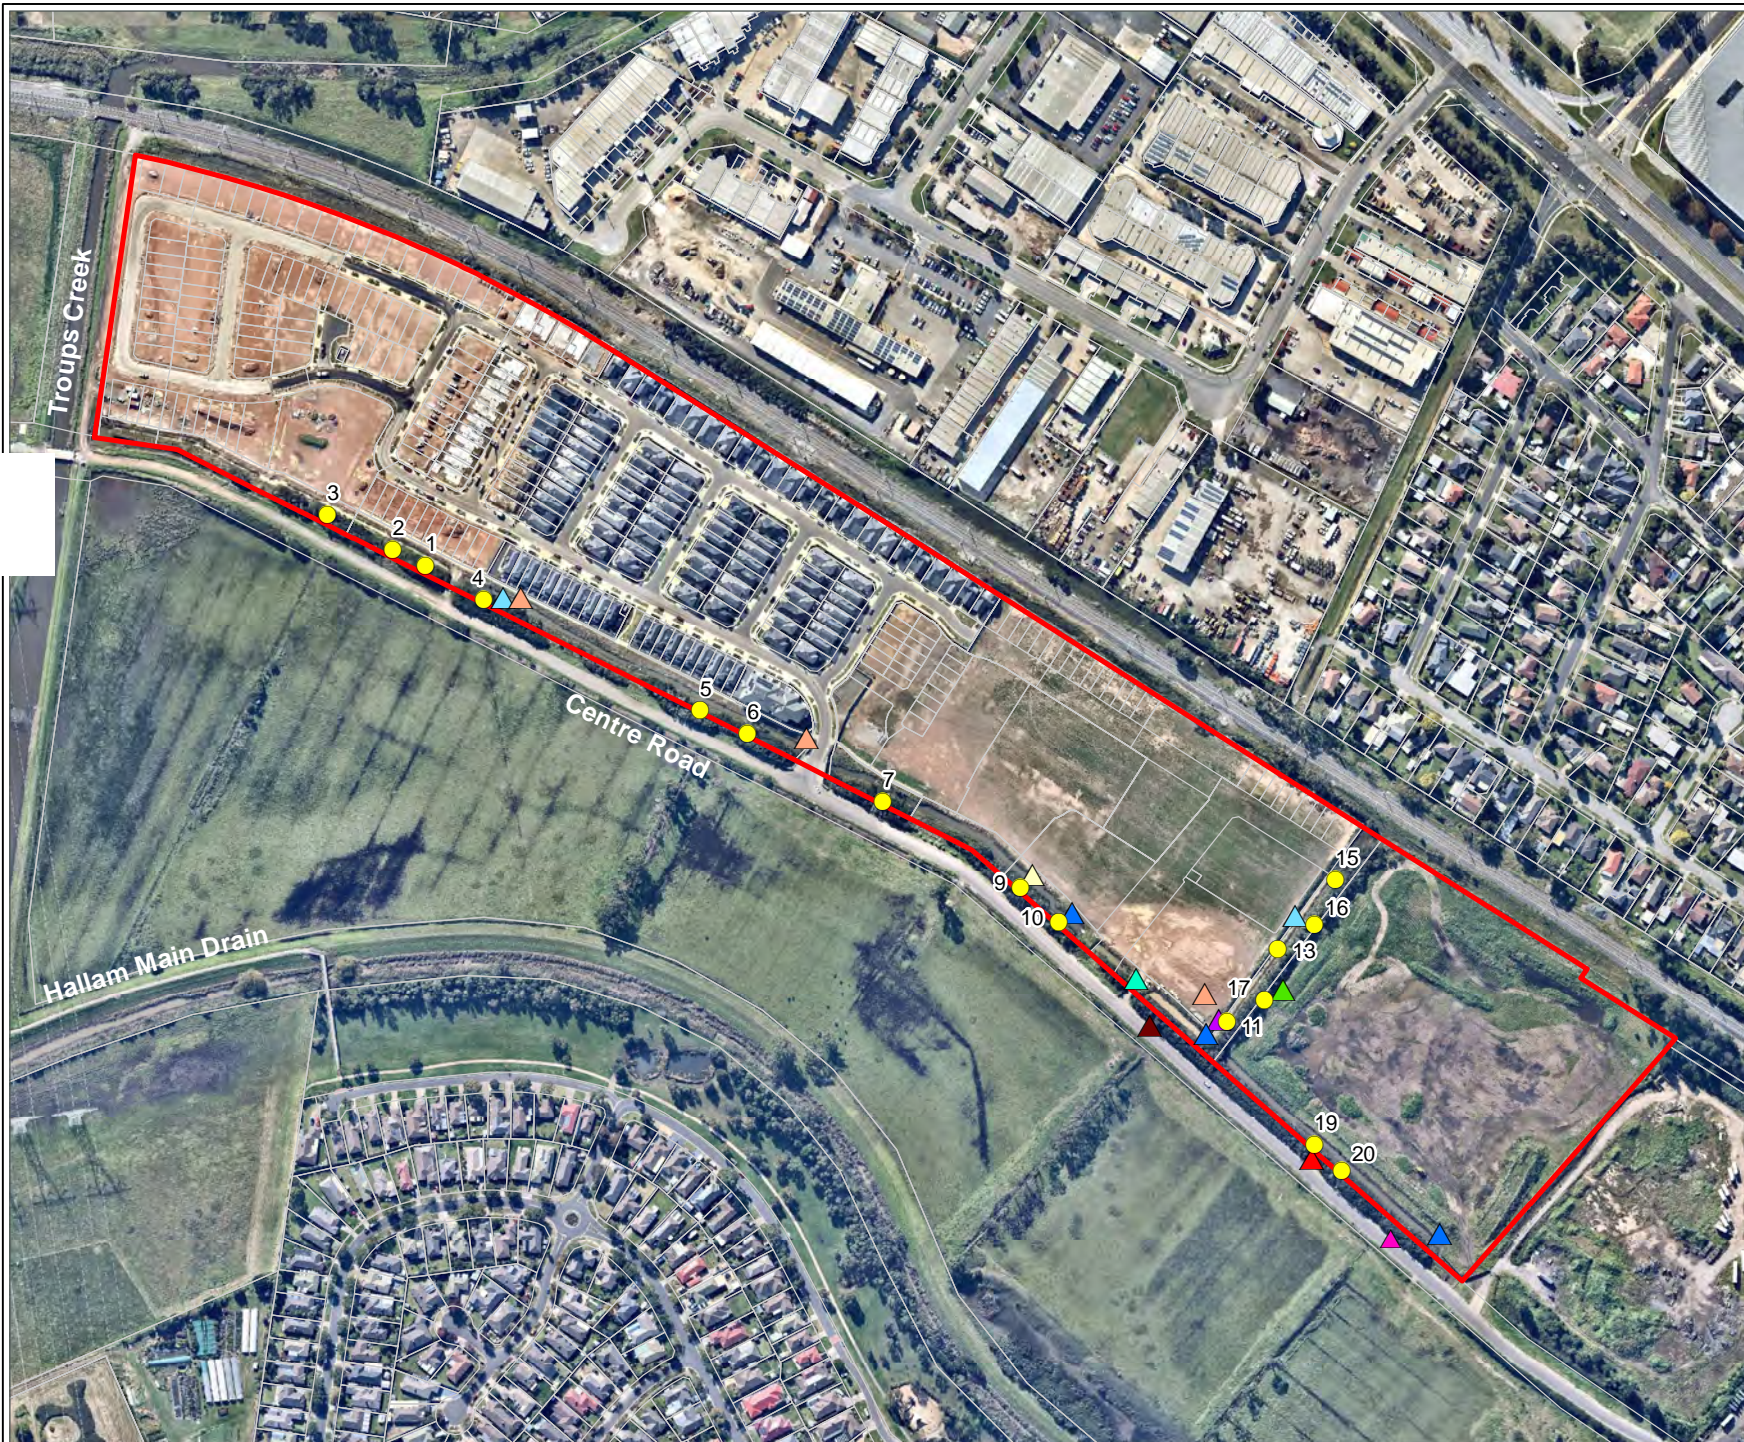
Figure 1: Site and monitoring locations

Sediment fencing between the habitat buffers and swales/drains was in generally good condition across the study area. A few areas of sediment fencing had collapsed or been damaged, as mapped in Figure 1. The previous monitoring had reported collapsed fencing with erosion channelling occurring in the central part of the study area; the current monitoring found this has been rectified with intact fencing and the erosion was addressed with some rock fill, hay bales and sandbags.

Collapsed or damaged sediment fencing (as mapped on Figure 1) should be rectified to prevent further sedimentation and run-off into the swales/drains. It is strongly recommended that all sediment fencing surrounding the habitat buffers are regularly checked and any collapsed/damaged fencing rectified in a timely manner, as part of routine on-ground works. Any sediment fencing that is no longer serving its purpose is to be removed to avoid the fencing becoming litter.

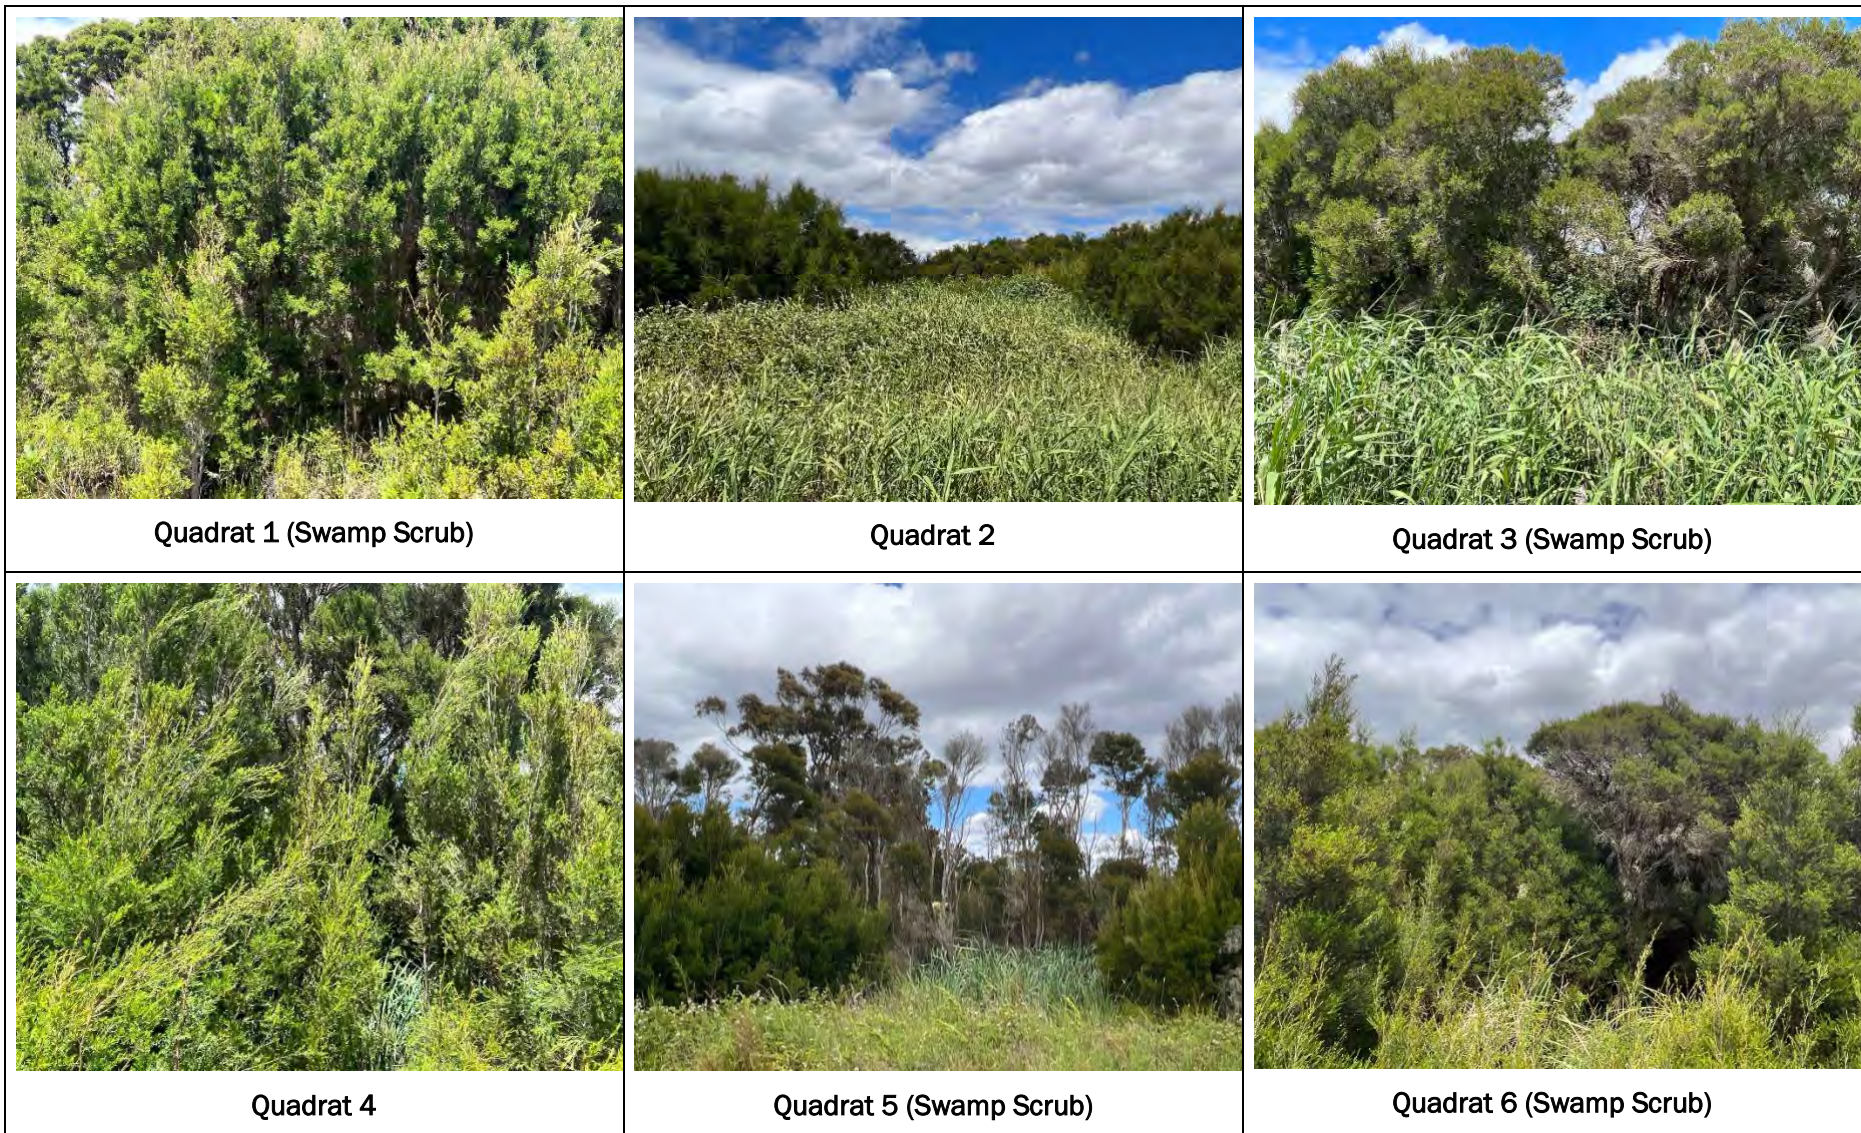
**Appendix 1: Representative photos of general quadrat locations**

The cover of native vegetation was generally high; 70-80% for nine out of 16 quadrats, 50-60% for five quadrats and less than 50% for two quadrats. This was mostly attributable to Swamp Paperbark (including mature individuals and heavy recruitment) with Black Wattle also present. It was further noted that the aquatic vegetation in the swales and drainage channels were usually dominated by native Narrow-leaf Cumbungi, Common Reed and (to a lesser extent) Slender Knotweed and Spike Rush.

It should be noted that at quadrats 7, 9, 19 and 20, the Swamp Paperbark appeared to have dieback occurring, i.e. moderate to severe crown decline.

The cover of weeds was generally medium to high; 40-50% for six out of 16 quadrats, 25-30% for four quadrats, 5-10% for four quadrats and 0% for two quadrats. This was mostly attributable to the high-threat species Blackberry. Other high threat weed species observed included Flax-leaf Broom, Patterson's Curse, Spear Thistle and Ox-tongue.

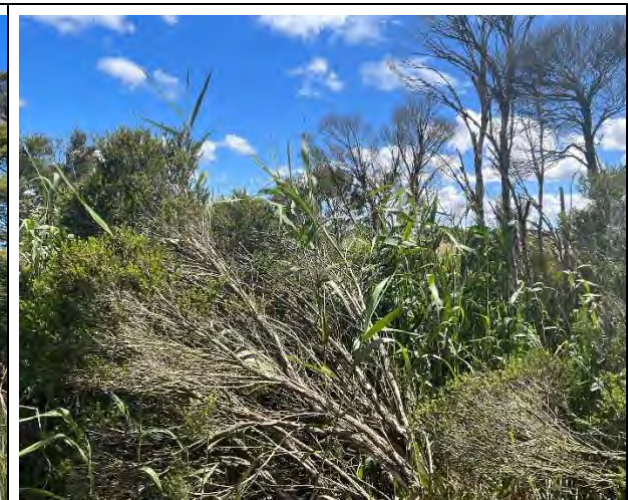
**Quadrat 19 (Swamp Scrub)**

As previously described, the Swamp Paperbark at quadrats 7, 9, 19 and 20 appeared to have dieback occurring. Concurrently, quadrats 7 and 9 also had the highest weed covers of the 16 quadrats (50%) due to Blackberry. There may have been less Blackberry at quadrats 19 and 20 due to very dense Swamp Paperbark and/or very wet conditions indicated by the presence of Common Reed.

The cause(s) of the dieback are not evident and it is possible that the lost foliage cover from Swamp Paperbark may return. However, it is strongly recommended that dieback in the habitat buffers be monitored regularly over the next year and at the next monitoring event, given the consequences of declining cover from Swamp Paperbark would be less native vegetation cover and likely increase of Blackberry. If this should occur, early detection would help support more effective intervention.

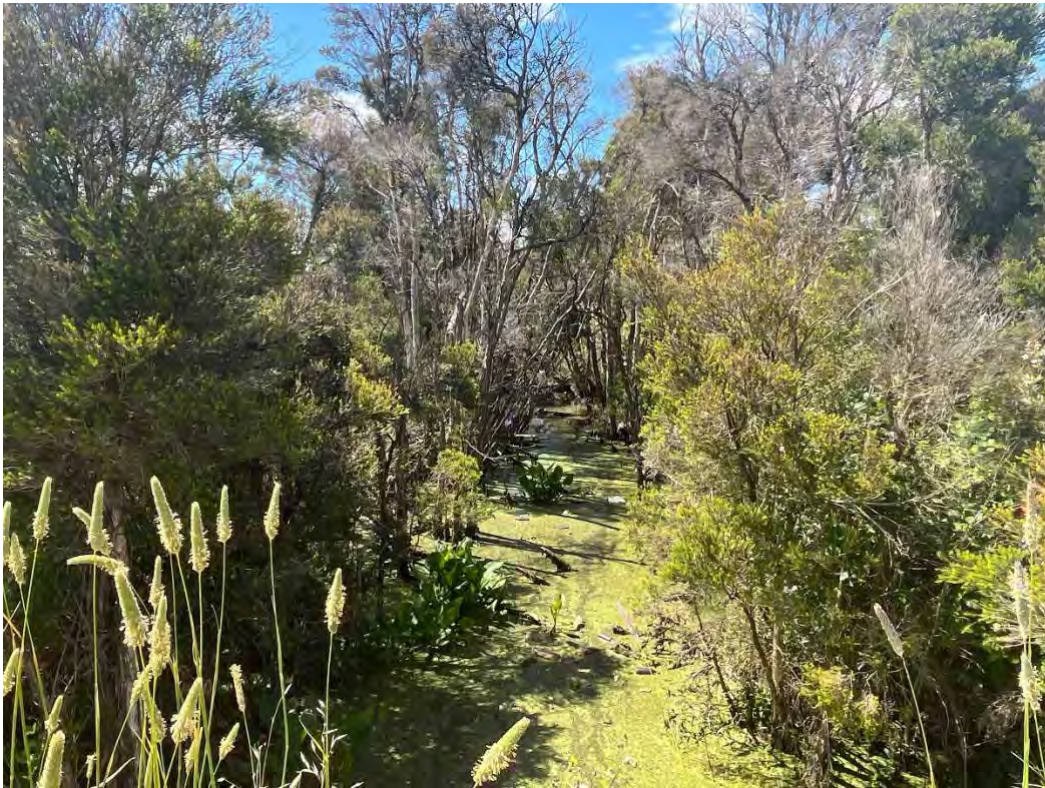
Algal blooms were observed in the water inside the habitat buffer along Centre Road, as seen and photographed from the entry to Billy Button Drive from Centre Road.

The drainage channel along Centre Road was full of water and contained algal bloom.

Algal blooms are an indicator of excess nitrogen and phosphorus in the water, and the algal blooms may impact on native aquatic plants (and therefore the quality of Dwarf Galaxias habitat) by consuming oxygen and blocking sunlight. Preventing soil erosion and run-off into the habitat buffers, as well as maintaining vegetation cover, will help to reduce algal blooms. In particular, sediment fencing around the habitat buffers will be required to be effective in controlling soil erosion and run-off (discussed above). Rubbish management will also support reduction of algal blooms.

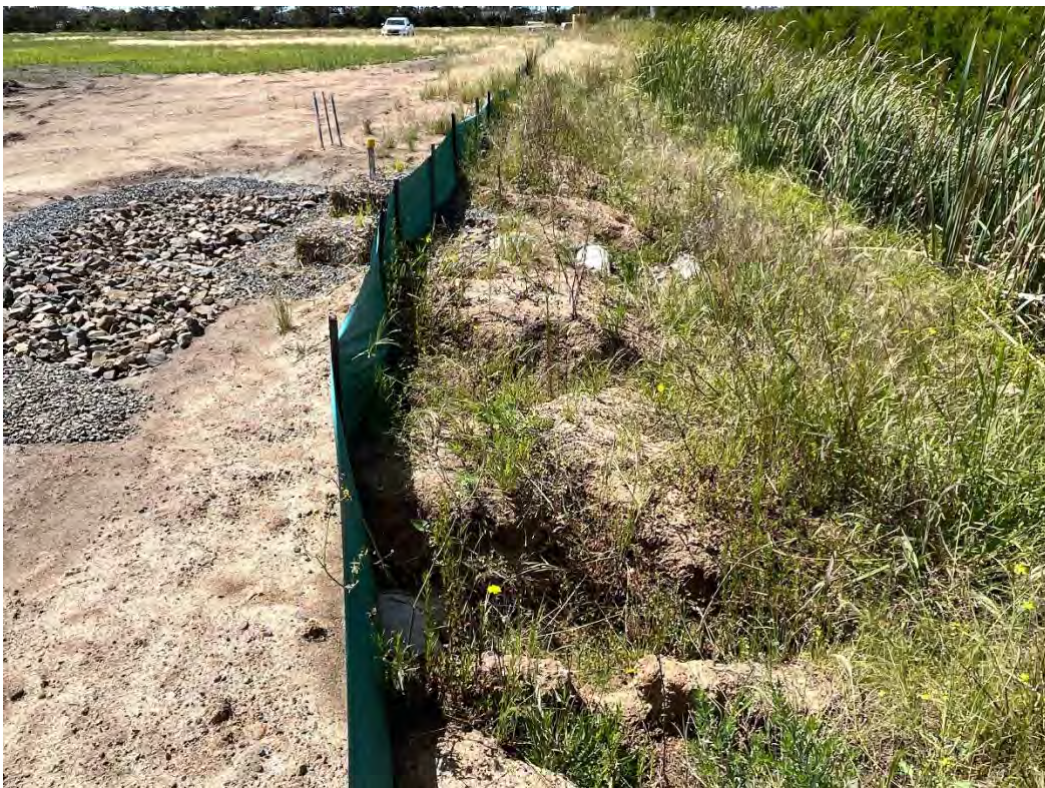
Sediment fencing in good condition, with efforts to control erosion through the use of rock fill, hay bales and sandbags along the northern edge of the swale in the central part of the study area.

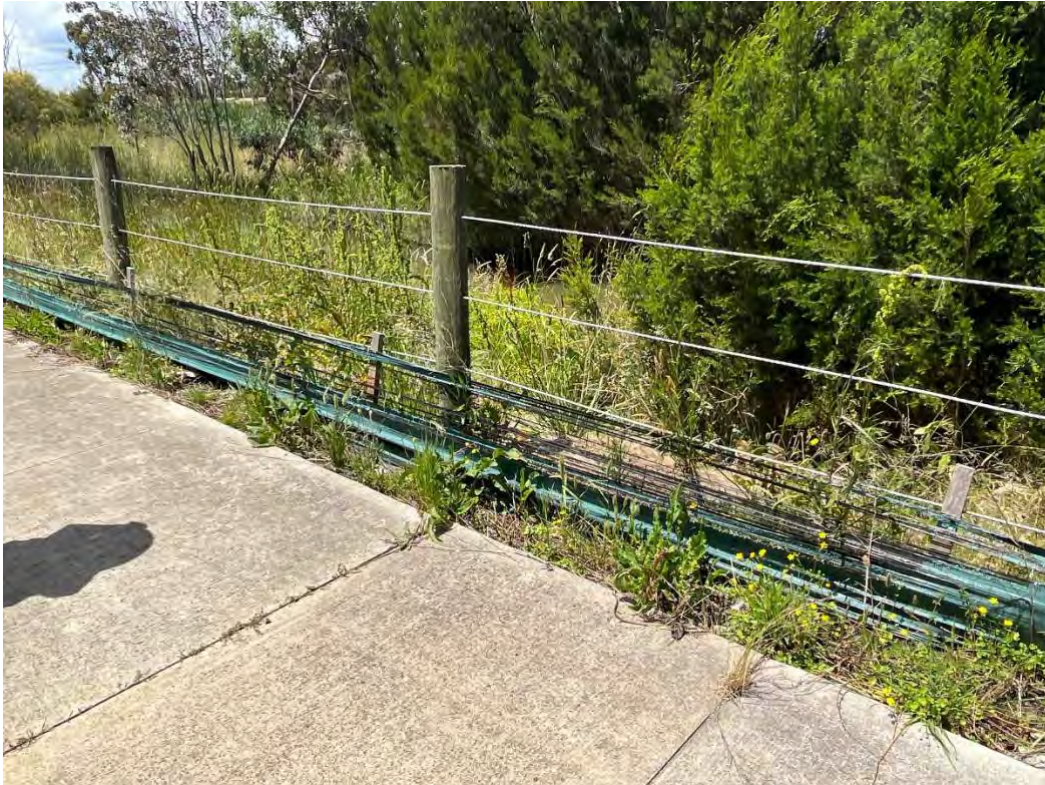
Sediment fencing along the path south of Billy Buttons Drive was generally intact but portions of it had begun to break down. The broken-down fencing must be rectified as soon as possible.

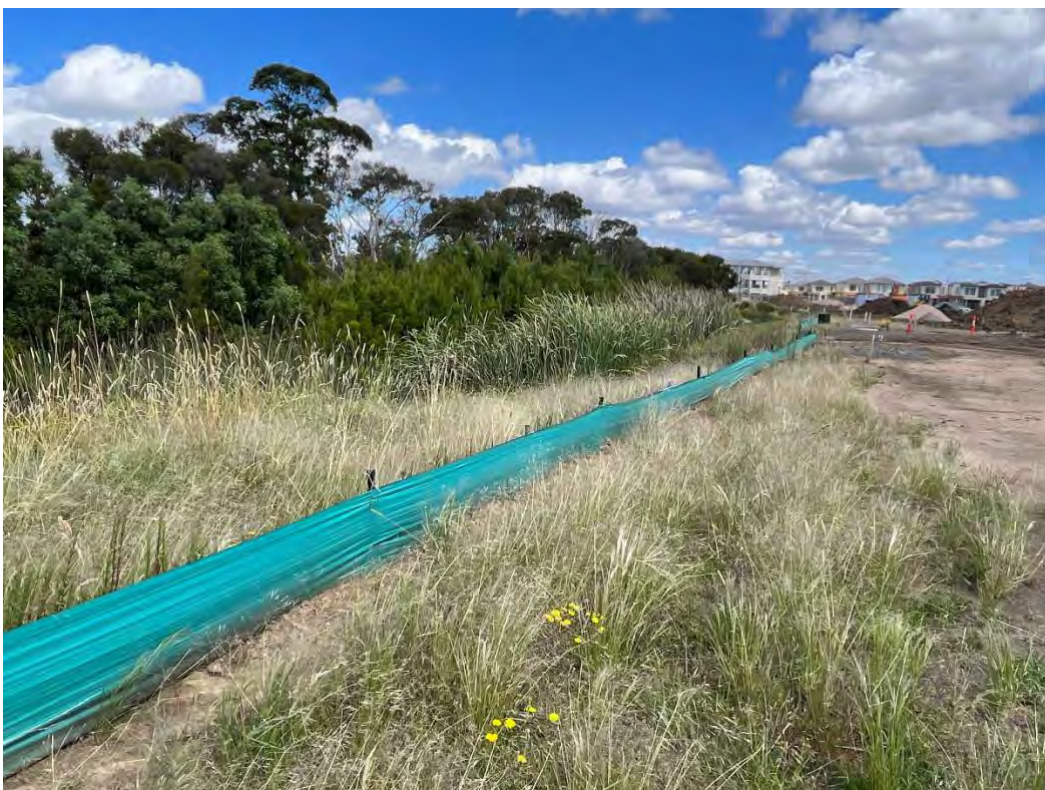
Example of sediment fencing in good condition along the northern edge of the swale in the eastern part of the study area.
