# **96-166 Centre Road, Narre Warren – Dwarf Galaxias habitat buffer**

## **Year 3 Vegetation Monitoring**

**Prepared for  
Narre Warren Central Pty Ltd  
c/- The Fidus Group**

December 2020  
Report No. 14090 (15.0)

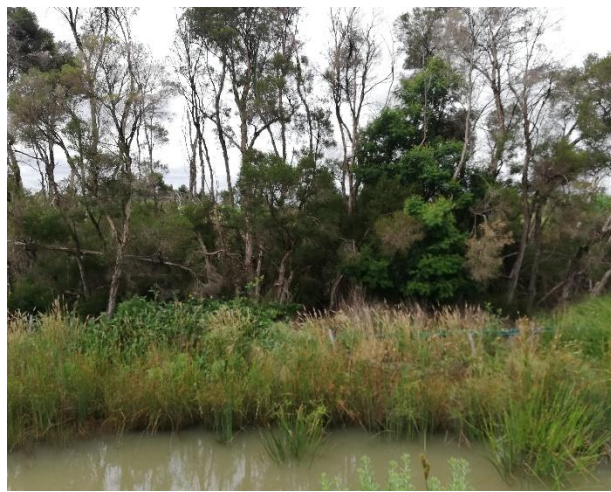
**Quadrat 16 (Swamp Scrub)**

16	Swamp Scrub	Co-dominated by Swamp Paperbark and Black Wattle, moderate cover of Blackberry	30	70
17	Non-native	Dominated by Swamp Paperbark. Blackberry present	10	90
19	Swamp Scrub	Swamp Paperbark, Common Reed and Blackberry present	30	70
20	Swamp Scrub	Dominated by Swamp Paperbark, with a low cover of Common Reed	10	80

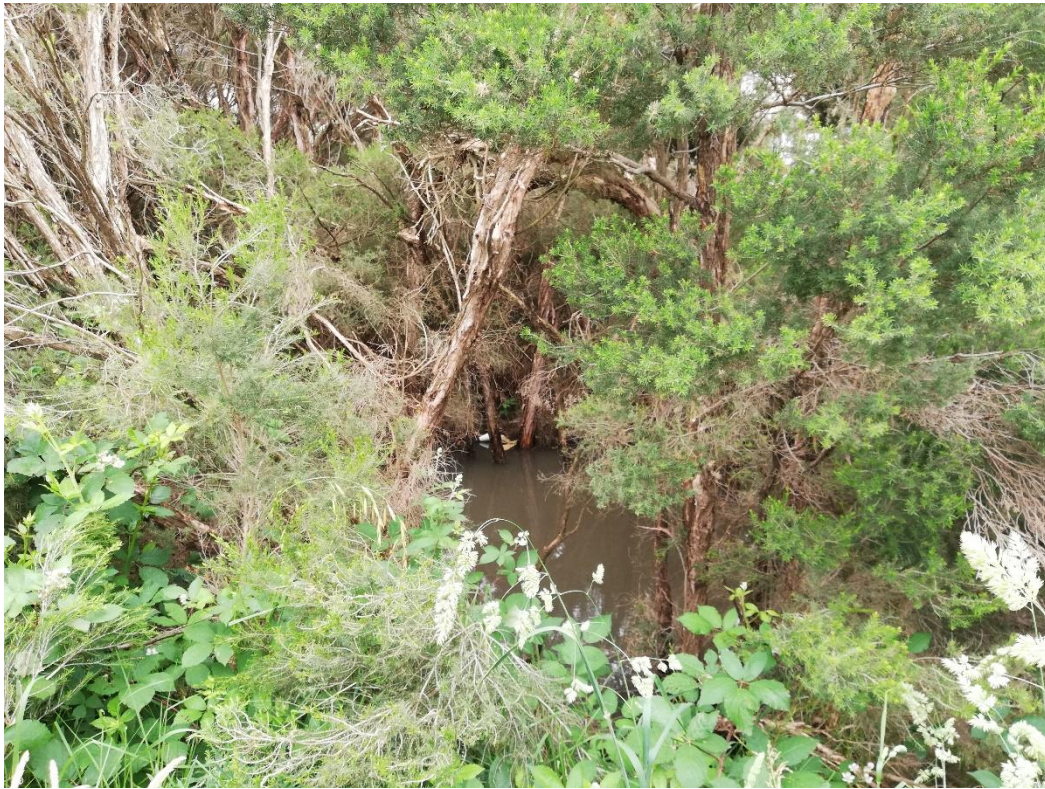
The habitat buffer which ran alongside Centre Road to the west of Billy Button Drive was unable to be accessed due to being surrounded by water, as both the drainage channel to the south of the habitat buffer and the swale that was present immediately north of the buffer, were full of water. This habitat buffer to the east of Billy Button Drive was also inaccessible due to the deep water present in the drainage channel and impenetrable vegetation.

**The drainage channel along Centre Road was full of water**

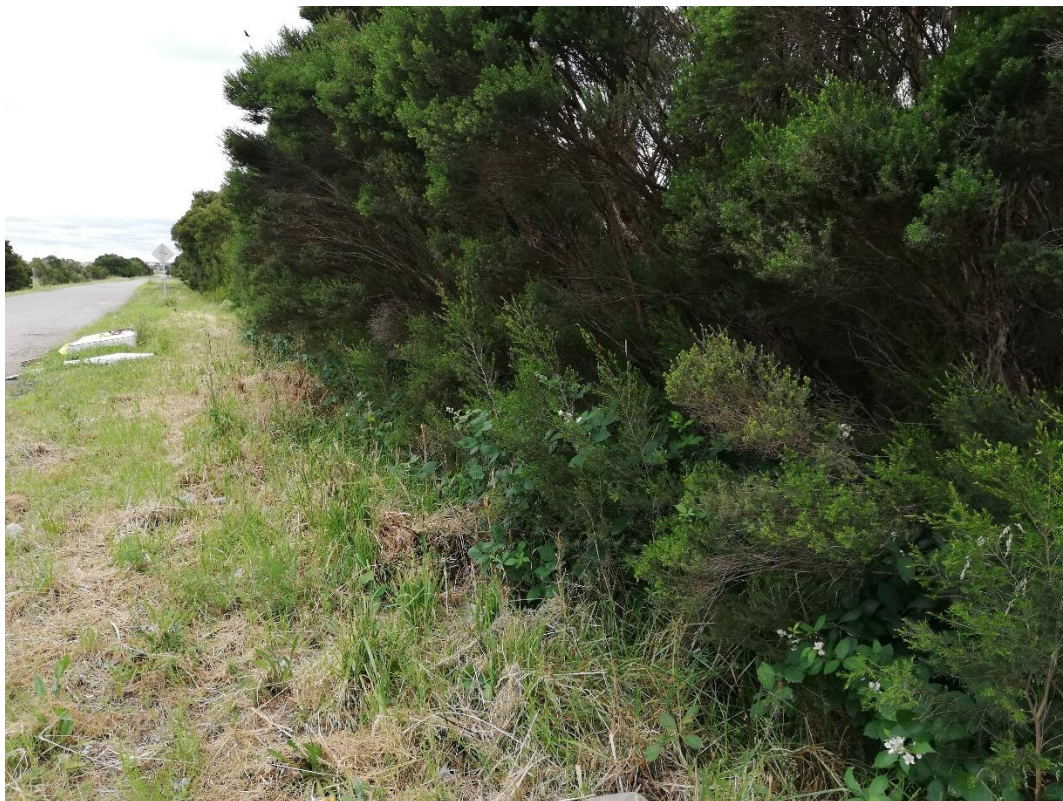
**Swamp Scrub vegetation along the southern bank of the drainage channel west of Billy Button Drive**

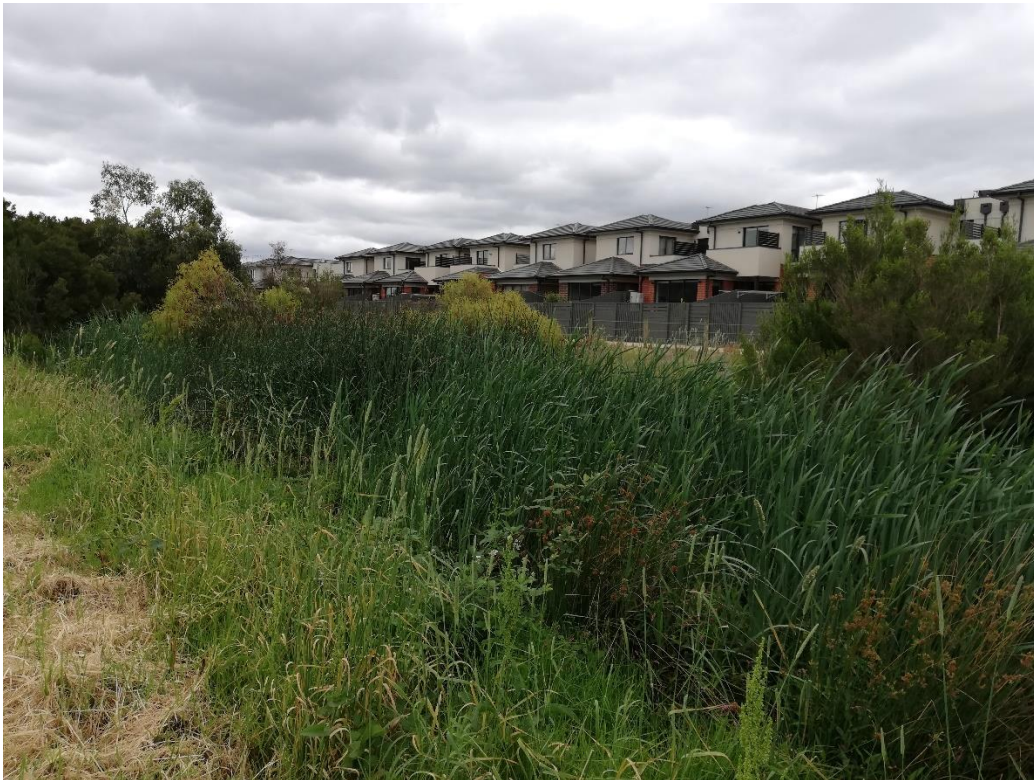
**Narrow-leaf Cumbungi and Rush present in the drainage channel**

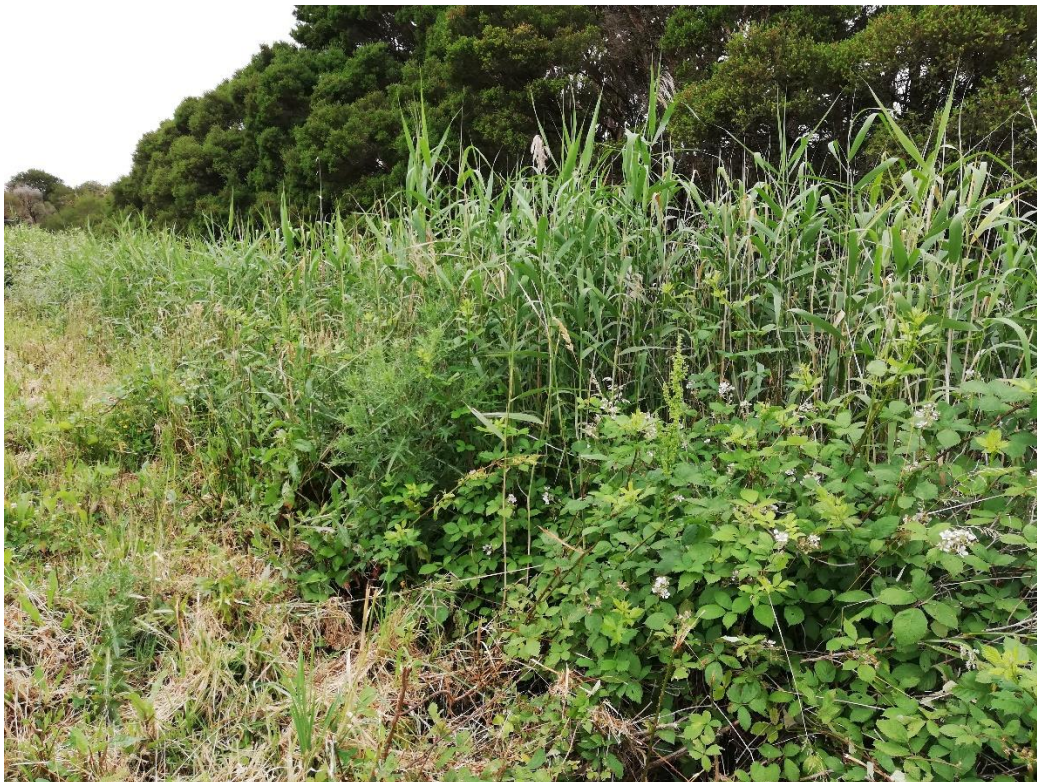
**Common Reed dominating large areas along the drainage channel in the west**

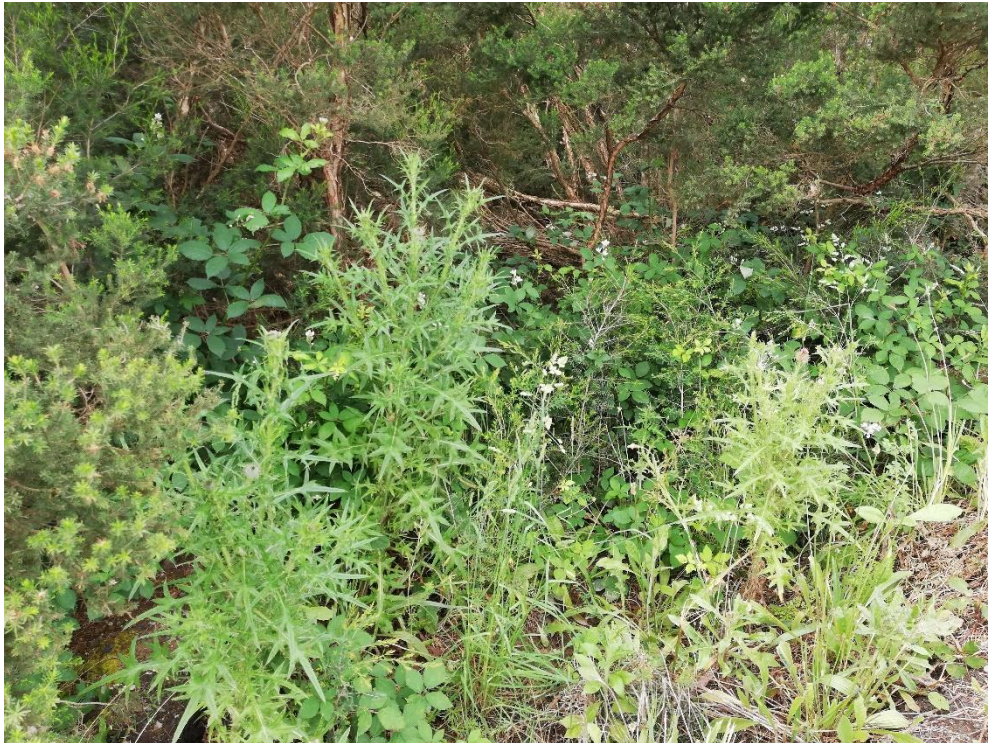
**The high-threat weed species Spear Thistle was common along the southern bank of the drainage channel west of Billy Button Drive and must be controlled**

accessed. The high-threat herbaceous weed Spear Thistle, common throughout the site, should also be treated via spot-spraying.

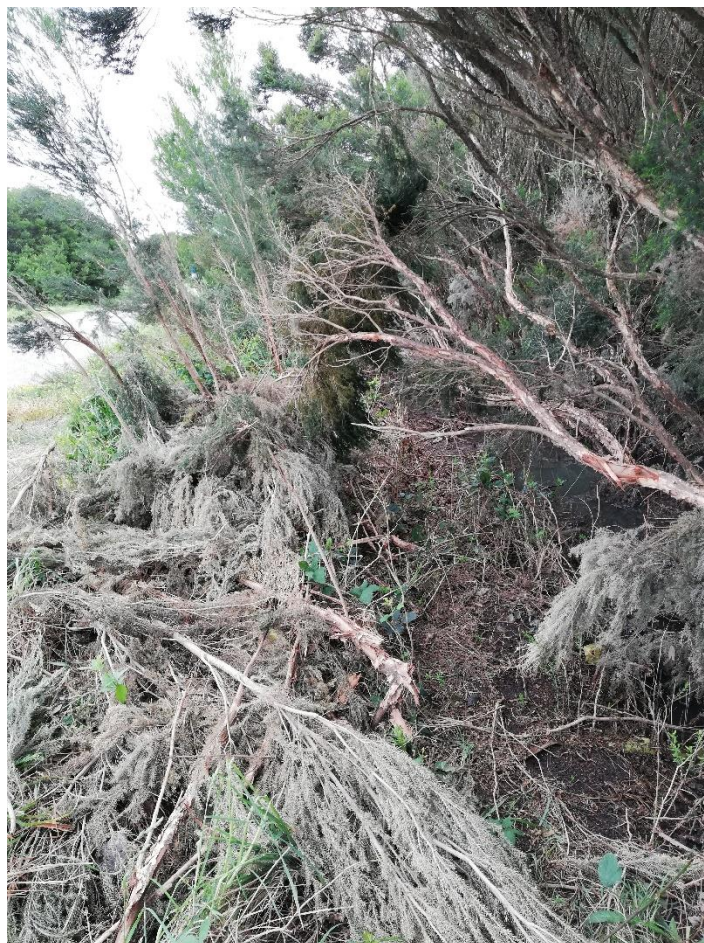
A significant amount of hard rubbish was observed within or close to the buffer areas, including polystyrene, dumped timber, car tyres, general construction refuse and plastic bottles. This was both from construction within the site as well as from the public using the road to the south of the site. Habitat destruction was present in one location to the west of Billy Button Drive where several Swamp Paperbark plants had been knocked over. In addition, sediment fencing between the habitat buffers and swales had collapsed and fallen, and in many cases, was breaking up. In particular, where construction was currently occurring in the very west of the site, sediment fencing had collapsed under the weight of recent sediment runoff, and erosion channels had occurred underneath the existing sediment fence. This has resulted in sediment build-up in the water near the edge of the drain and amongst the native Common Reed.

**Habitat destruction where Swamp Paperbark plants have been knocked over**

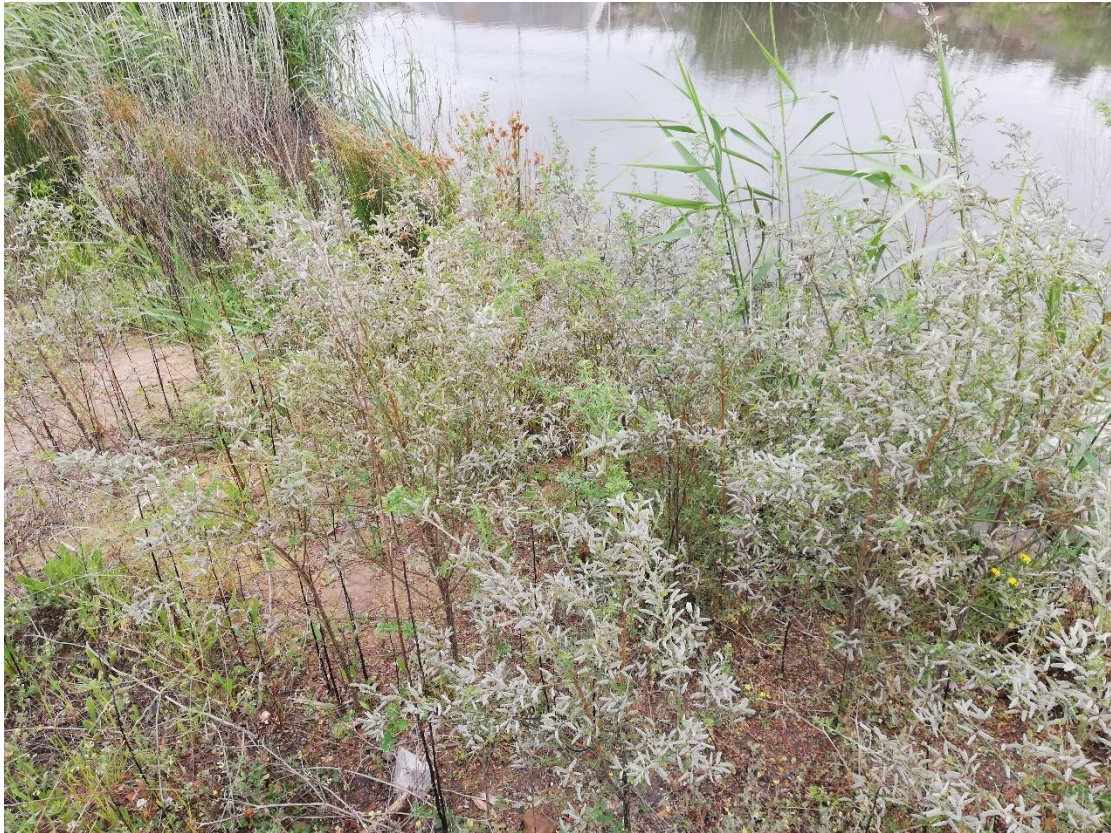
**Montpelier Broom at the very western end of the drainage channel is to be removed**

Alternatively, Nature Advisory recommend that weed control efforts should focus on the other woody weeds on the site, namely Montpelier Broom, Flax-leaf Broom, Hawthorn and Desert Ash, that can be easily treated via the cut and paint method, providing they can be

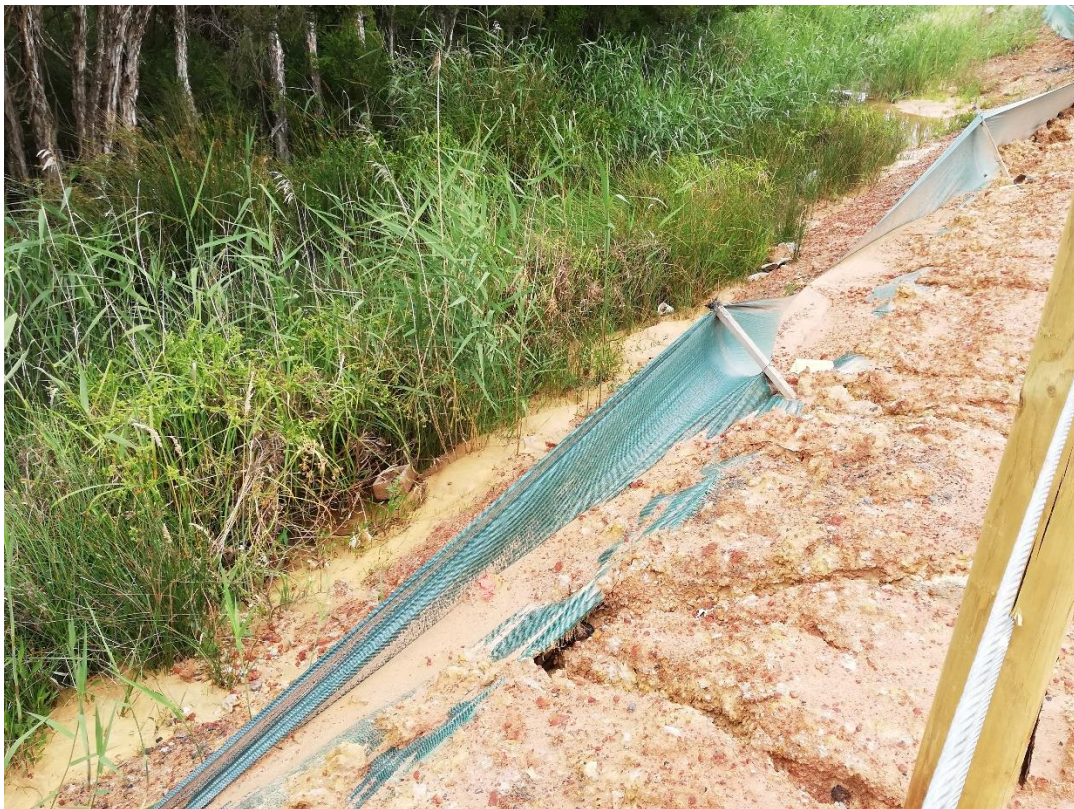
**Sediment fencing has collapsed, with erosion channels running beneath the fencing, along the northern edge of the swale in the west of the site. Sedimentation of the water can be seen.**

Collapsed sediment fencing along the northern edge of the swale drain in the west of the site is to be repaired to prevent further sedimentation into the drains. Where required, sediment fencing must be replaced before construction begins. Any sediment fencing that is no longer serving its purpose it to be removed to avoid it becoming litter.

**This fencing must be rectified as soon as possible**

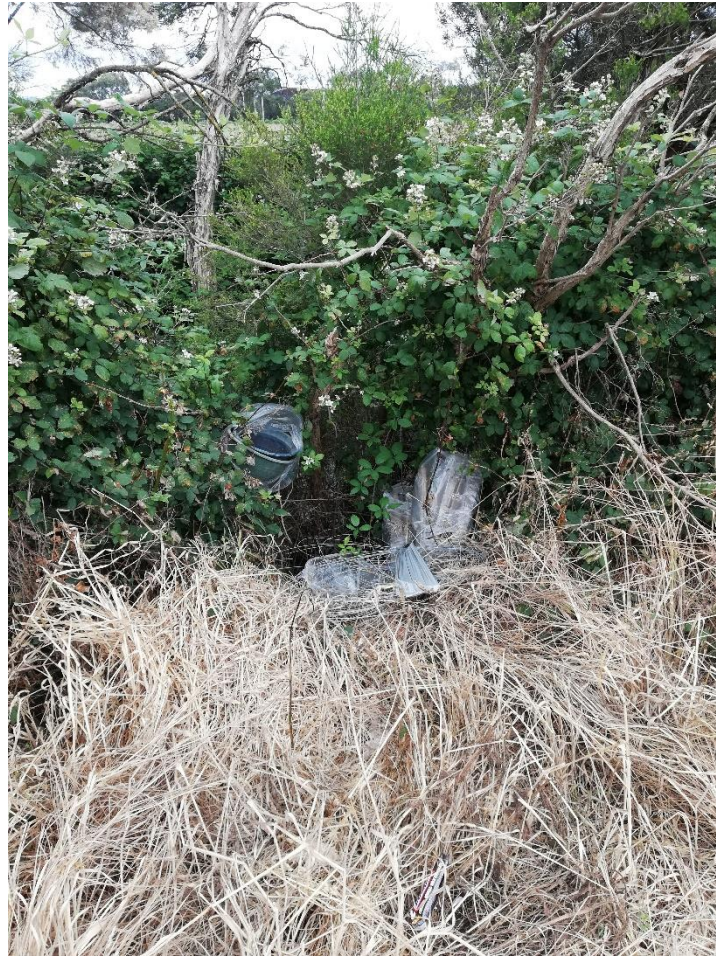
**Excessive amounts of hard rubbish were present throughout the survey site and is to be removed**

All rubbish should be removed from the site as soon as possible. This is to be undertaken by the proponent within private land and by Council along Centre Road. Signage should be employed along the drainage channels to deter rubbish dumping.

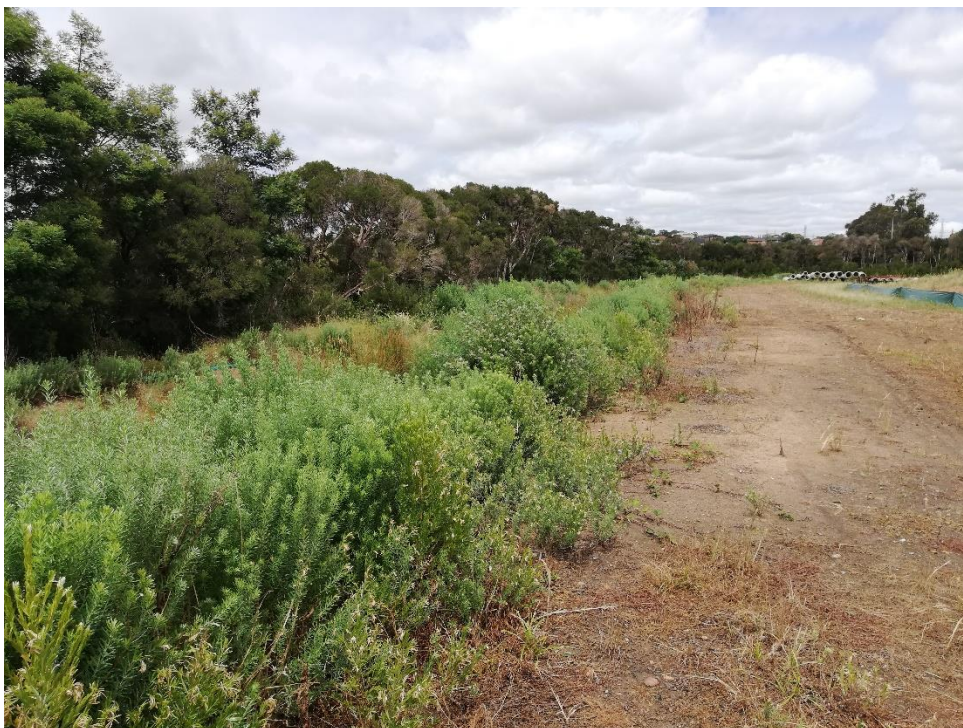
**Flax-leaf Broom was abundant along the western edge of the drainage channel running from Centre Road to the Pakenham Railway line. This is to be removed.**
