# **96-166 Centre Road, Narre Warren – Dwarf Galaxias habitat buffer**

Year 7  
Vegetation Monitoring

**Prepared for  
Narre Warren Central Pty Ltd  
c/- The Fidus Group**

December 2023  
Report No. 14090.8 (19.0)

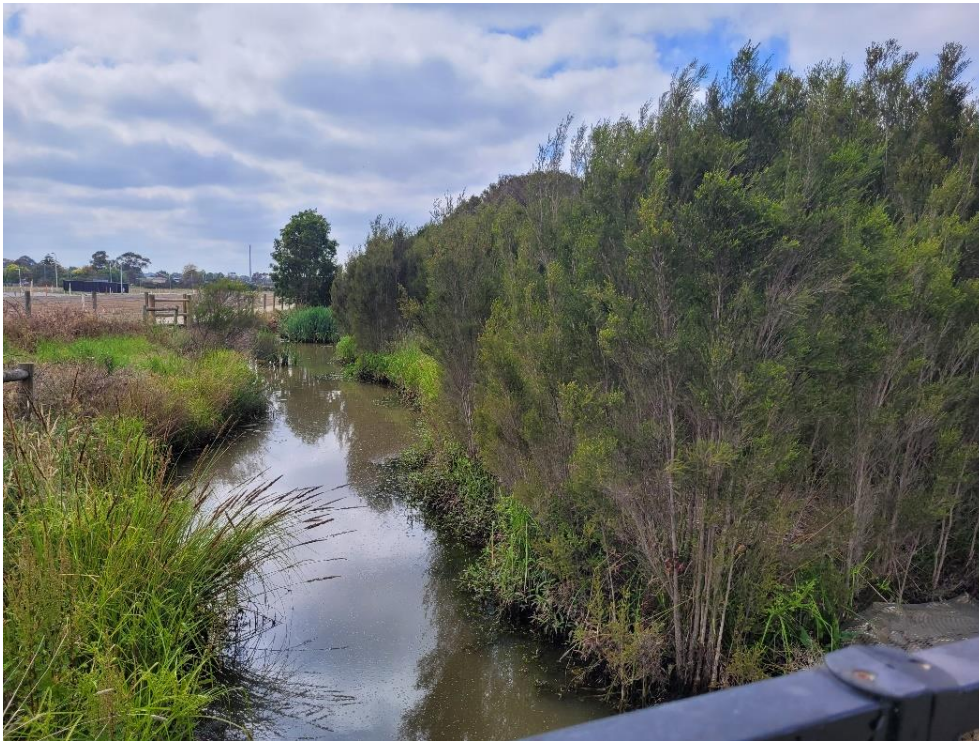
Of the 16 quadrats, none were able to be accessed and surveyed directly (i.e. close-up assessment from standing directly adjacent to the quadrat) during the current survey, due to the habitat buffers being surrounded by deep water and/or impenetrable vegetation.

The habitat buffer running located alongside Centre Road is surrounded by water, as both the deep swale drains along the southern edge of the buffer (separating the buffer from Centre Road) and along the northern edge of the buffer (separating the buffer from the residential development) were full of water.

Furthermore, even if the swale drains were crossed, the vast majority of the habitat buffers including the quadrat locations comprised impenetrable vegetation (Swamp Paperbark and Blackberry).

**Photo 1.** Representative photo of the swale drains with deep water surrounding both sides of the habitat buffers, preventing access to the quadrats. Thick vegetation also shown.

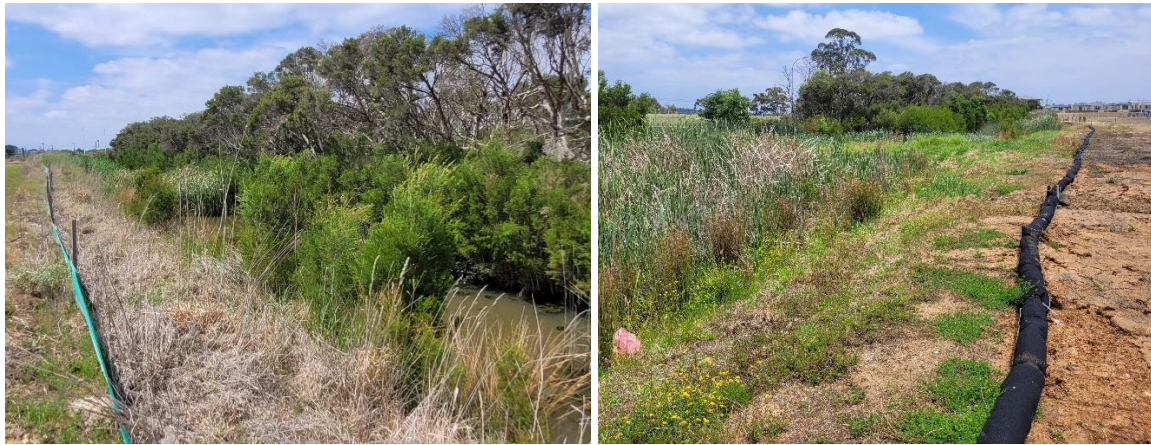
Sediment fencing or sediment logs between the swales and the project site were generally present though requiring repair/replacement in occasional locations due to wear and tear (as shown in Figure 1). The sediment fencing along the footpath between the buffers and houses at Billy Buttons Drive was in generally poor condition and requires replacement. Furthermore, the sediment log along the buffer between Centre Road and the Pakenham

Railway line ended at the location indicated near quadrat 17; it will need to be extended up to the northern site boundary.

**Photo 2. Photos of sediment fencing and sediment log outside the swales, in the project site.**

Collapsed or damaged sediment fencing will need to be rectified to prevent further sedimentation and run-off into the swales. This must include (but not be limited to) the sediment fencing along the footpath between the buffers and houses at Billy Buttons Drive. Furthermore, the sediment log along the buffer between Centre Road and the Pakenham Railway line will need to be extended up to the northern site boundary.

All sediment fencing surrounding the habitat buffers should be regularly checked and any collapsed/damaged fencing rectified in a timely manner, as part of routine on-ground works. Any sediment fencing that is no longer serving its purpose is to be replaced to avoid the fencing becoming litter.

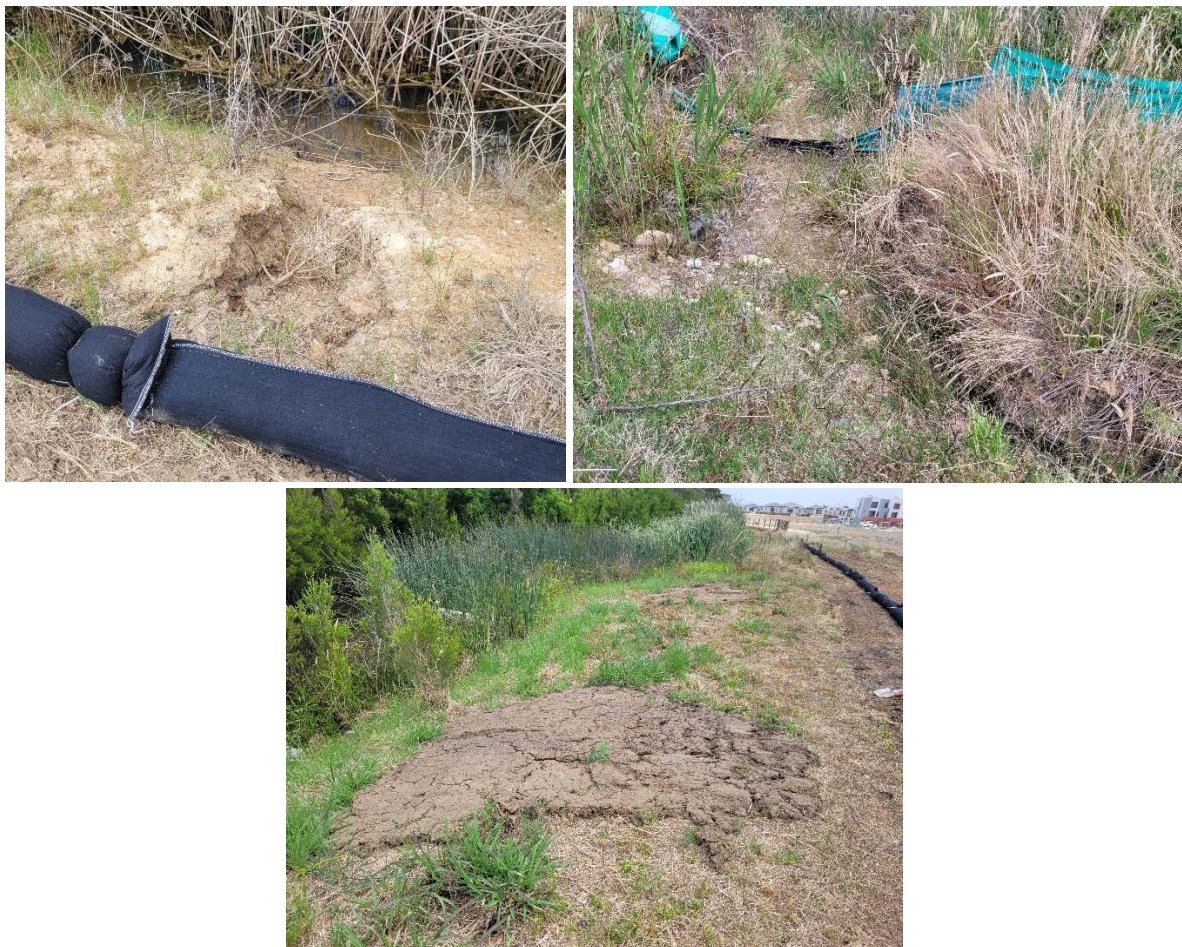
Two areas of soil erosion and one area of soil disturbance were observed near the swales, as mapped in Figure 1 and shown in Photo 3 below.

**Photo 3. Photos of the soil erosion and disturbance mapped in the project site.**

Erosion sites observed near the swales will need to be addressed (e.g. rock fill, hay bales and/or sandbags).

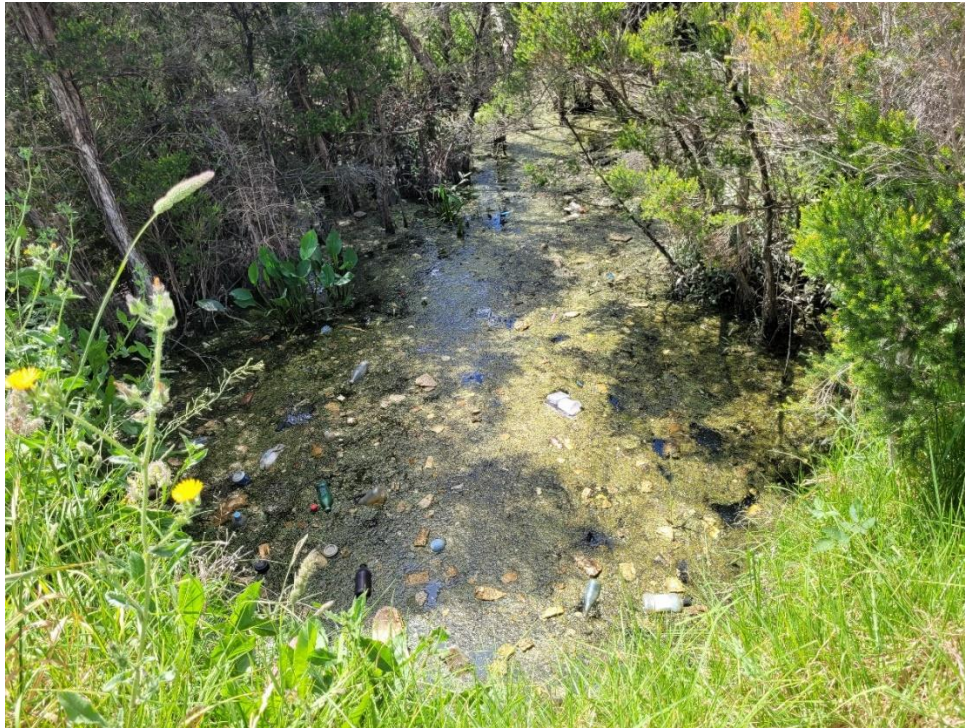
Algal blooms were observed in the swale along Centre Road, as seen and photographed at the crossing from Centre Road into the project site.

**Photo 4. Algal blooms and some litter in the swale on council land, along Centre Road. Specifically at the crossing from Centre Road into the project site.**

Algal blooms are an indicator of excess nitrogen and phosphorus in the water, and the algal blooms may impact on native aquatic plants (and therefore the quality of Dwarf Galaxias habitat) by consuming oxygen and blocking sunlight.

Preventing run-off into the swales using sediment fencing and bunds will help to reduce algal blooms. Rubbish management will also support reduction of algal blooms.

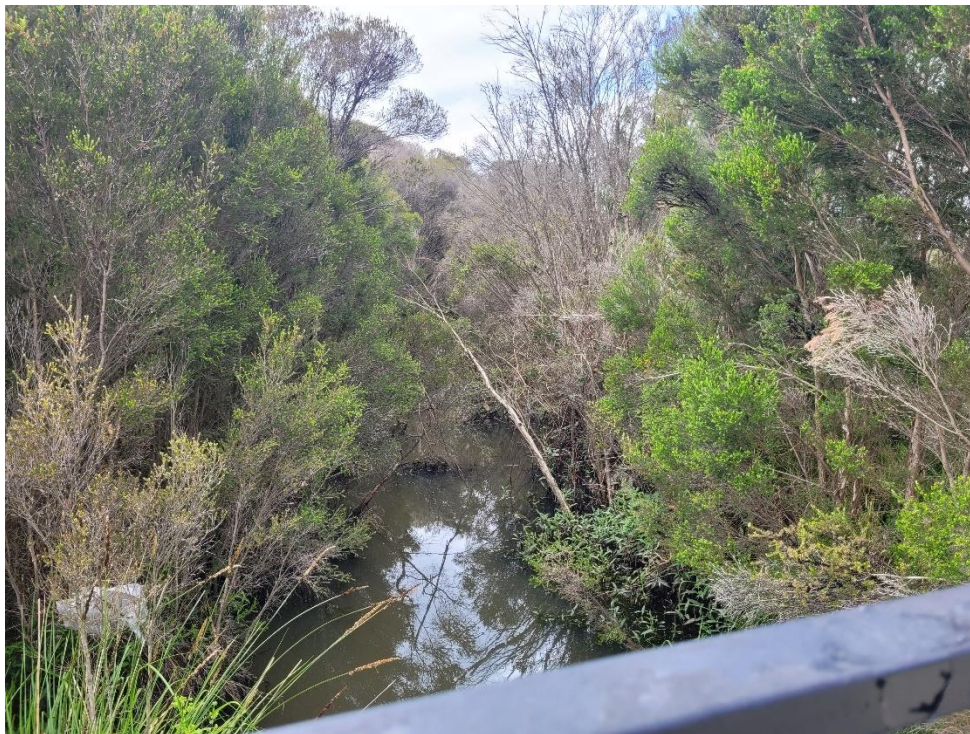
**Photo 5. Representative photo of most of the swales, which are less impacted than in Photo 4 above (less or no algal blooms and no rubbish).**

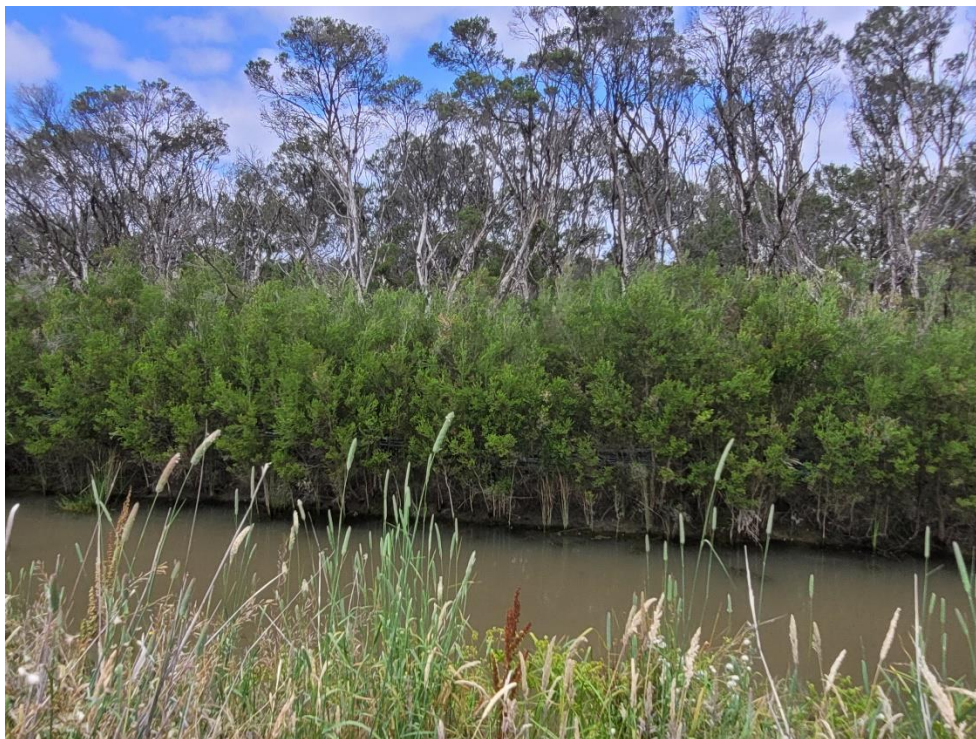
Active revegetation through planting in the revegetation buffers has not been undertaken due to the dense vegetation cover and difficulties in managing Blackberry (which are discussed below). Furthermore, revegetation was considered to not be required along the habitat buffers, as natural recruitment should be successful and likely to occur in areas where weeds are removed – this has since proven to be the case, with high levels of natural recruitment of Swamp Paperbark visible in the buffers.

**Photo 6. Photo of Swamp Paperbark recruitment along the northern side of the habitat buffers along Centre Road – cohort of young trees under the taller, older cohort.**

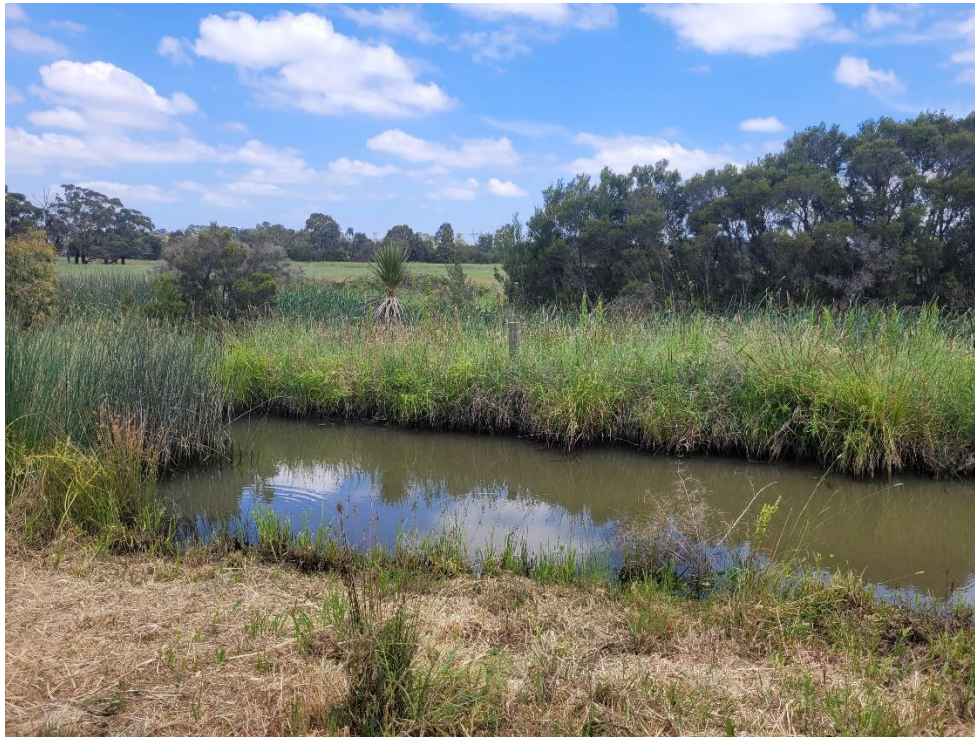
Notwithstanding the above, the site assessment has identified three areas in the buffers that would benefit from revegetation efforts, particularly where Swamp Paperbark has not naturally established (as mapped on Figure 1). The lack of native recruitment may be due to the dense presence of weeds. Weed control and native plantings such as Swamp Paperbark and Tall Sedge would enhance the native vegetation cover and continuous habitat of Swamp Paperbark in the buffers. The suggested planting areas are named in order of priority, i.e. 'suggested planting area 1' being the most important (Photo 7 below).

**Photo 7. Photo of 'suggested planting area 1' which has some native vegetation cover (some Swamp Paperbark, Tall Sedge and Cumbungi) and would benefit from active planting.**

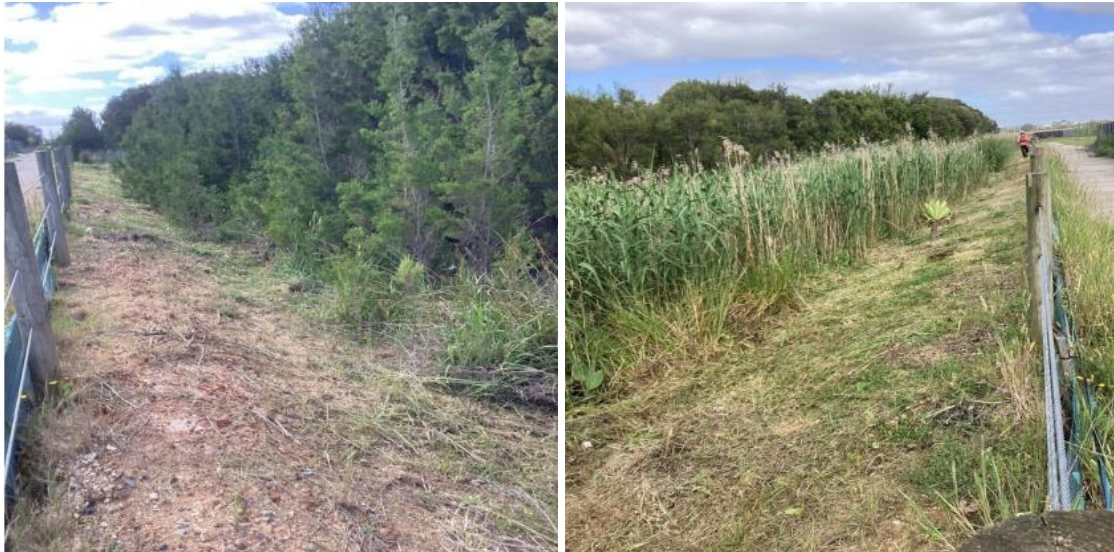
Weed treatments in and around the habitat buffers have been undertaken by Australian EcoSystems, including treatment of Blackberry, weed grasses and broad-leaved weeds. Spot-spraying with Glyphosate was used in treatments when appropriate but given the sensitivity of the site with swales containing habitat for Dwarf Galaxias, brush-cutting was also used where possible.

**Photo 8. Photos of brush-cut areas from the Daily Works Record by Australian Ecosystems (Nov 2023). These photos reflected the conditions observed during the current monitoring survey.**

Weed control efforts should continue to remove Blackberry and broad-leaved weeds, as well as treatment of weed grasses along the edges of the swales around the habitat buffers.

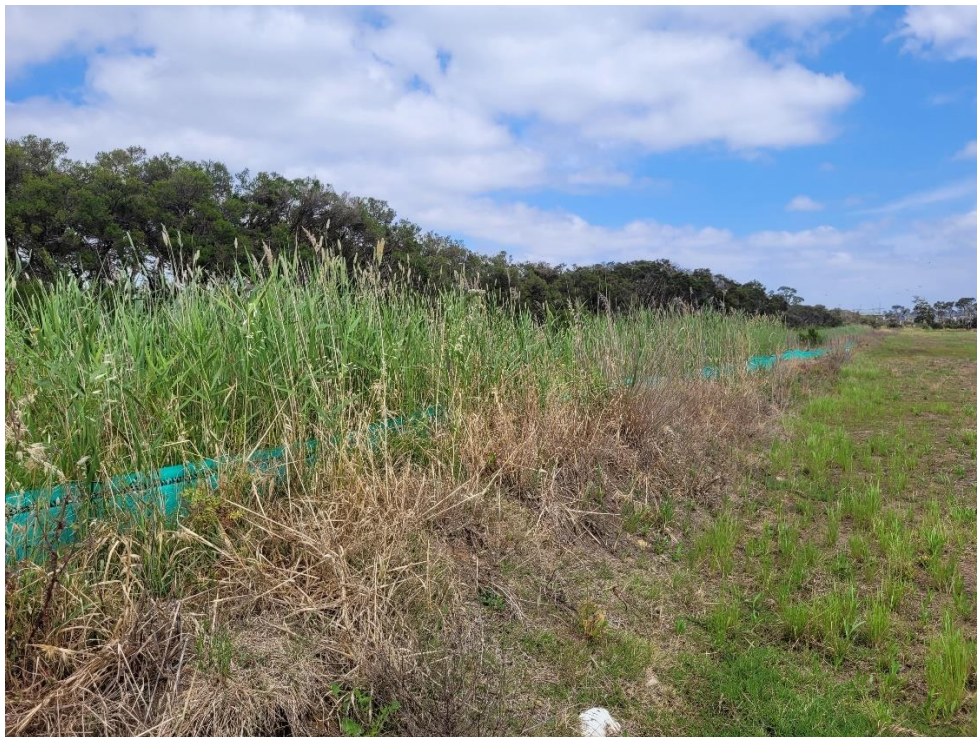
It was noted that the banks of the swales outside of the habitat buffers (in the project site) were often occupied by a mixture of Toowoomba Canary-grass and Cocksfoot with Common Reed and Cumbungi (Photo 9 below). Effective weed control up to the sediment fencing beyond was evident. Although these banks are outside the buffers/Dwarf Galaxias habitat, it is recommended that the Toowoomba Canary-grass and Cocksfoot be treated to encourage natural spread of Common Reed and Cumbungi, although this should be done in stages given the current weed grasses are helping to reduce soil erosion.

**Photo 9. Strip of mixed Toowoomba Canary-grass and Cocksfoot with Common Reed and Cumbungi outside the habitat buffers along Centre Road (photo taken from the north of the buffers, facing southwest).**

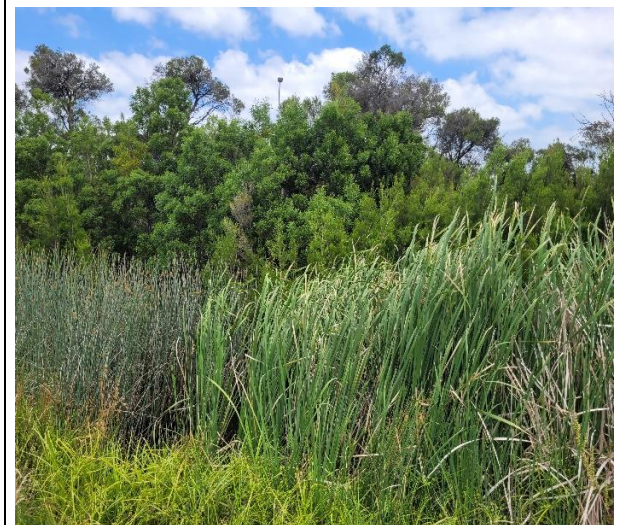
Quadrat 10

There was little rubbish observed in or near the habitat buffers on the project land, namely a few items of plastic in the swale near quadrat 10, which may have blown in from the adjacent construction area. Some litter was seen in the swale on council land at the crossover between quadrat 10 and 11, most of which likely came from upstream and was carried to this swale from water flows. Some rubbish was also observed along the roadside vegetation on council land, directly adjacent to Centre Road. Rubbish items included food wrappers and fast food containers, evidently from public littering along the road. It should be noted that clean-up of litter or dumped waste on council/public land is not the responsibility of the Proponent.
