96-166 Centre Road,
Narre Warren

Annual EPBC
Compliance Report 2023
– EPBC 2014/7380

Prepared for
Narre Warren Central Pty Ltd

March 2023
Report No. 14090 (20.0)

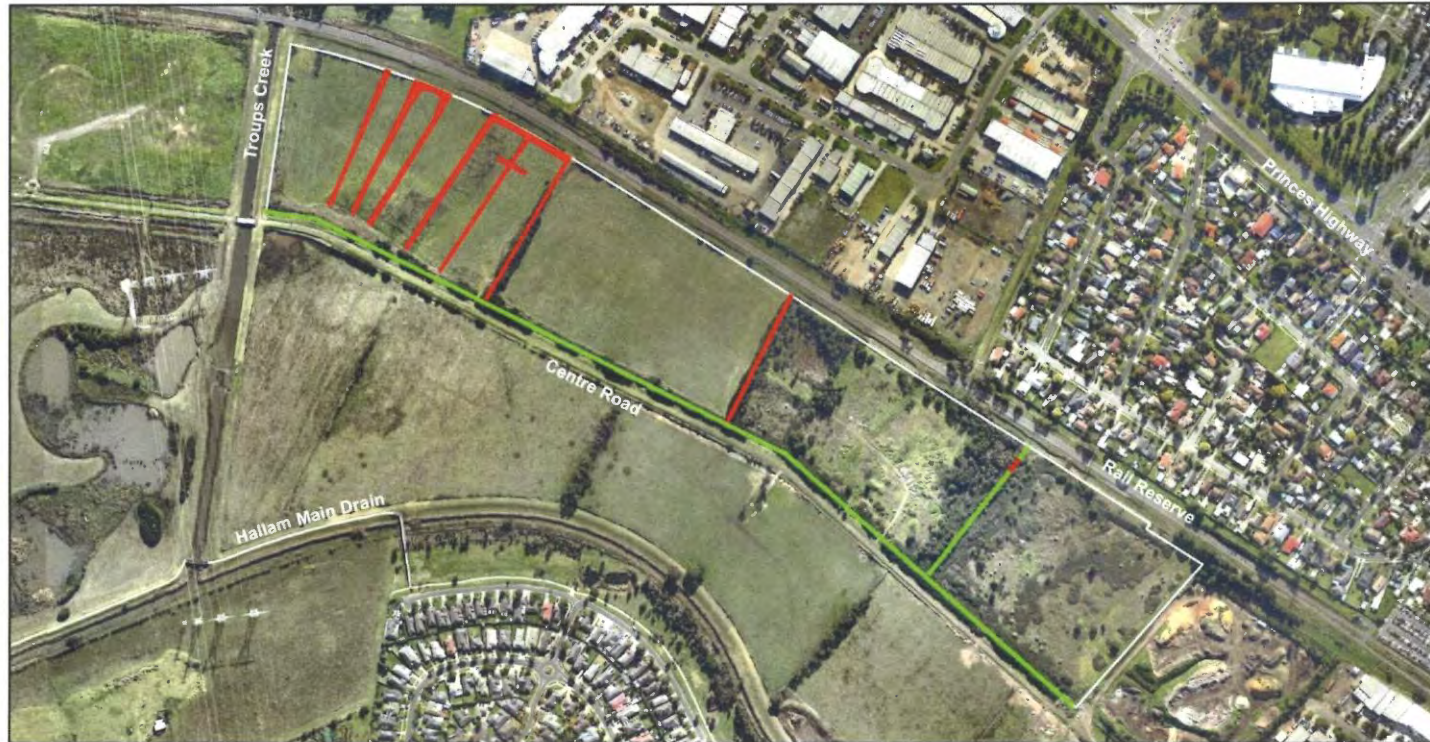
Annex 1

Figure 3: Dwarf Galaxias habitat areas		
Project: 96-166 Centre Rd, Narre Warren		
Client: Narre Warren Central Pty Ltd		
Project No.: 14090	Date: 17/11/2015	Created By: M. Ghazemi / D. Coppolins
Brett Lane & Associates Pty. Ltd. <small>Environmental & Planning Consultants</small>		
Experience 11 years Subdivisions 1000+	Suite 5, 61 - 63 Camberwell Road Camberwell, VIC 3173 Australia	Ph: (03) 9633 3011 / Fax: (03) 9633 3065 enquiries@brettlane.com.au www.brettlane.com.au

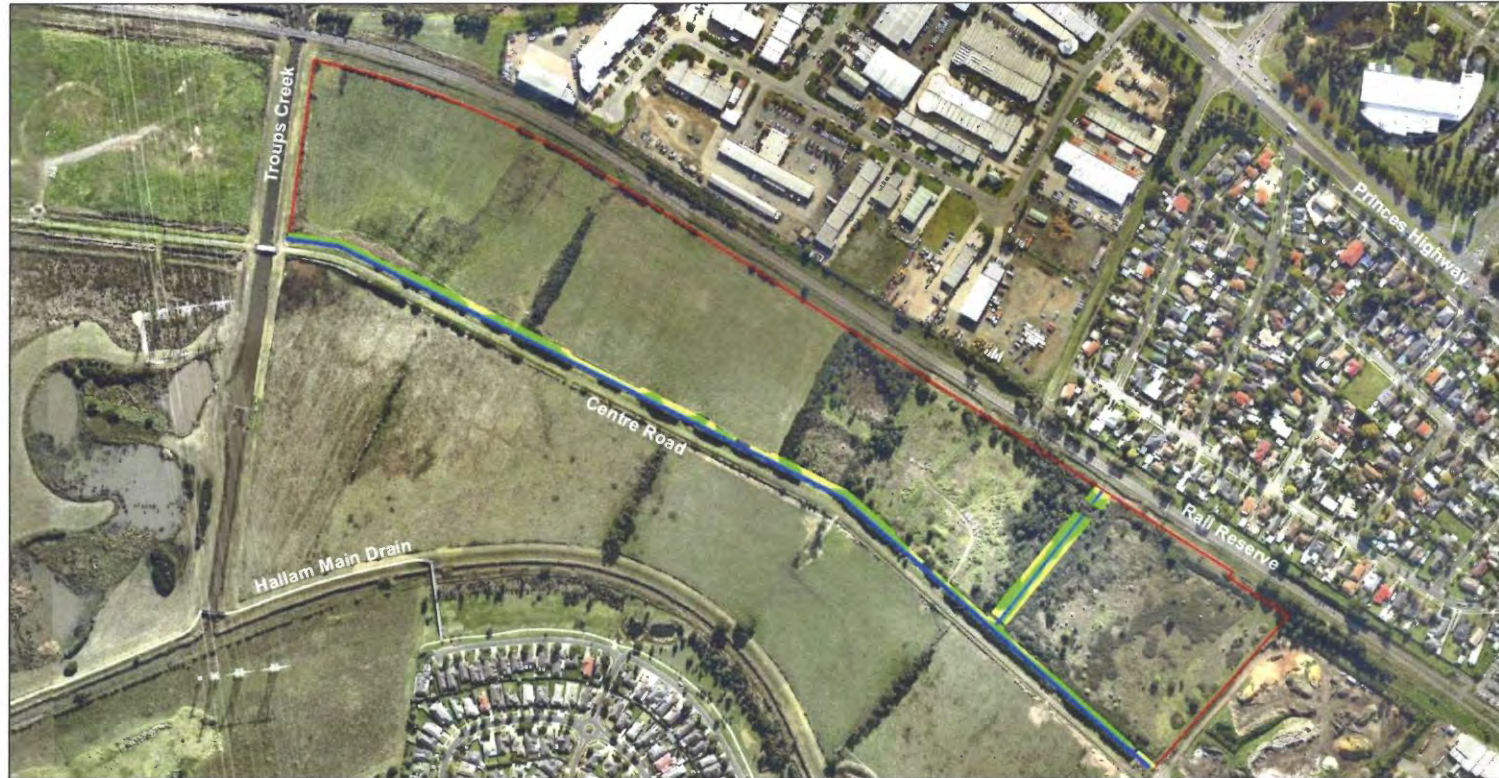
Annex 3

Figure 2: Dwarf Galaxias habitat buffer areas		
Project: 96-166 Centre Rd, Narre Warren		
Client: Narre Warren Central Pty Ltd		
Project No.: 14090	Date: 19/01/2016	Created By: M. Ghasemi / D. Coppolino
Brett Lane & Associates Pty. Ltd. <small>Consultants of Biological Science & Environmental Engineering</small>		
<ul style="list-style-type: none"> ● Experience ● Knowledge ● Solutions 	Suite 5, 61 - 63 Cranberry Road Hamilton Road, VIC 3122 PO Box 337, Camberwell, VIC 3124, Australia	Ph (03) 9419 2111 / Fax (03) 9419 2653 enquiries@ecologicalresearch.com.au www.ecologicalresearch.com.au

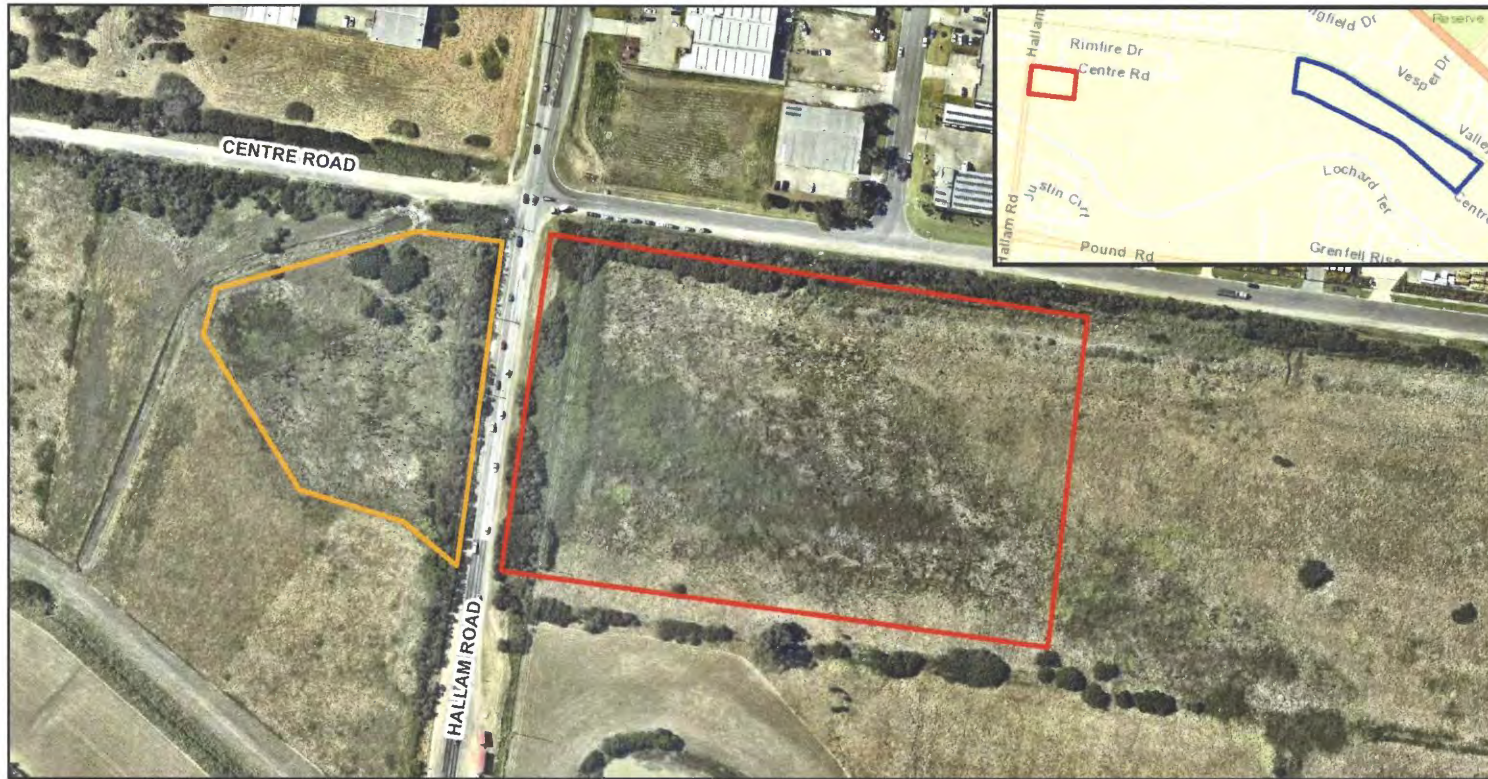
Annex 4

Figure 3: Offset site location		
Project: 96-166 Centre Rd, Narre Warren		
Client: Narre Warren Central Pty Ltd		
Project No.: 14090	Date: 27/10/2015	Created By: M. Ghasemi / L. Kulik
Bert Lau & Associates Pty Ltd <small>Practising as Bert Lau & Associates</small>		
<ul style="list-style-type: none"> ● Experience: 30+ years ● Knowledge: 30+ years ● Solutions: 30+ years 	Suite 3, 41 - 63 Cambewell Road Hawthorn East, VIC 3123 290 Bora Street, Camberwell, VIC 3184, Australia	Ph (03) 9515 2111 / Fax (03) 9515 2665 enquiry@bertlau.com.au www.bertlau.com.au

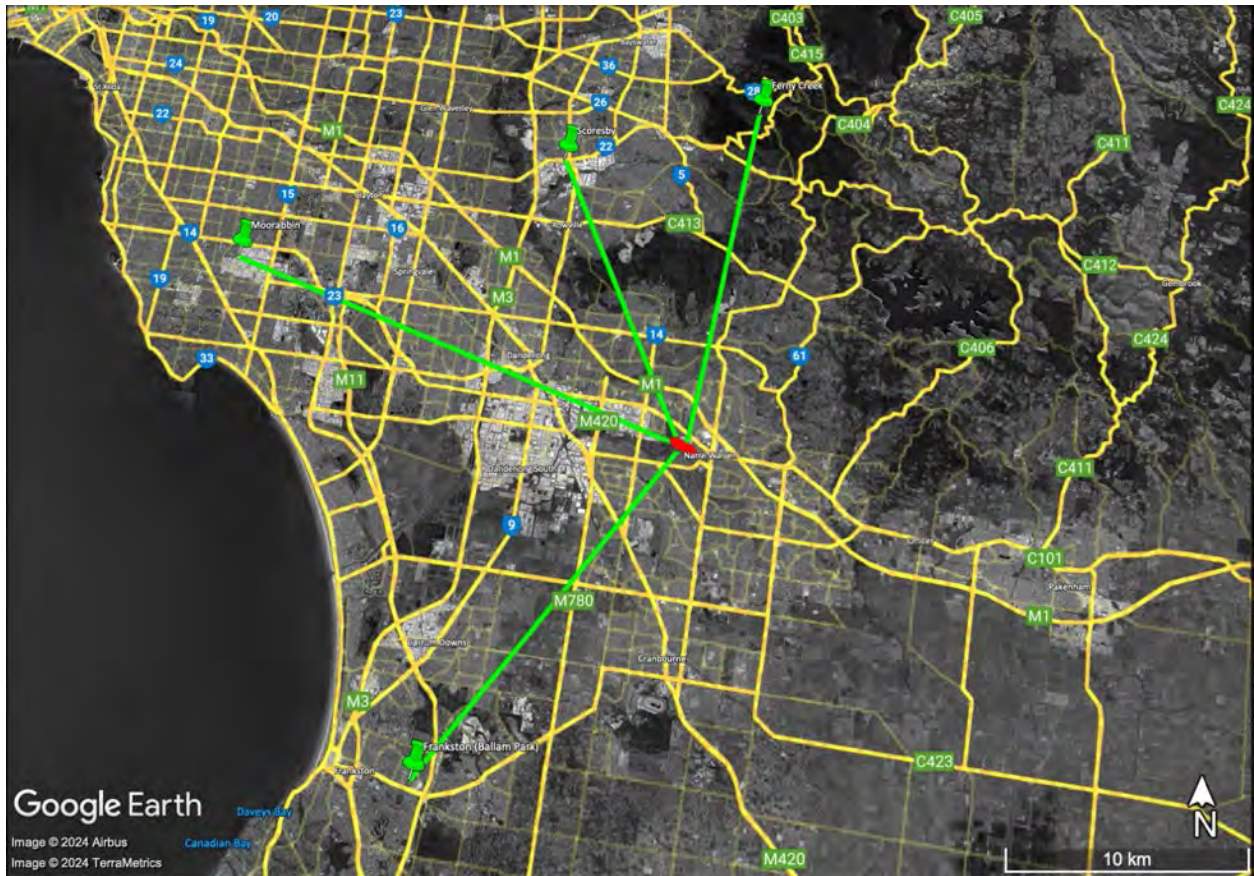
Figure 1 Bureau of meteorology weather station locations (green) relative to the site (red)

There is no rainfall gauge located on the site. The nearest Bureau of Meteorology (BOM) weather stations, with current / live rainfall monitoring data, are located at Ferny Creek (16km north), Frankston (Ballam Park, 18km southwest), Moorabbin (20km west northwest) and Scoresby (14km north northwest)(Figure 1). To determine whether an approximately >10mm rainfall event had occurred at the site the average of the daily totals from the four BOM weather stations was used as the trigger.

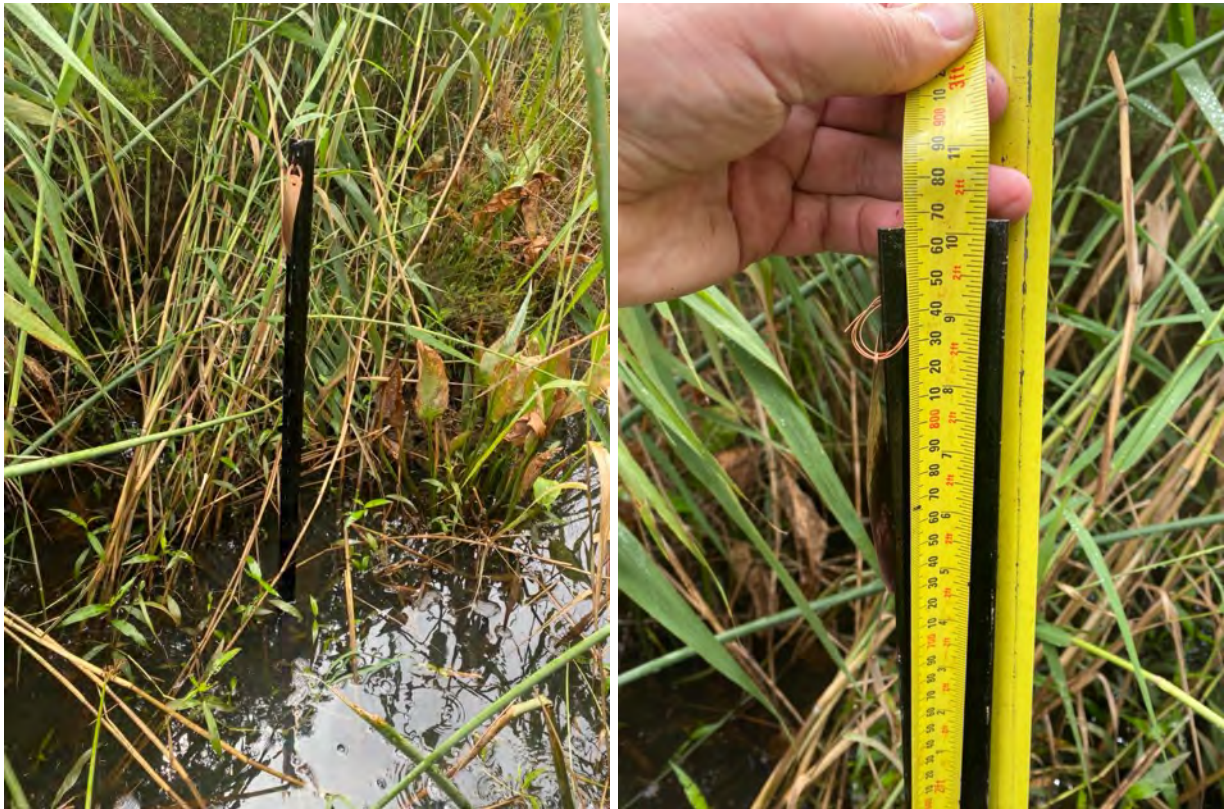
Photo 1 Water measuring gauge

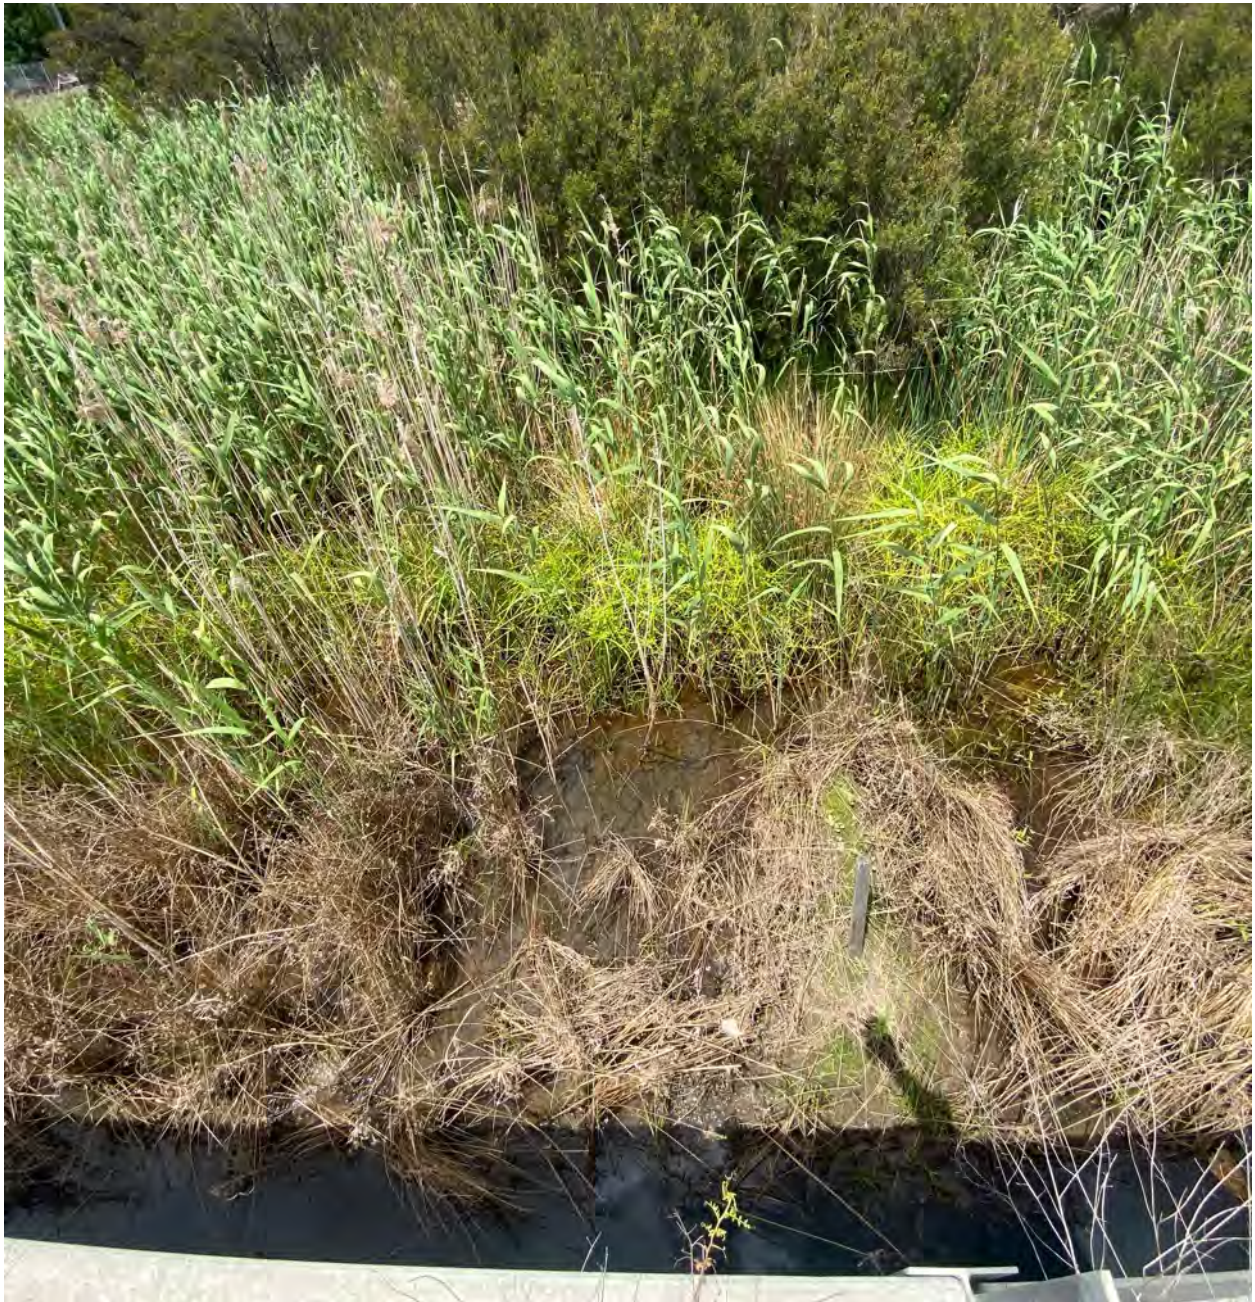
Photo 2 Habitat vegetation and inundation at Site Dwarf Galaxias survey location in December 2023 during the dwarf galaxias survey

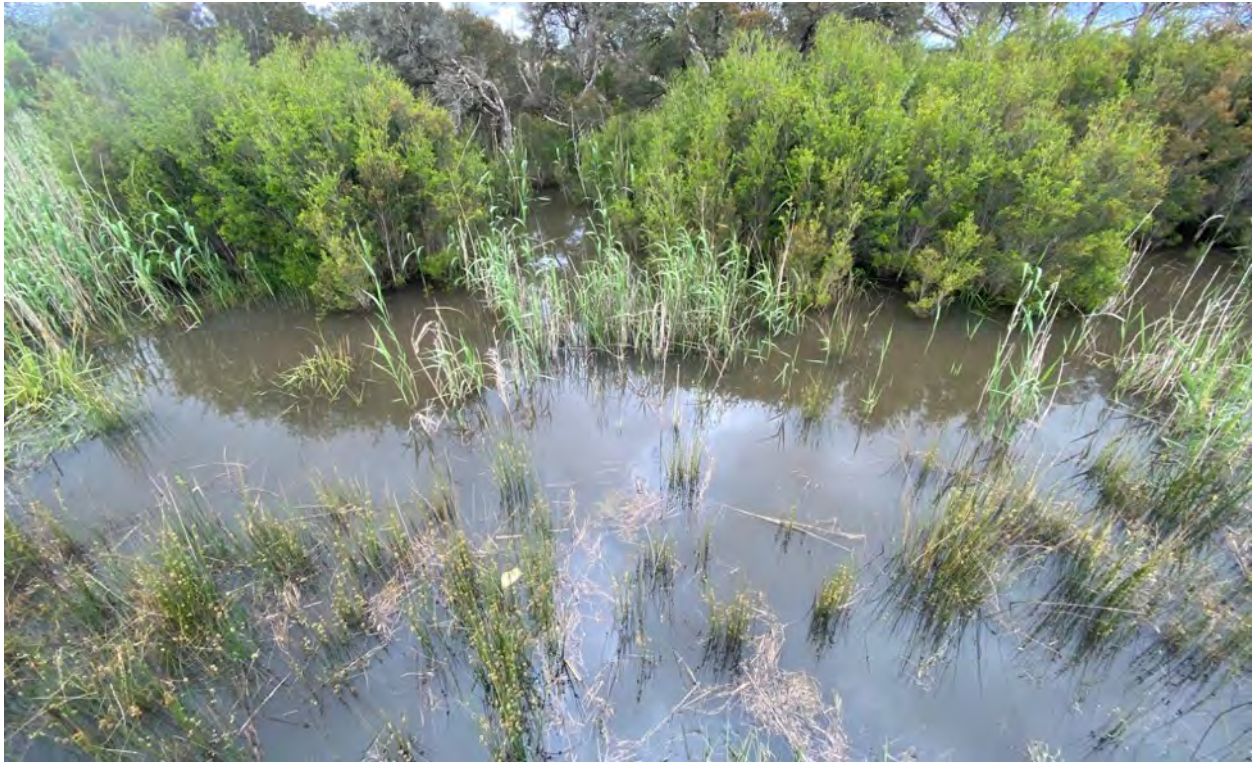
Photo 3 Habitat vegetation and inundation at Site Dwarf Galaxias survey location in November 2022

During the 2023 Dwarf Galaxias survey the vegetation within the retaining habitat (WQ6) increased in overall density as compared to previous rounds of monitoring (Photo 2). This increased appears to be particularly beneficial for dwarf galaxias, with numerous individuals being recorded in the more open exposed area near the concrete retaining wall compared to previous rounds of monitoring with they were mostly found most centralised within the dense stands of paperbark (*Melaleuca* spp.) (i.e. there appears to have been an increase in their area of habitation). The difference was markedly observable compared to the 2022 annual survey, when retained habitat was significantly inundated due to recent rainfall and seasonal vegetation growth impeded (Photo 3). Another marked variation was the increase in

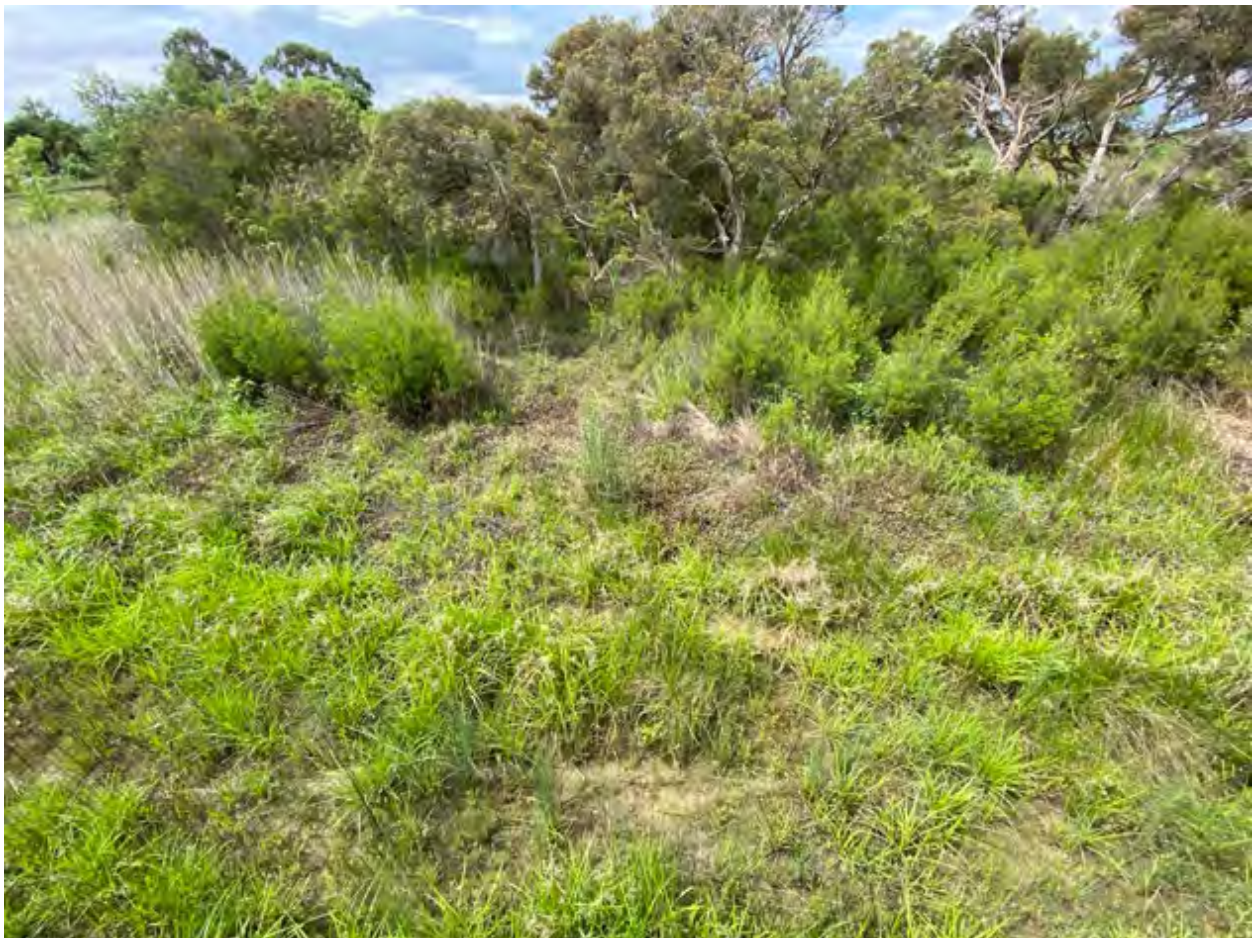
Photo 4 Habitat vegetation at Site Dwarf Galaxias survey location in November 2020

Error! Reference source not found. is provided for additional temporal comparison of the quality and condition of the retained habitat in November 2020 (i.e. prior to the approved construction of the concrete retaining wall and swales), when the habitat was inclined to dry quite extensively second during the summer months. Compared to the 2022 and 2023 monitoring it is visually clear that the size of individual melaleuca plants has increased, as well as their overall area of coverage and shading (i.e. beneficial to the species).

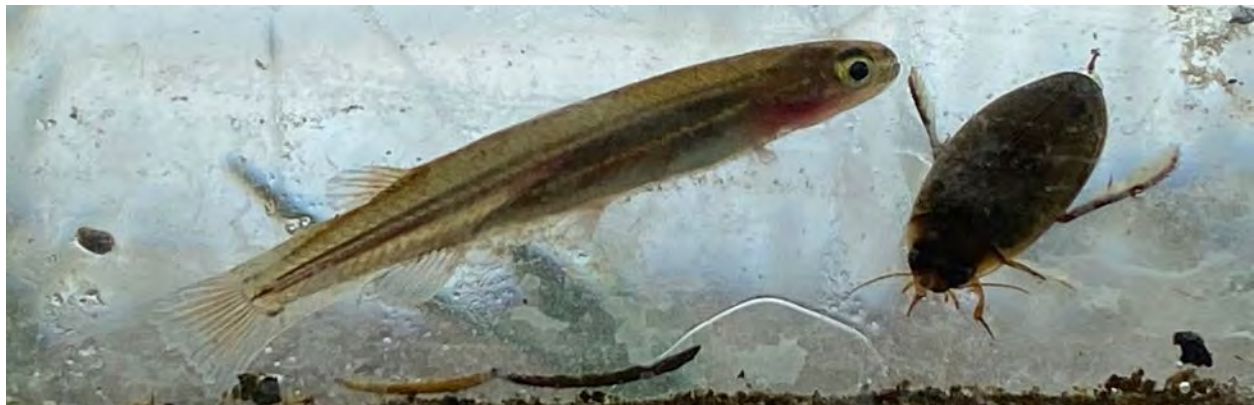
Photo 5 Dwarf Galaxias adult male (top) and juvenile (bottom)

A total of 18 Dwarf Galaxias (Photo 5 and Photo 6) were recorded during the November survey, including 10 adult males and 8 juveniles/sub-adults from the most recent breeding season, which likely occurred through August to October.

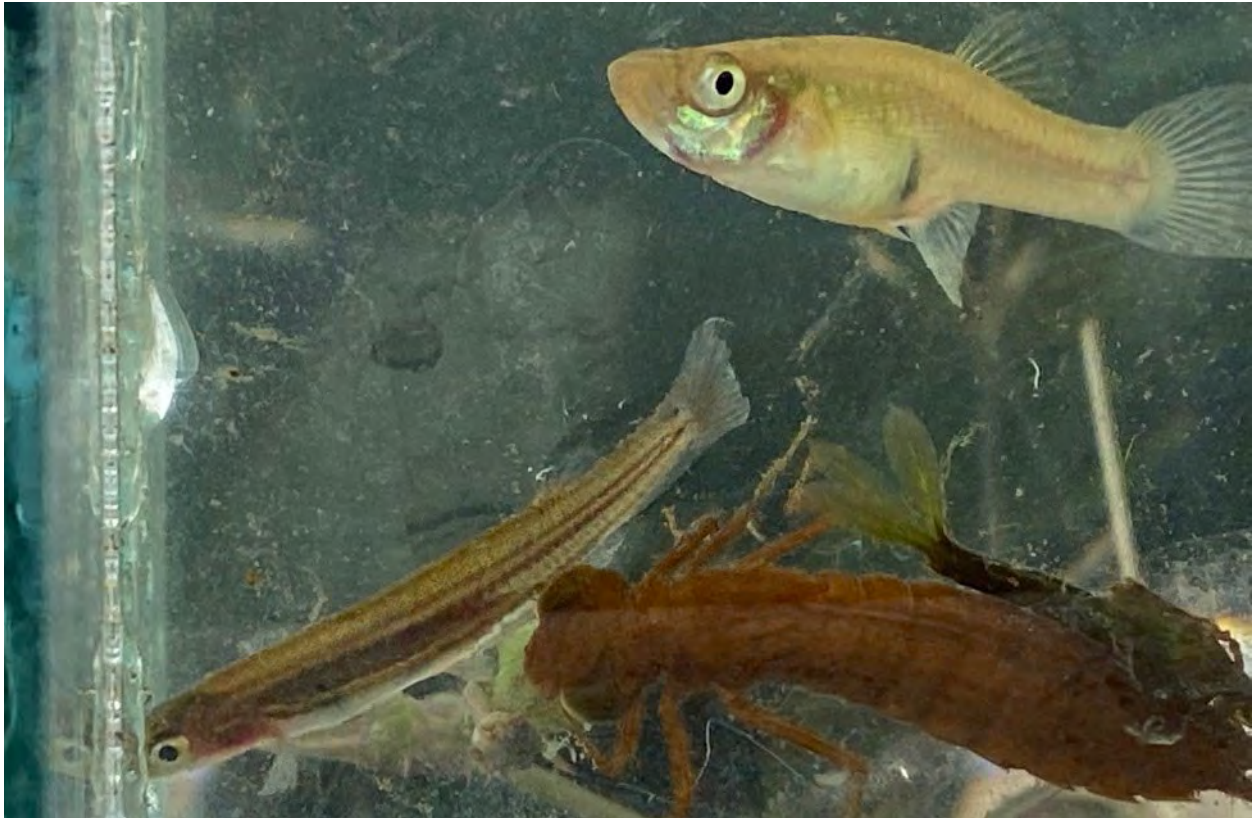
Photo 6 Dwarf Galaxias adult male, female Mosquitofish and dragonfly/damselfly larvae

Large numbers of Mosquitofish (*Gambusia holbrooki*; Photo 6) were also recorded, much higher than previous years. Most appeared to be residing near the concrete retaining wall, where there is less shading and therefore warmer water (Photo 7). Though Dwarf Galaxias were also caught in this location.

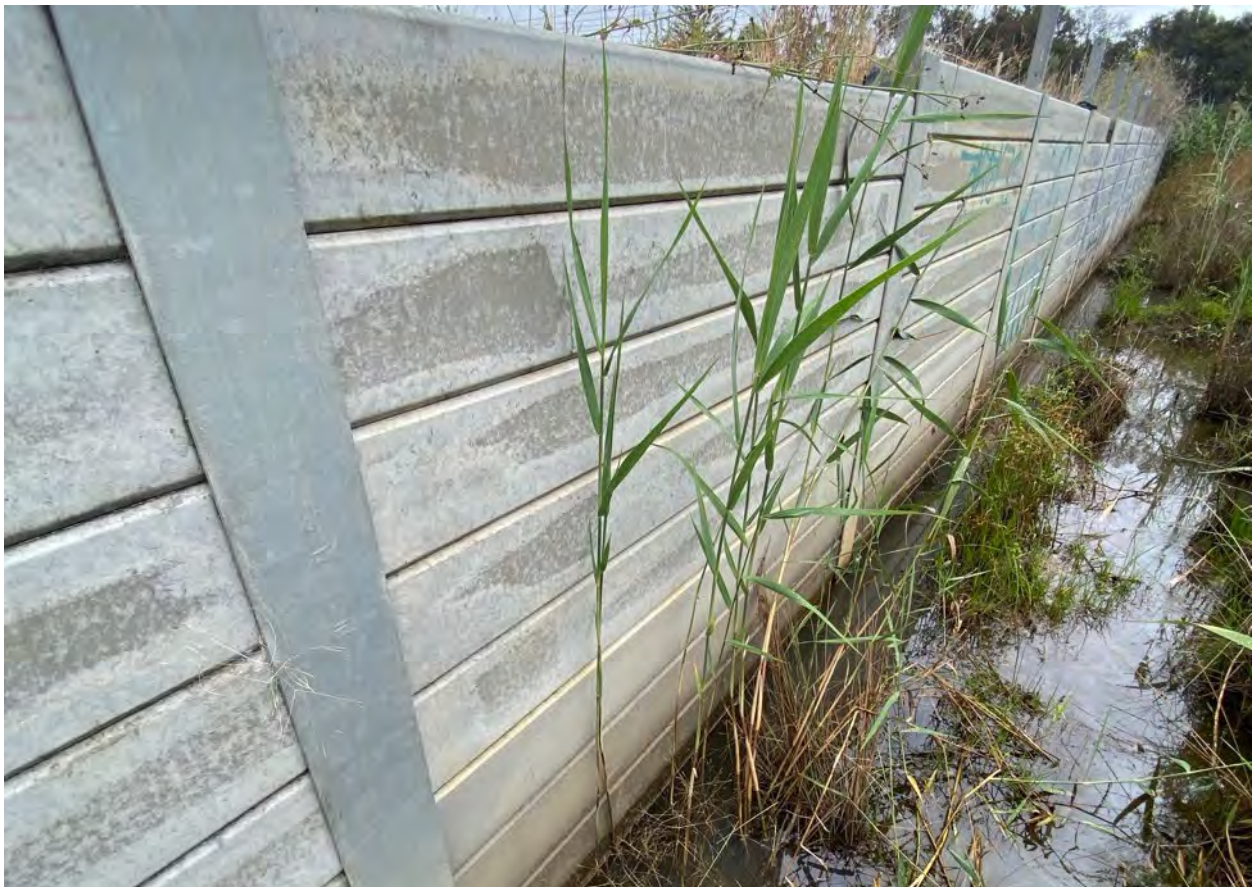
Photo 7 More open habitat at the concrete retaining wall.

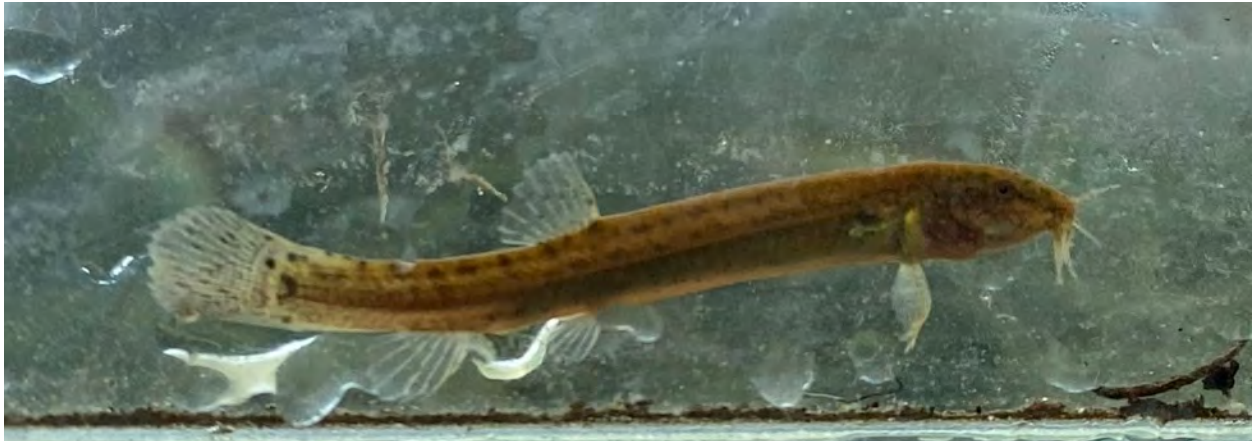
Photo 8 Oriental Weatherloach

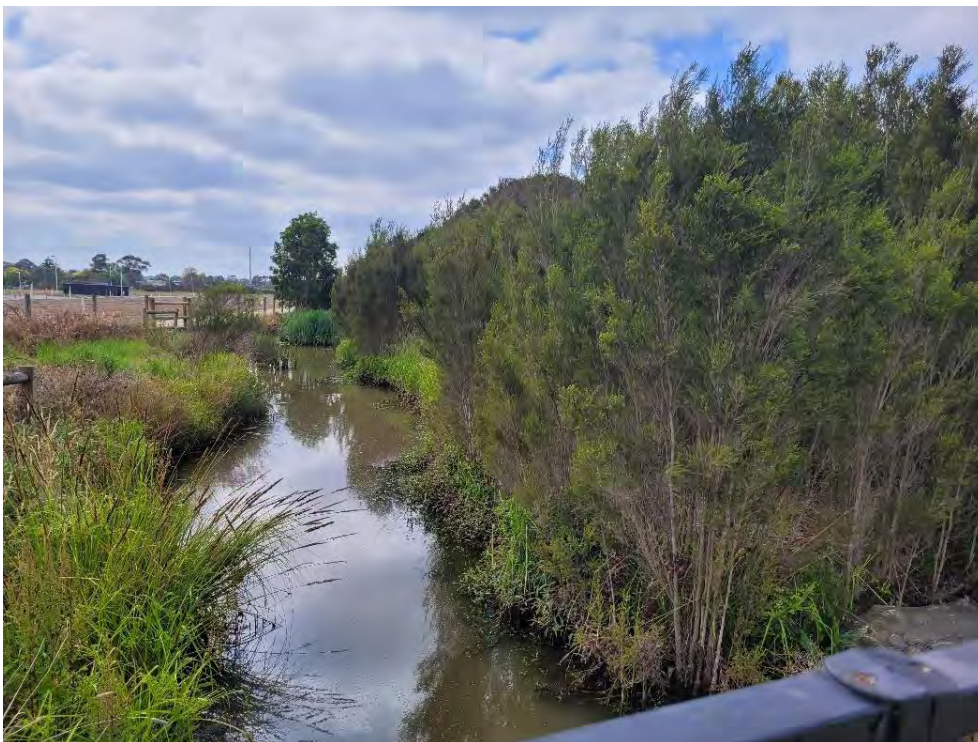
Photo 1. Representative photo of the swale drains with deep water surrounding both sides of the habitat buffers, preventing access to the quadrats. Thick vegetation also shown.

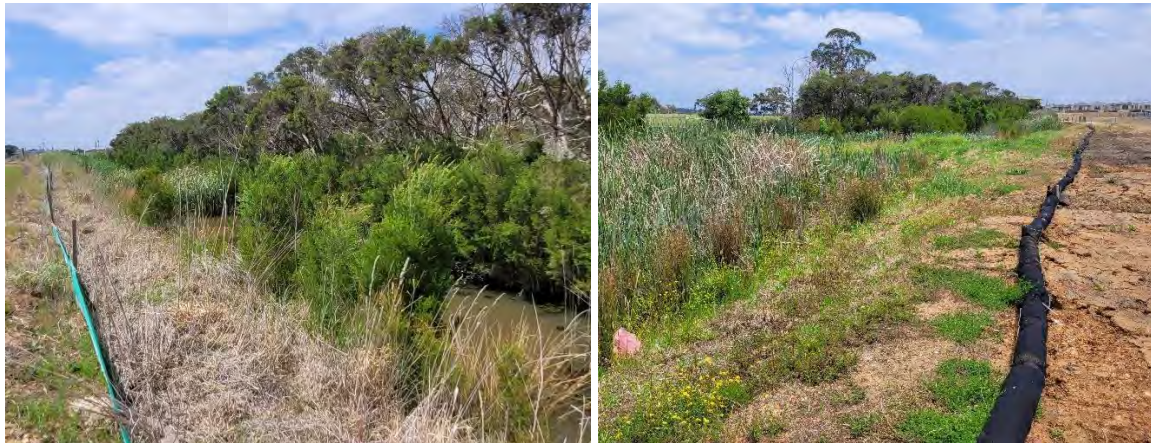
Photo 2. Photos of sediment fencing and sediment log outside the swales, in the project site.

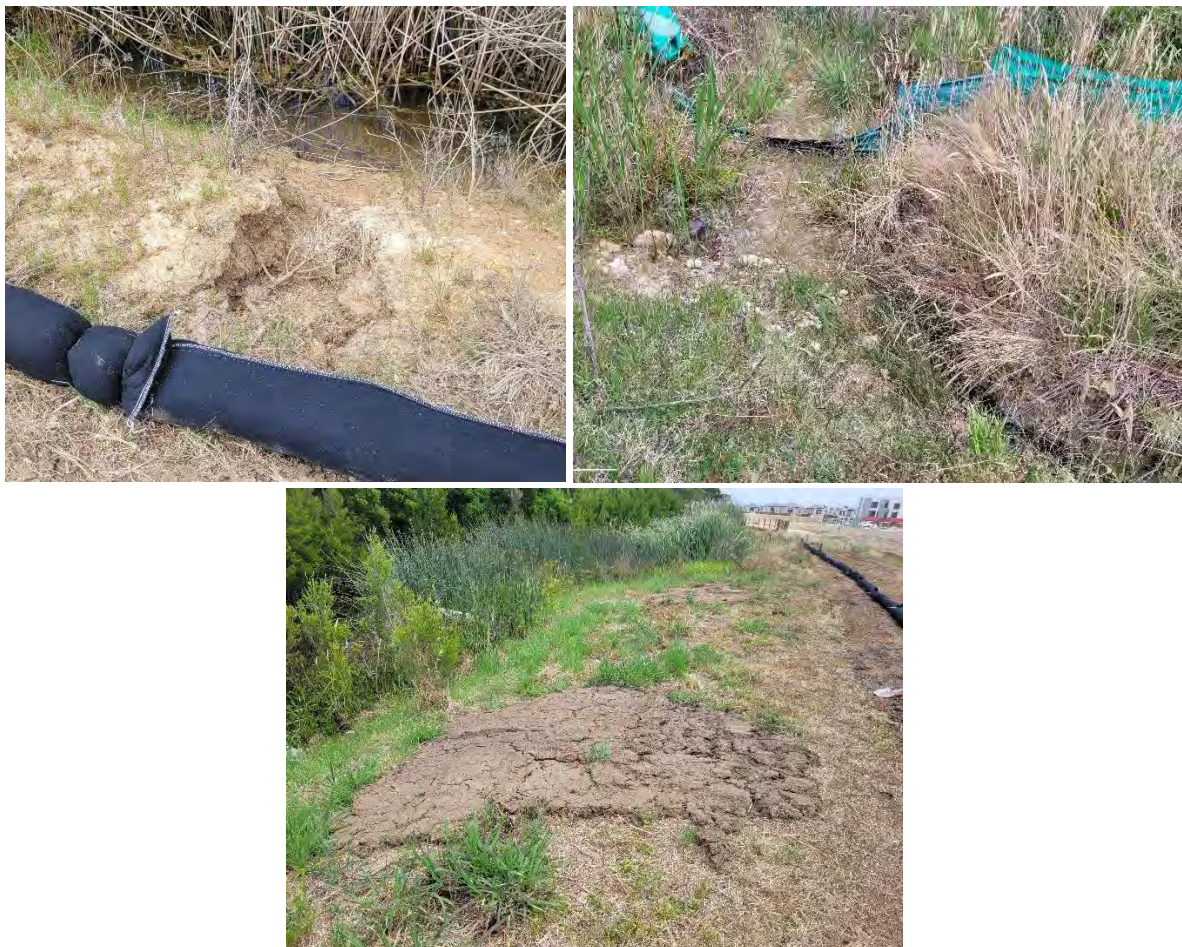
Two areas of soil erosion and one area of soil disturbance were observed near the swales, as mapped in Figure 1 and shown in Photo 3 below.

Photo 3. Photos of the soil erosion and disturbance mapped in the project site.

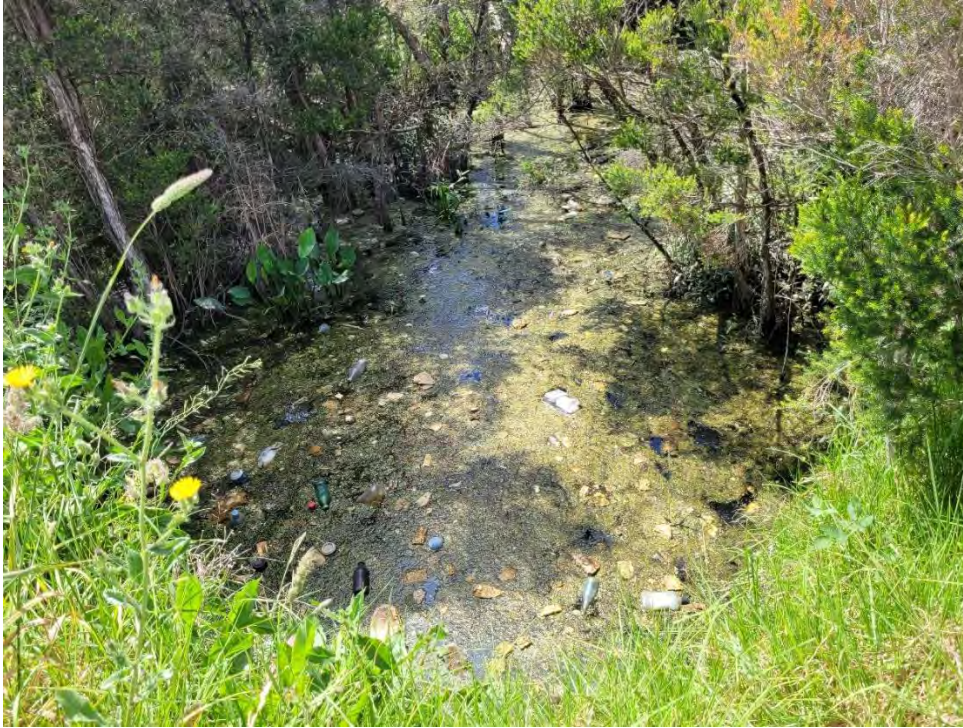
Algal blooms were observed in the swale along Centre Road, as seen and photographed at the crossing from Centre Road into the project site.

Photo 4. Algal blooms and some litter in the swale on council land, along Centre Road. Specifically at the crossing from Centre Road into the project site.

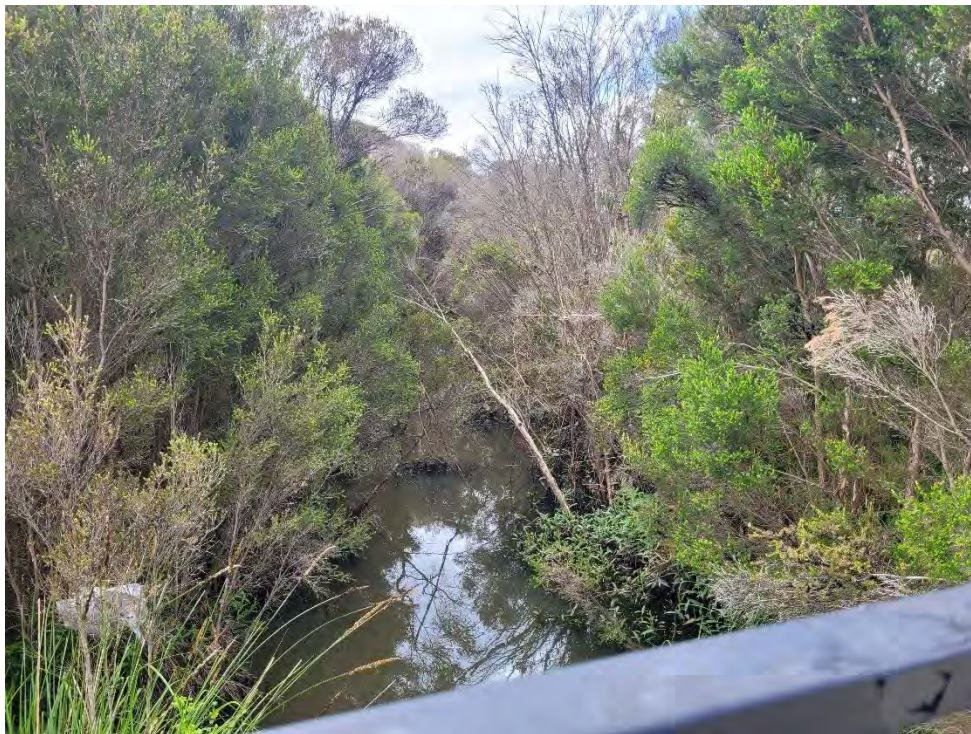
Photo 5. Representative photo of most of the swales, which are less impacted than in Photo 4 above (less or no algal blooms and no rubbish).

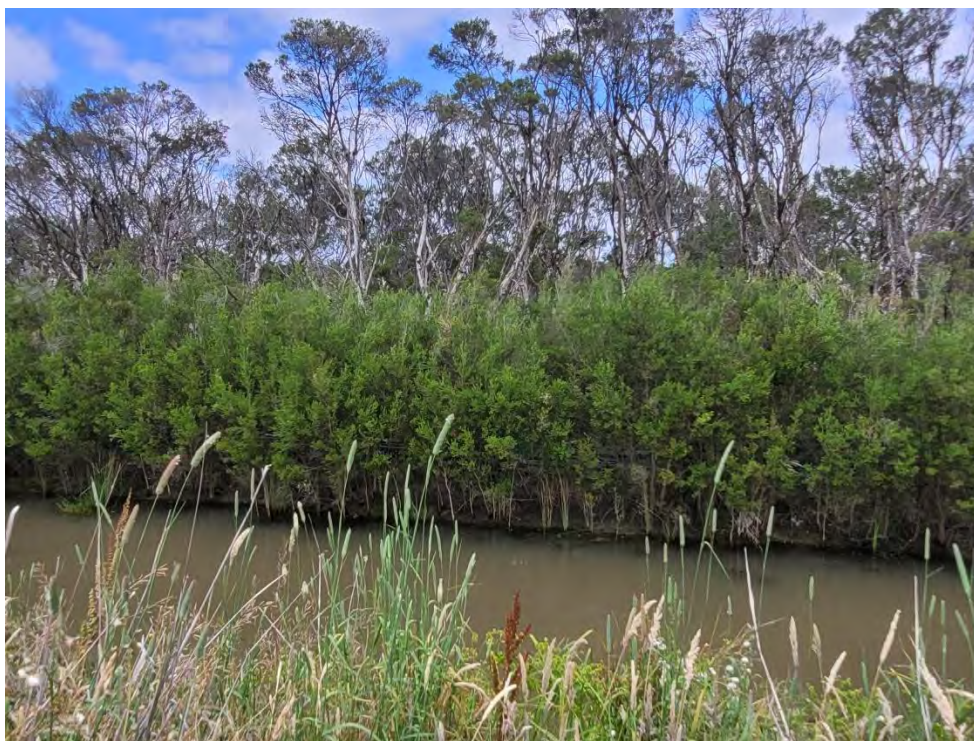
Photo 6. Photo of Swamp Paperbark recruitment along the northern side of the habitat buffers along Centre Road – cohort of young trees under the taller, older cohort.

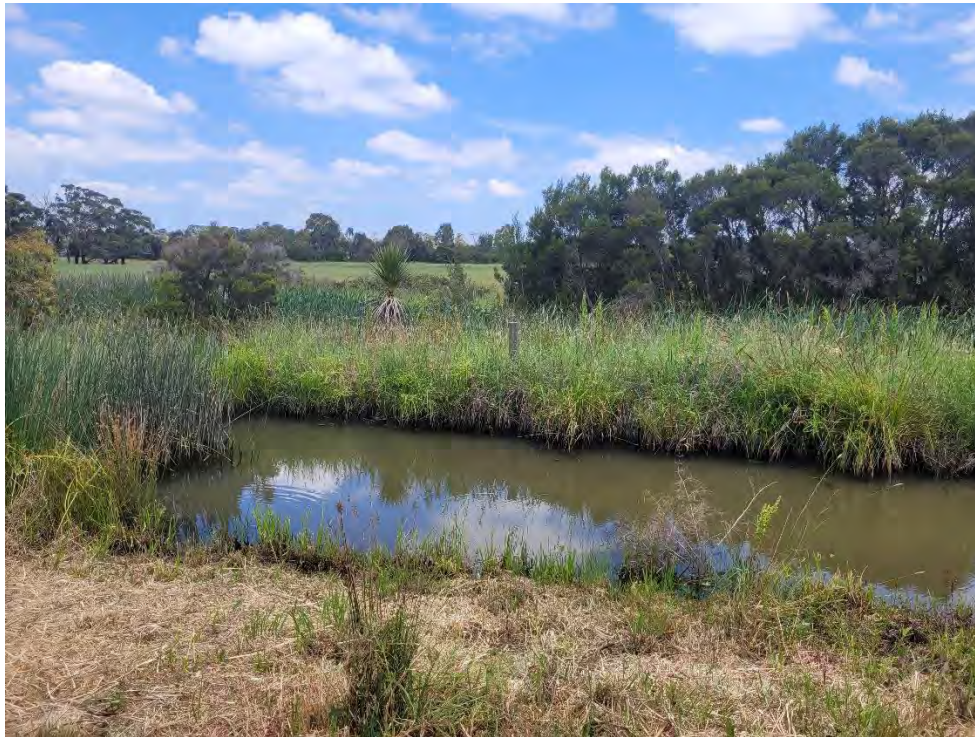
Notwithstanding the above, the site assessment has identified three areas in the buffers that would benefit from revegetation efforts, particularly where Swamp Paperbark has not naturally established (as mapped on Figure 1). The lack of native recruitment may be due to the dense presence of weeds. Weed control and native plantings such as Swamp Paperbark and Tall Sedge would enhance the native vegetation cover and continuous habitat of Swamp Paperbark in the buffers. The suggested planting areas are named in order of priority, i.e. 'suggested planting area 1' being the most important (Photo 7 below).

Photo 7. Photo of 'suggested planting area 1' which has some native vegetation cover (some Swamp Paperbark, Tall Sedge and Cumbungi) and would benefit from active planting.

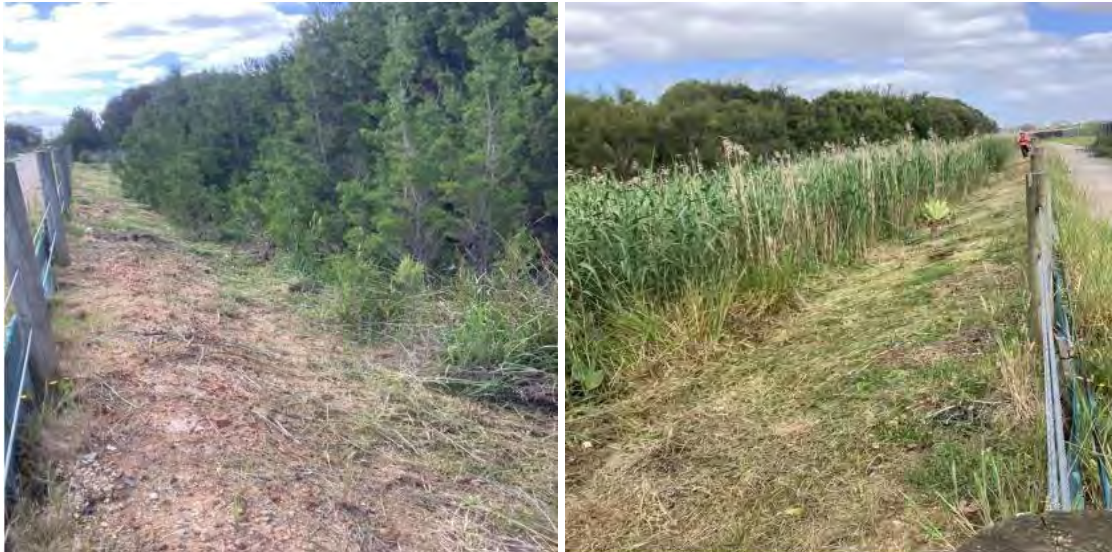
Photo 8. Photos of brush-cut areas from the Daily Works Record by Australian Ecosystems (Nov 2023). These photos reflected the conditions observed during the current monitoring survey.

Weed control efforts should continue to remove Blackberry and broad-leaved weeds, as well as treatment of weed grasses along the edges of the swales around the habitat buffers.

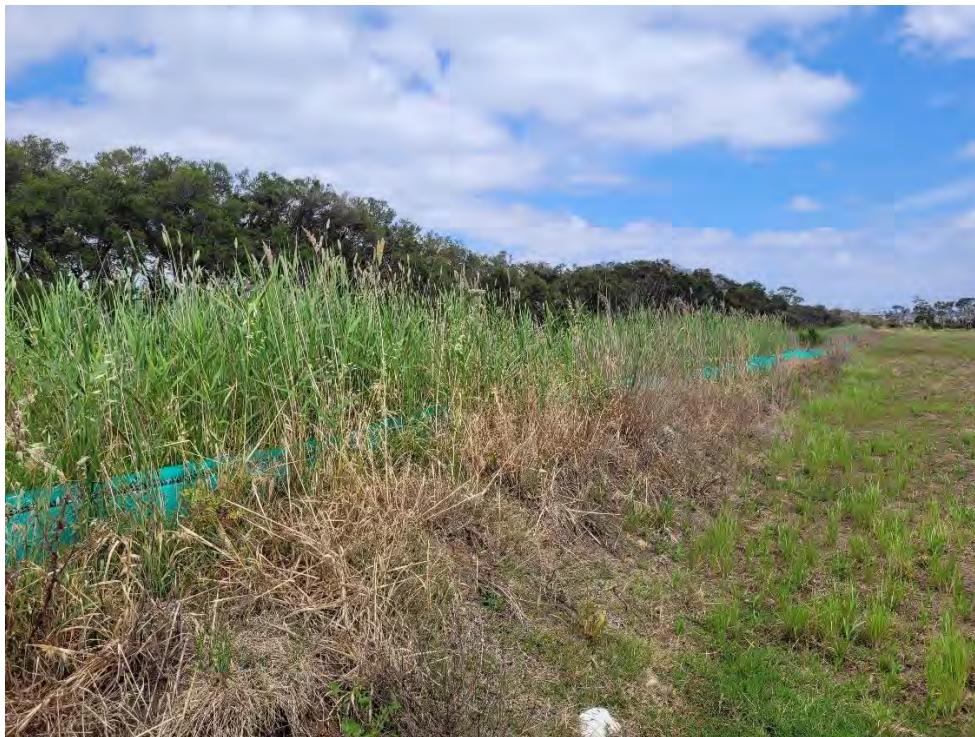
It was noted that the banks of the swales outside of the habitat buffers (in the project site) were often occupied by a mixture of Toowoomba Canary-grass and Cocksfoot with Common Reed and Cumbungi (Photo 9 below). Effective weed control up to the sediment fencing beyond was evident. Although these banks are outside the buffers/Dwarf Galaxias habitat, it is recommended that the Toowoomba Canary-grass and Cocksfoot be treated to encourage natural spread of Common Reed and Cumbungi, although this should be done in stages given the current weed grasses are helping to reduce soil erosion.

Photo 9. Strip of mixed Toowoomba Canary-grass and Cocksfoot with Common Reed and Cumbungi outside the habitat buffers along Centre Road (photo taken from the north of the buffers, facing southwest).
