96-166 Centre Road,
Narre Warren

Annual EPBC
Compliance Report 2023
– EPBC 2014/7380

Prepared for
Narre Warren Central Pty Ltd

March 2023
Report No. 14090 (20.0)

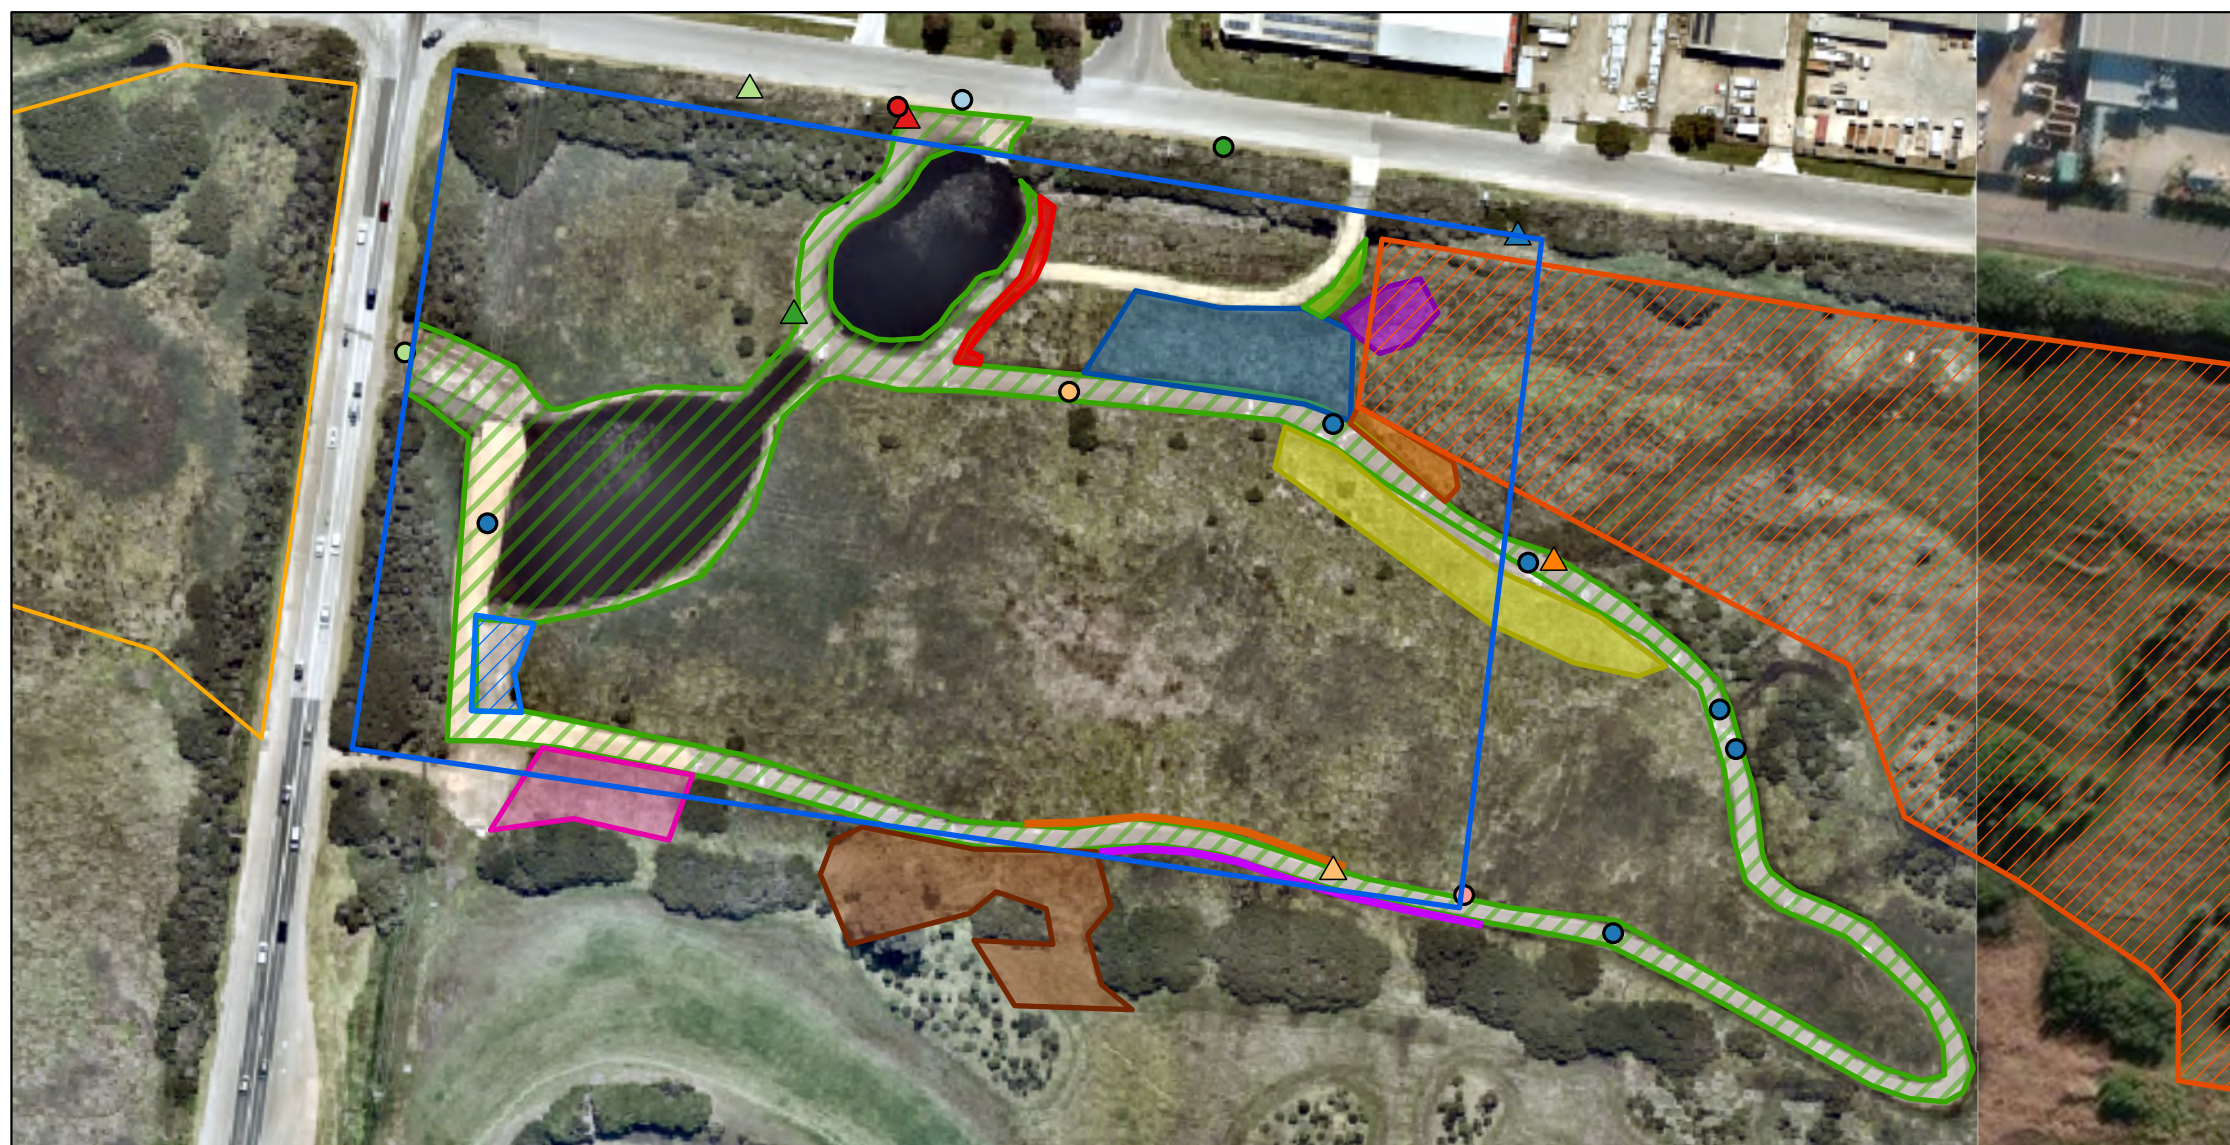
Figure 1: Study area and monitoring observations

Two areas of soil erosion and one area of soil disturbance were observed near the swales, as mapped in Figure 1 and shown in Photo 3 below.

Notwithstanding the above, the site assessment has identified three areas in the buffers that would benefit from revegetation efforts, particularly where Swamp Paperbark has not naturally established (as mapped on Figure 1). The lack of native recruitment may be due to the dense presence of weeds. Weed control and native plantings such as Swamp Paperbark and Tall Sedge would enhance the native vegetation cover and continuous habitat of Swamp Paperbark in the buffers. The suggested planting areas are named in order of priority, i.e. 'suggested planting area 1' being the most important (Photo 7 below).

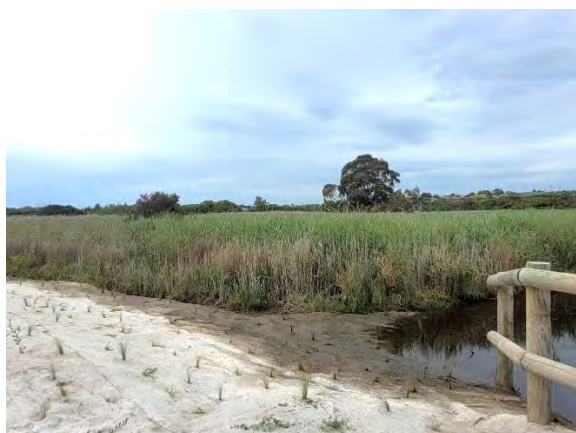
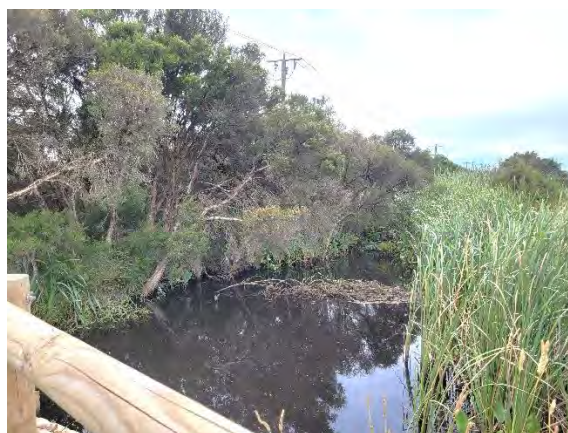
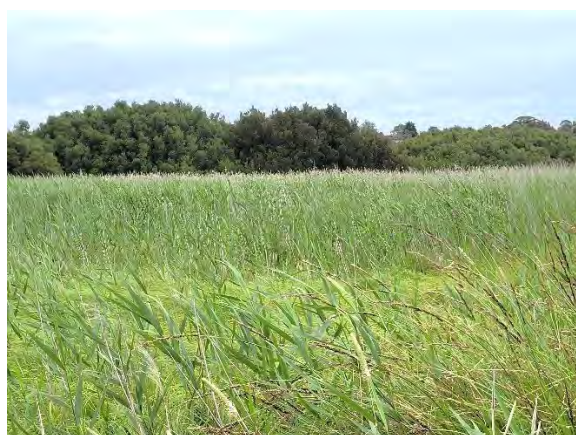
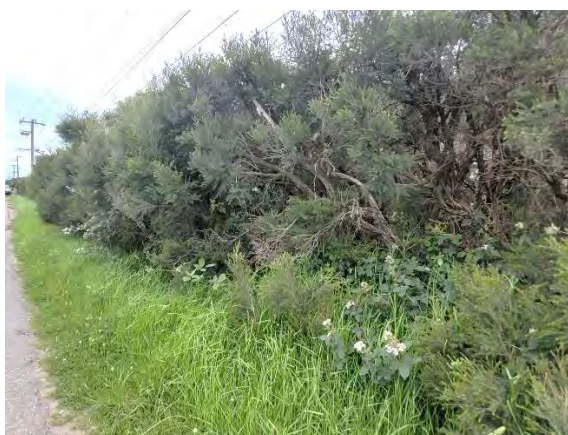
Stands of Swamp Scrub dominated by Swamp Paperbark and often Woolly Tea-tree were observed along the northern, southern and western fringes of the offset site, as well as scattered Swamp Paperbark trees around the site. In particular, Swamp Scrub comprising dense Swamp Paperbark surrounded the inundated drains along the northern and western boundaries, with indigenous Slender Knotweed and Rushes in the understorey.

Photos 1-4. Native wetland vegetation with Swamp Scrub along the northern and western boundaries.

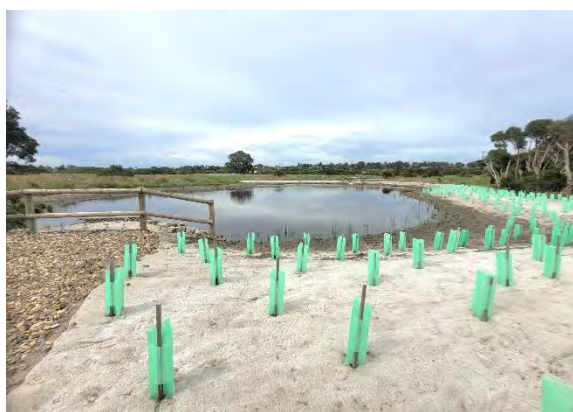
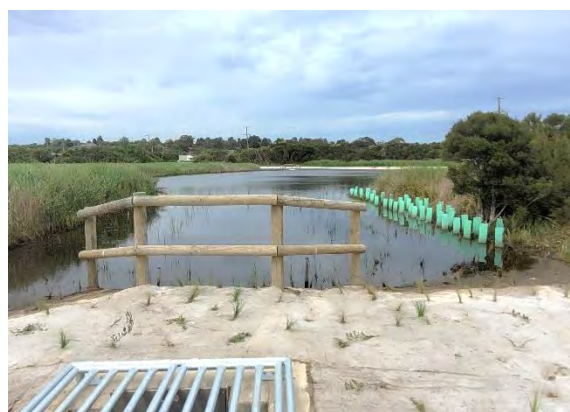
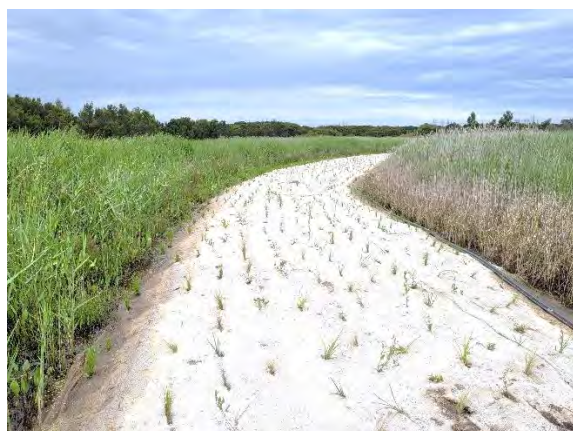
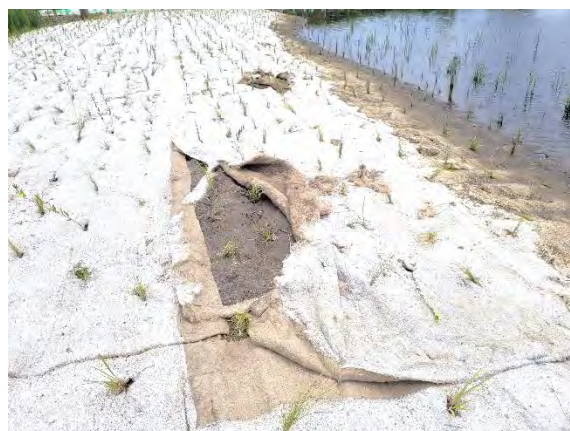
Photos 8-12. Revegetation works at refuge pools and revegetation track. Some damaged erosion matting.

- Damaged areas of erosion matting will require repair.
- Collect tree guards and dispose of appropriately (offsite), when no longer required.

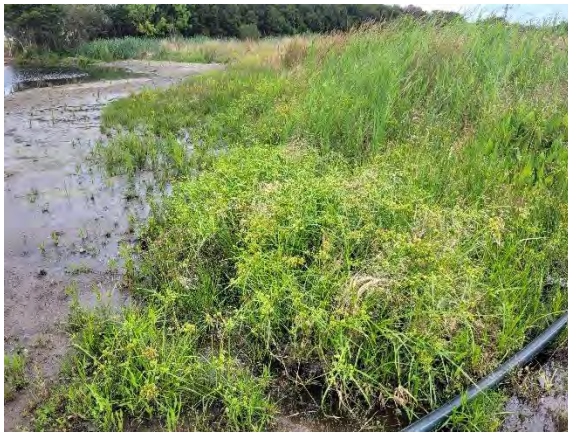
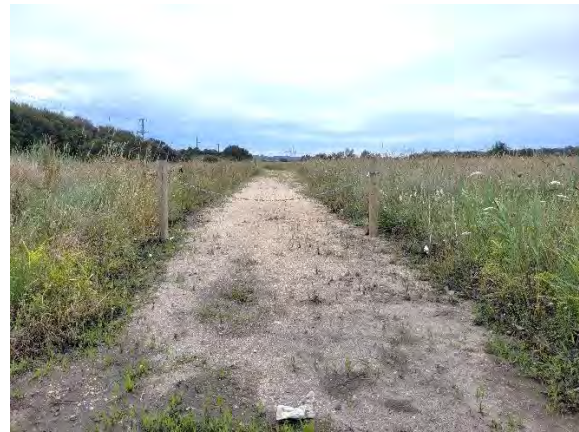
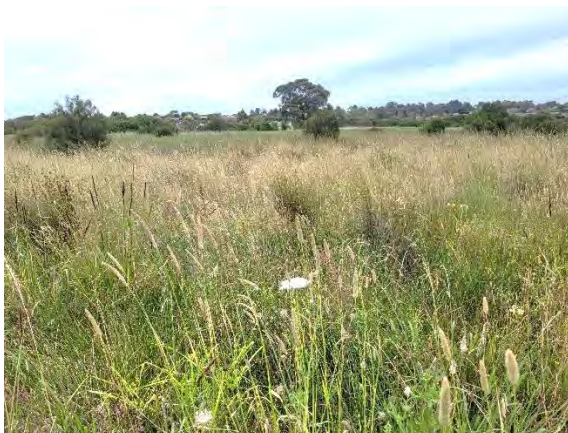
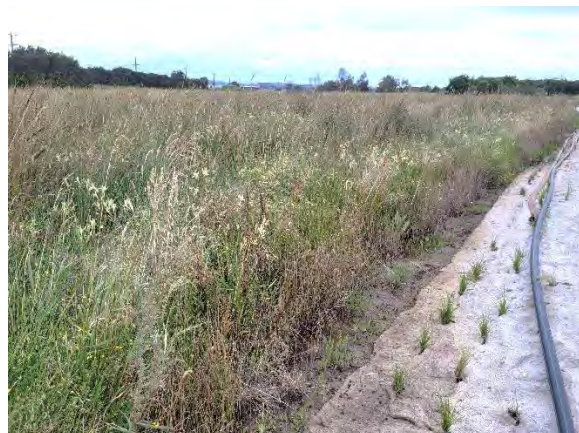
Photos 13-16. Top left – Weed Area 1. Top right – dirt track in the northern part of the offset site. Bottom left – Toowoomba Canary-grass infestation in Weed Area 2. Bottom right – weeds along revegetation track.

- Woody weeds (Blackberry, Dracaena, Hawthorn and Sweet Briar) can be removed using the cut-and-paint method, at any time of the year.

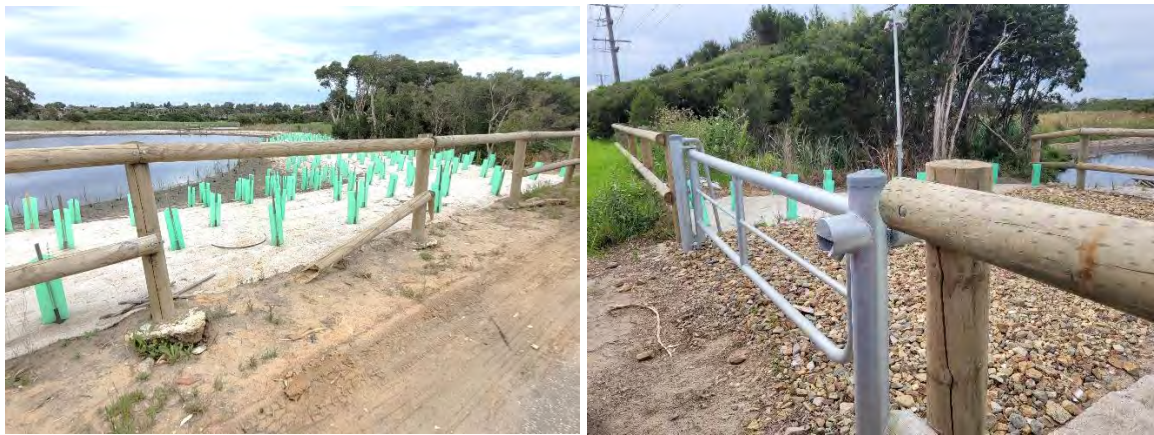
Permanent fencing was installed at the two refuge pools as indicated on Figure 1. The current perimeter fencing along the norther boundary does not prevent members of the public from accessing the offset site (this appears to be intentional as there is an open entryway incorporated into the fence). However, this leaves the revegetation works vulnerable to vandalism and damage. The survey found that the northern fencing had been damaged, likely by vandals (see photo below and Figure 1).

Photos 17-18. Damaged perimeter fencing and the entryway at the northern boundary.

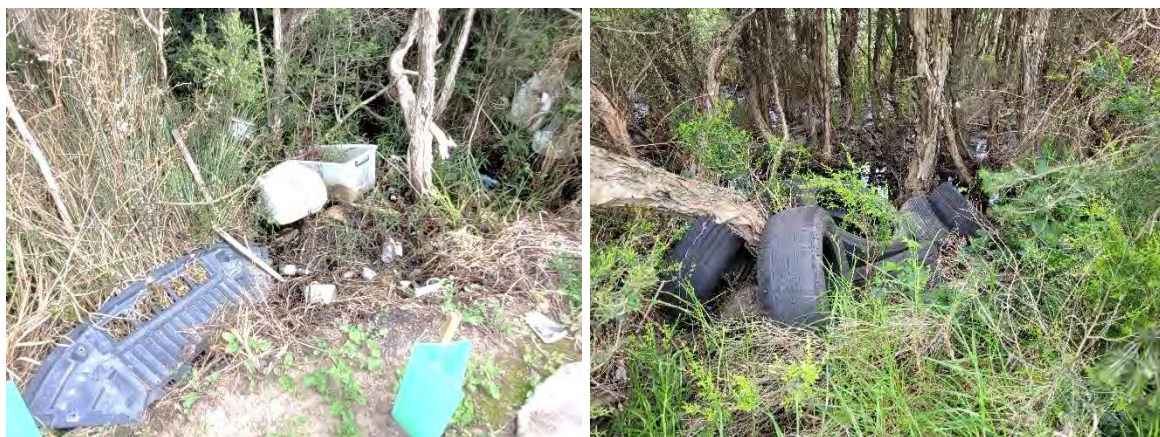
Some rubbish was also found near this fencing, at the edge of the Swamp Scrub along Centre Road (Figure 1). More rubbish (such as car tyres) was found along Centre Road, in or near the Swamp Scrub along this road. Unfortunately, this Swamp Scrub can be easily accessed by members of the public from Centre Road. Clean-up of litter or dumped waste on the roadsides is not the responsibility of the Proponent, and clean-up is required to be addressed by council.

Photos 19-20. Litter inside the offset site and dumped tyres in the Swamp Scrub along Centre Road.

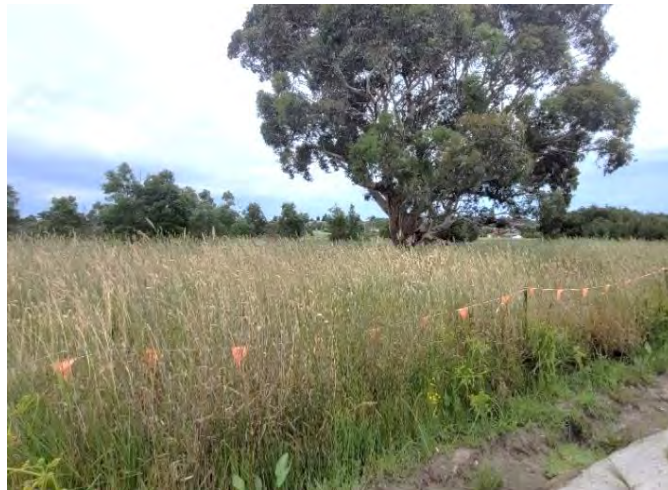
Some roped bunting was observed along the interface of the existing wetland vegetation and the revegetation track, in the southern part of the offset site. This was evidently used

to prevent accidental encroachment into the vegetation during construction of the revegetation track, however it currently does not appear to serve a purpose and some sections had fallen. The roped bunting could become rubbish inside the site over time.

Photo 21 Rope bunting along the revegetation track.

- Remove all roped bunting (and stakes) at the southern part of the offset site, otherwise these may become rubbish in the site over time.
- Future use of the non-revegetation area is to be confirmed. If this area is to be a permanent area set aside for maintenance and access, soil erosion may become an issue and this area may require works to provide a proper foundation. If this area will not serve a maintenance purpose and is intended to become part of the wetland vegetation on site, it is recommended that revegetation treatment be undertaken here to rapidly provide native vegetation cover and manage soil erosion. This area might be revegetated with Common Reed or native Rushes, for example.

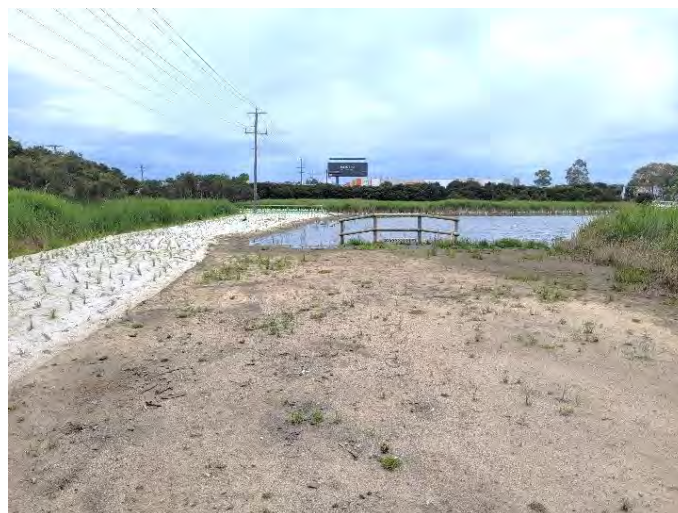
The current monitoring found an area at the south-western part of the offset site that was generally devoid of vegetation, except for recolonising small plants (see photo below and Figure 1). This area appeared associated with access to the southern refuge pool from the entryway at the south-west corner of the site. It is currently not known what the intention for this area is, i.e. whether it is for maintenance vehicle access or if it will be left to become wetland vegetation. If no action is taken for this area, it is likely that it will become colonised by weeds which will threaten the adjacent existing native wetland vegetation and revegetation works.

Photo 22 Rope bunting along the revegetation track.

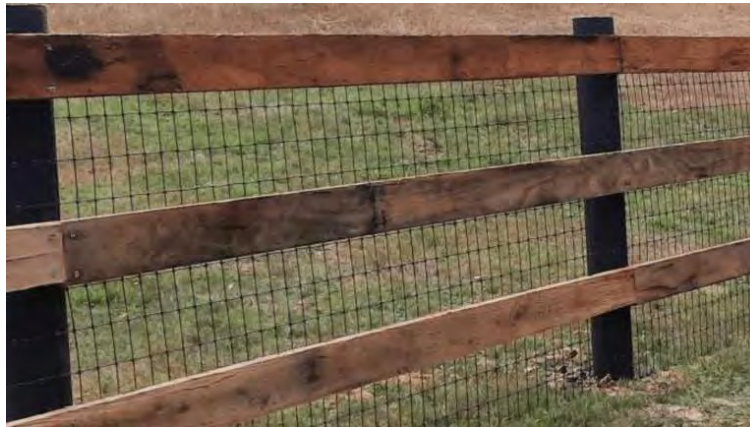
Image 1. Example photo of mesh fencing.
