**96-166 Centre Road,
Narre Warren**

Offset Site Monitoring for
Revegetation and Weeds –
6 Months Post-construction

**Prepared for
Narre Warren Central Pty Ltd
c/- The Fidus Group**

June 2024
Report No. 14090.7 (2.0)

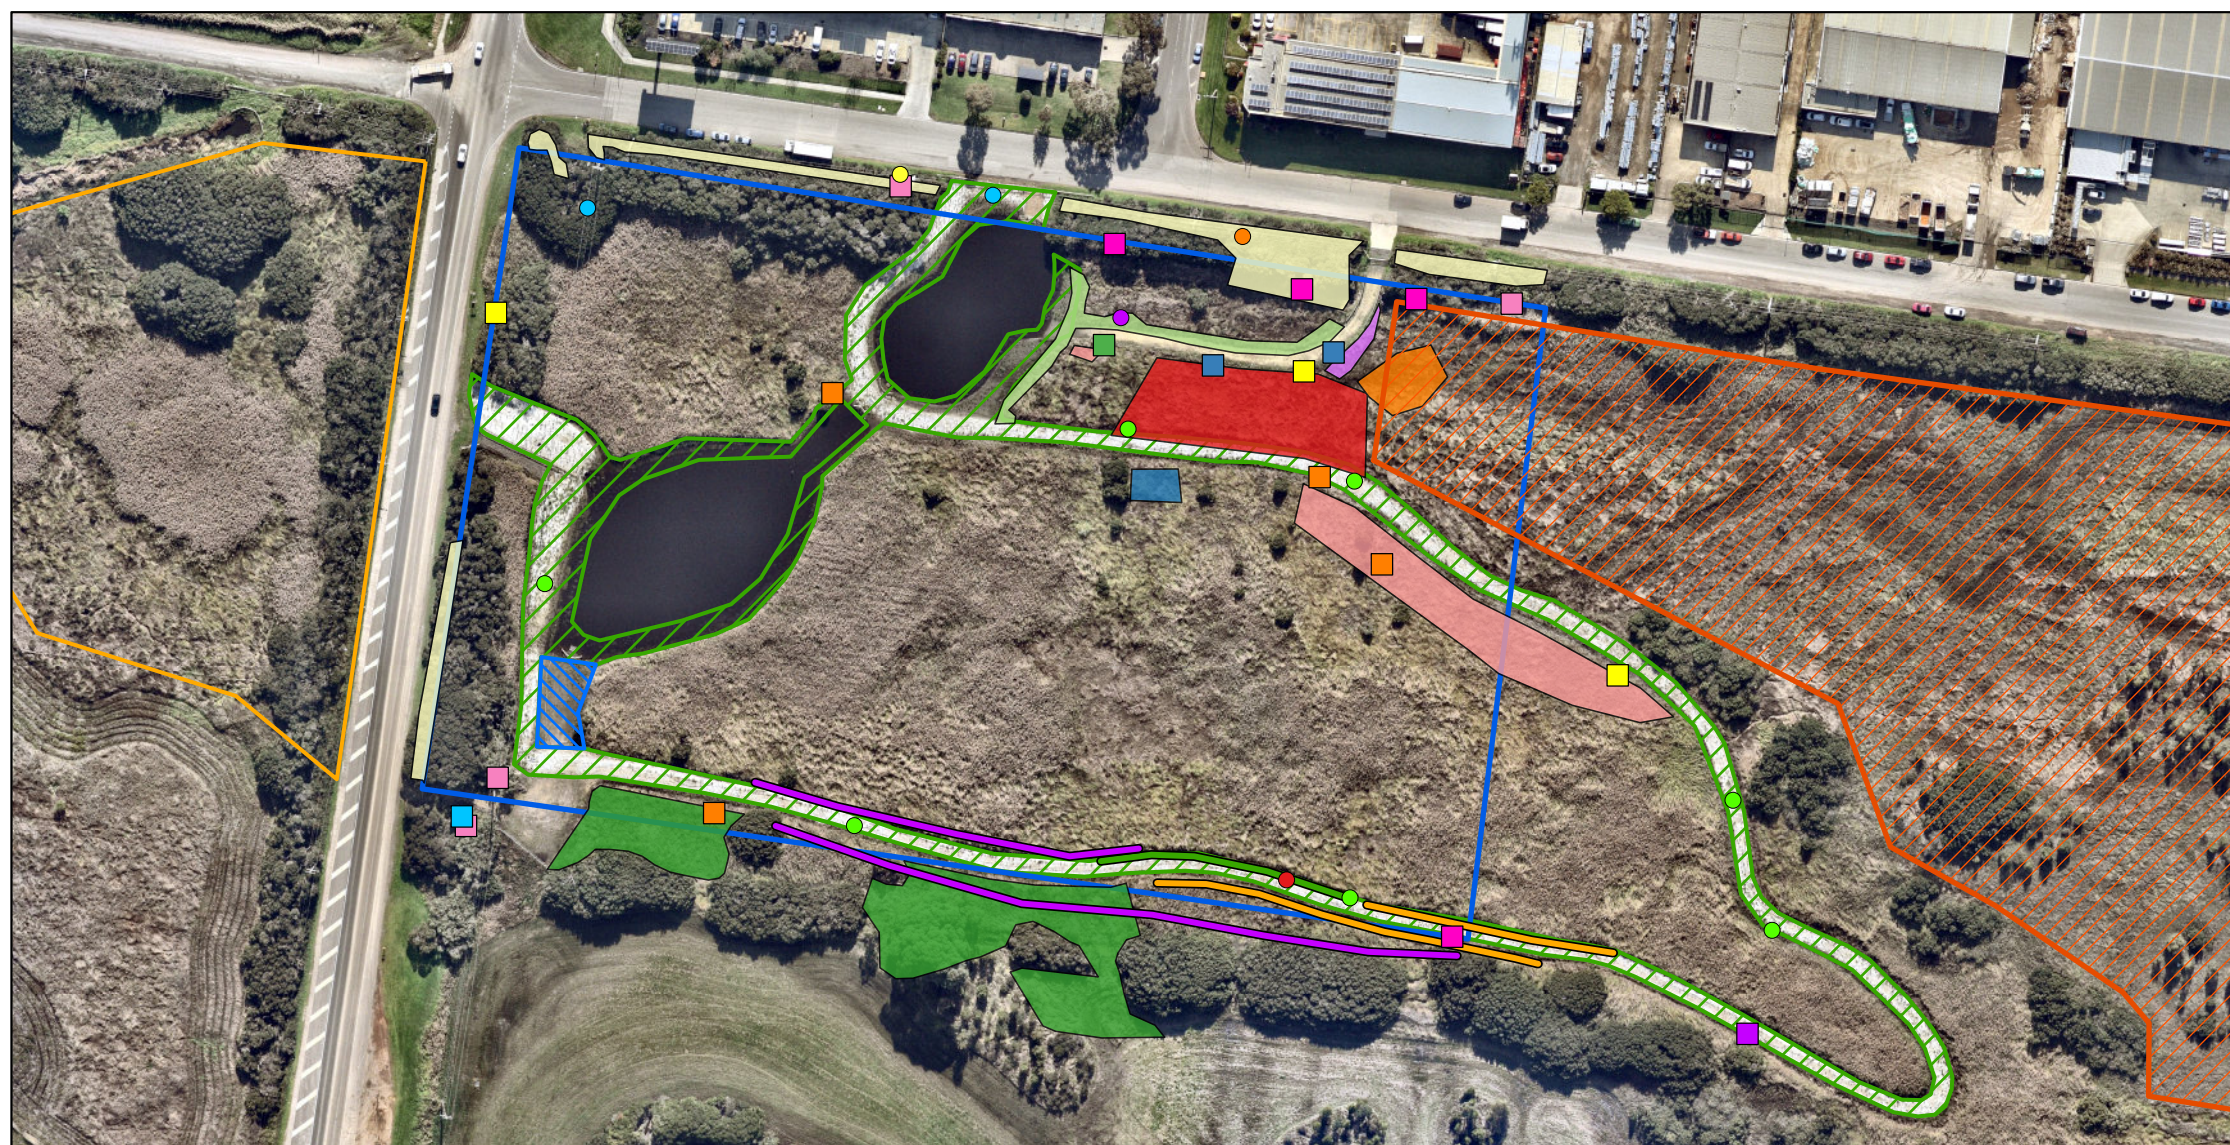
Figure 1: Study area and monitoring observations

The offset site is approximately 3.35 hectares in area (see Figure 1). It is bordered by Centre Road to the north, Hallam Road and a large drain to the west, with grassland and constructed stormwater wetlands owned by Melbourne Water to the east and the south. Past land use at the offset site appears to have been agriculture (e.g. grazing). There is a Melbourne Water managed site for Eastern Dwarf Galaxias located west of the offset site, on the opposite side of Hallam Road. However, there was no connectivity between this western site and the offset site prior to the works at the offset site.

Some areas of the erosion matting had become unpinned and damaged (see photo below). Locations of the most damaged mat areas are shown in Figure 1.

Overall, weeds at the offset site were at a low level, apart from mapped Weed Areas (shown in Figure 1) and the edges of the existing dirt track at the northern part of the site. The density of the native wetland vegetation, particularly in the areas dominated by Common Reed, Cumbungi and Tall Sedge, has helped to suppress weed infestations in the rest of the site.

It was noted that the expanses of grassland northeast and east of the offset site appeared to contain a mixture of native and non-native vegetation, with Toowoomba Canary-grass as the main weed, as viewed from afar inside the offset site and Centre Road (Figure 1).

Permanent fencing was installed at the two refuge pools as indicated on Figure 1. The current perimeter fencing along the northern boundary does not prevent members of the public from accessing the offset site (this appears to be intentional as there is an open entryway incorporated into the fence). However, this leaves the revegetation works vulnerable to vandalism and damage as shown by the dumping of rubbish within the offset site. The survey found that the northern fencing had been damaged, likely by vandals (see photo below and Figure 1).

- Reduce weed cover in the Weed Areas mapped on Figure 1.
 - Reduce weed cover along the dirt track in the northern part of the site and in the areas of Swamp Scrub, including reducing woody weeds (Blackberry, Gorse, Sweet Briar, Sweet Pittosporum and Yucca).

- For areas containing significant infestations of Toowoomba Canary-grass (as shown in Figure 1), it is strongly recommended that the Toowoomba Canary-grass be regularly slashed every 3 months, including in late spring. Slashing prior to seed set in late spring will help prevent their spread and recruitment. Slashing also reduces biomass, enhancing visibility for weed treatment.

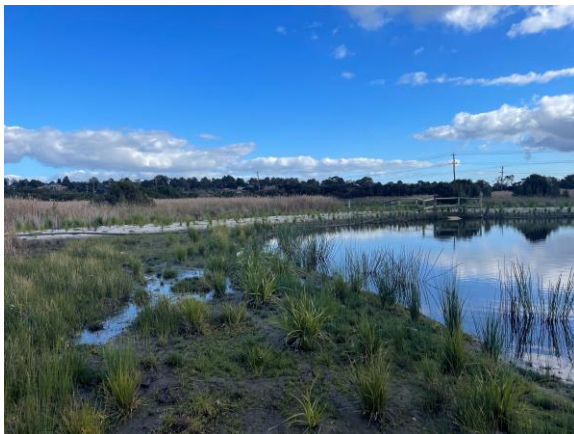
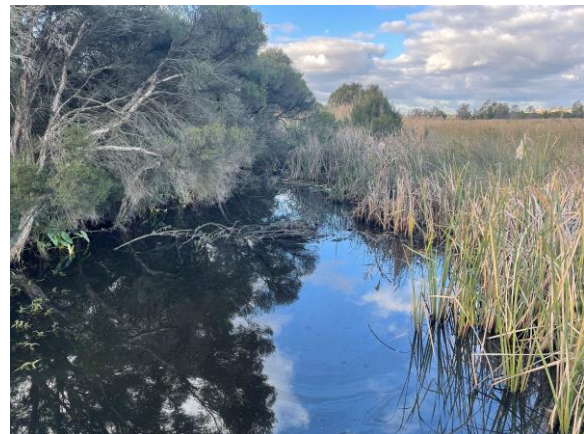
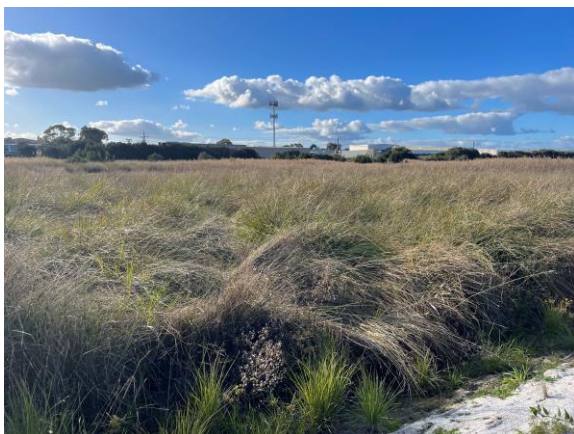
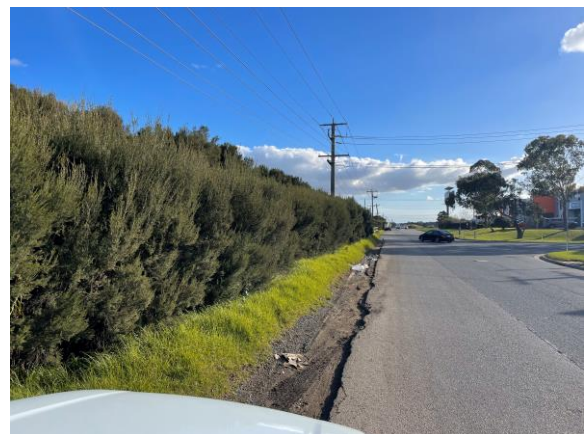
Areas of Tall Marsh were dominated by Common Reed in most of the offset site, with Tall Marsh dominated by Cumbungi present near the northern boundary. Areas of Plains Grassy Wetland occurred at the northern part of the site, often dominated by dense Tall Sedge while containing a variety of native plants such as Common Blown-grass, Common Spike-sedge, Small Loosestrife, Mat-rushes, Jointed Rush and other Rushes.

Stands of Swamp Scrub dominated by Swamp Paperbark and often Woolly Tea-tree were observed along the northern, southern and western fringes of the offset site, as well as scattered Swamp Paperbark trees around the site. In particular, Swamp Scrub comprising dense Swamp Paperbark surrounded the inundated drains along the northern and western boundaries, with indigenous Slender Knotweed and Rushes in the understorey.

Photos 1-4. Native wetland vegetation in the offset site, including open wetlands and dense Common Reed (top and bottom left), with Swamp Scrub along the northern and western boundaries (top and bottom right).

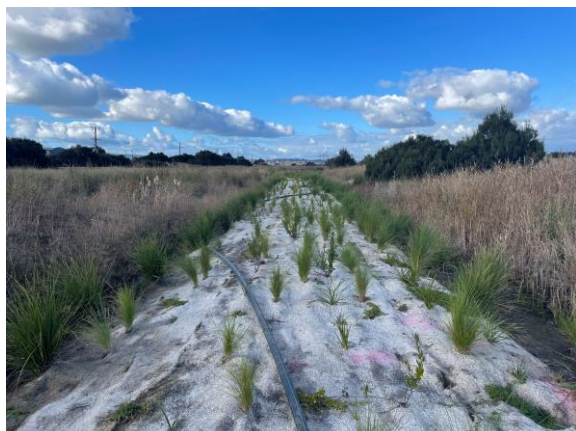
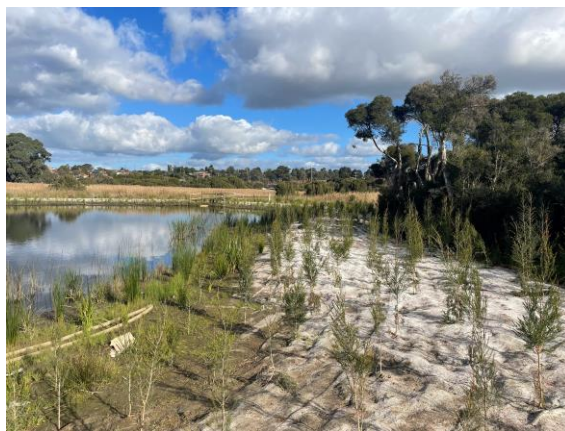
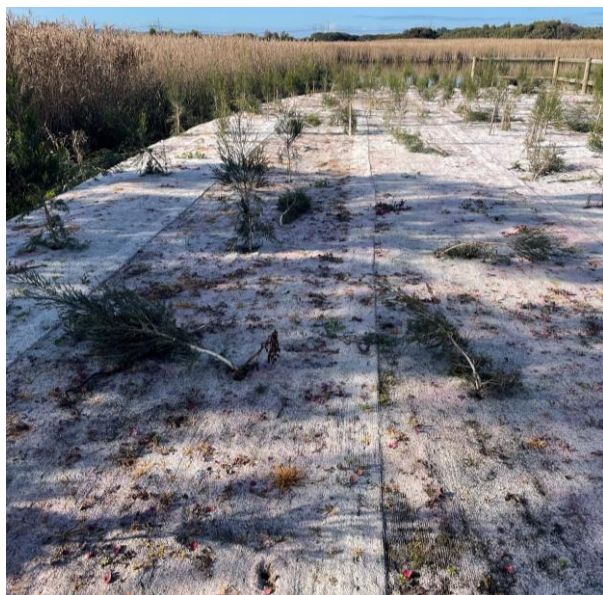
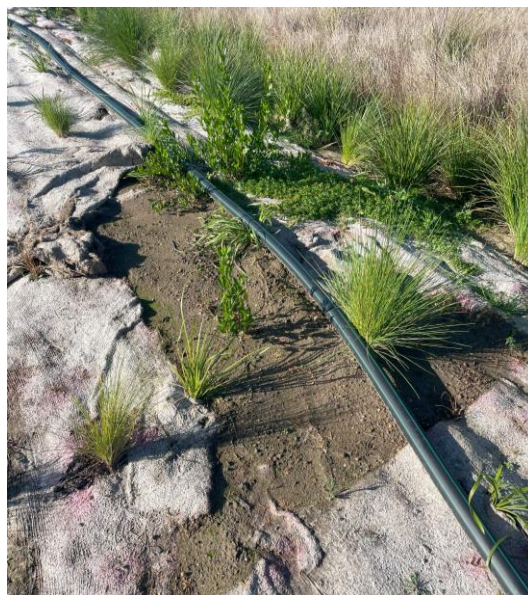
Planted Swamp Paperbark and Woolly Tea-tree in the western entrance have mostly survived. However, some have been knocked over relatively recently, as fallen individuals still have green vegetation (see photo below). The cause of this is unclear.

Photos 5-8. Revegetation works at refuge pools and revegetation track. Some damaged erosion matting.

- Damaged areas of erosion matting will require repair and the plantings in these areas that died as a result will need to be replaced. We recommend replanting with Hop Goodenia, Mat-rushes and Spear Grasses (avoid using Kidneyweed).
- The planted Swamp Paperbark and Woolly Tea-tree that have fallen over will need to be replaced.
- Most tree guards have been removed from site. A small collection of planted shrubs along the border of the southern dam still have tree guards. These will need to be removed and disposed of appropriately (offsite), when no longer required.

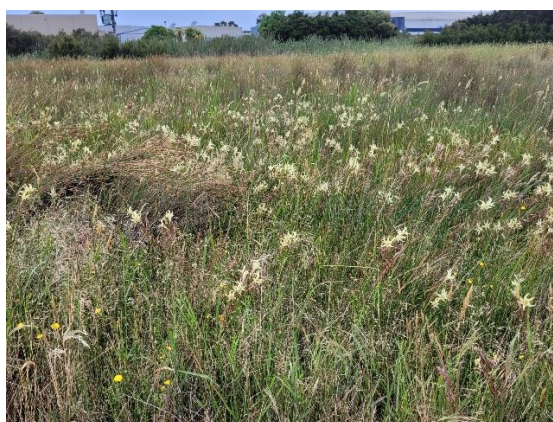
During the baseline survey which occurred in summer, a large infestation of Wild Gladiolus was also observed at the northern part of the offset site (this area is included in Figure 1), as well as scattered individuals around the site. Due to the winter timing of the current survey, this weed species was not flowering and therefore a lot less conspicuous to detect. Therefore, though not seen in this survey, it should be assumed that they are still present.

Photo 9. Area of Wild Gladiolus infestation mapped and photographed in December 2023.

- Woody weeds (Blackberry, Yucca, and Sweet Briar) can be removed using the cut-and-paint method, at any time of the year.
- Spot-spraying of Wild Gladiolus should occur in summer when it is flowering and therefore easily visible.

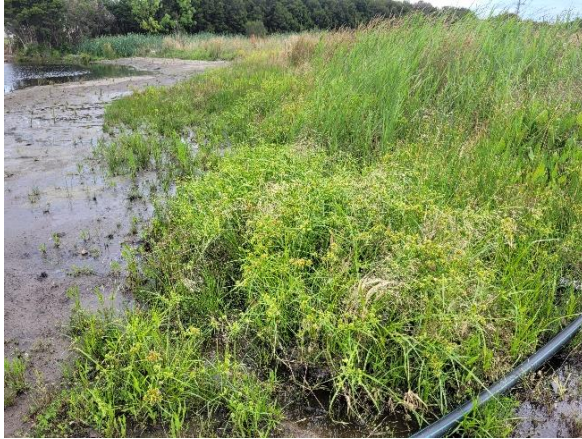
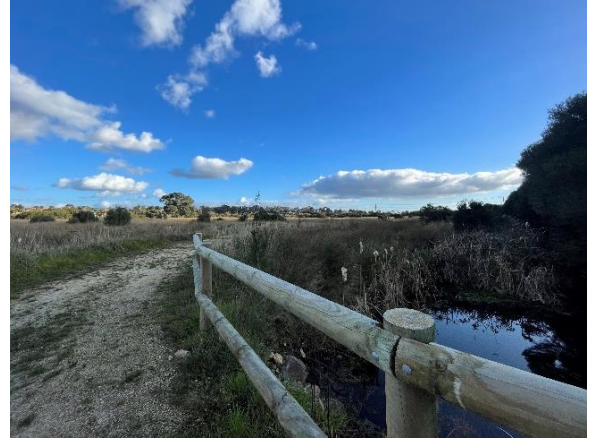
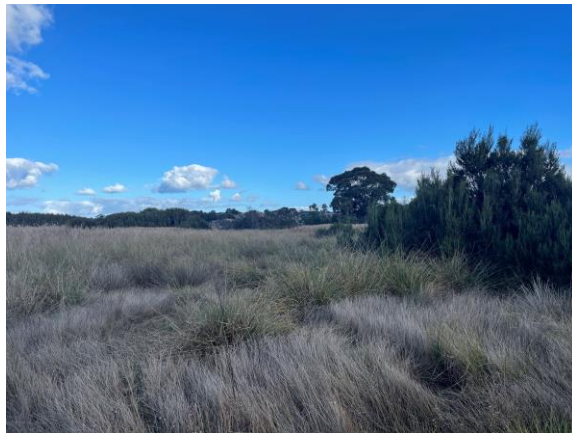
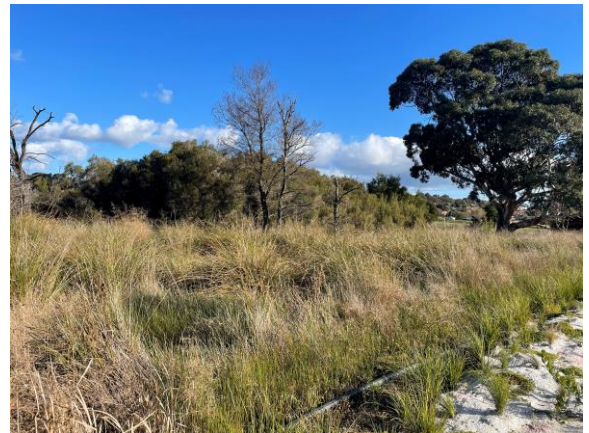
The edges of the existing dirt track at the northern part of the offset site contained scattered infestations of Toowoomba Canary-grass, Yorkshire Fog, Dallis Grass and many herbaceous weeds such as Asterweed, Flaxleaf Fleabane, Scarlett Pimpernel, Carrot Weed, Ox-tongue, Wild Gladiolus, Clustered Dock and Drain Flat-sedge. A few high threat and woody weed species were observed along this track like multiple occurrences of sweet briar, blackberry, a spear thistle, and a few larger Ox-tongue individuals.

The edges of the revegetation track had similar weeds to the existing dirt track, though infestations were to a lesser degree (varying from moderate to minor/scattered). The dominant weeds were the Drain Flat-sedge and Aster Weed, often limited to the drainage line either side of the track.

Photos 10-14. Top left – Weedy area along the dirt track. Top right – Entrance point at the northeastern part of the offset site. Bottom left – example of Toowoomba Canary-grass dominated area. Bottom right – weeds along the revegetation track in the southern part of the site.

- Continue to spot-spray weeds growing amongst the revegetation works.
- Continued weed control actions should include the following:
 - Weed control should mostly occur during the times of the year when herbaceous and grassy weeds are actively growing and prior to flowering/seed set (generally in late spring), so treatment is most effective.

- Spot-spray using a herbicide that is appropriate for use in environmentally sensitive areas, such as Roundup Biactive® (Glyphosate). Spot-spray on target grassy and herbaceous weeds, with care to avoid off-target damage to revegetation works and native plants in the existing wetland vegetation.

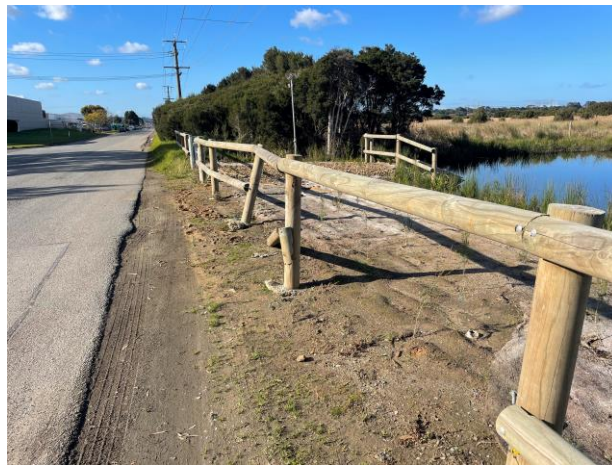
Photos 15. Damaged perimeter fencing next to the entryway at the northern boundary.

- The damaged section of the northern fencing will require repair.
- Although the intention may be to enable public access to the offset site in the long-term, it is recommended that the fencing along Centre Road include wire mesh (Image 1 below) and that the entry ways be locked off outside of maintenance activities, to further

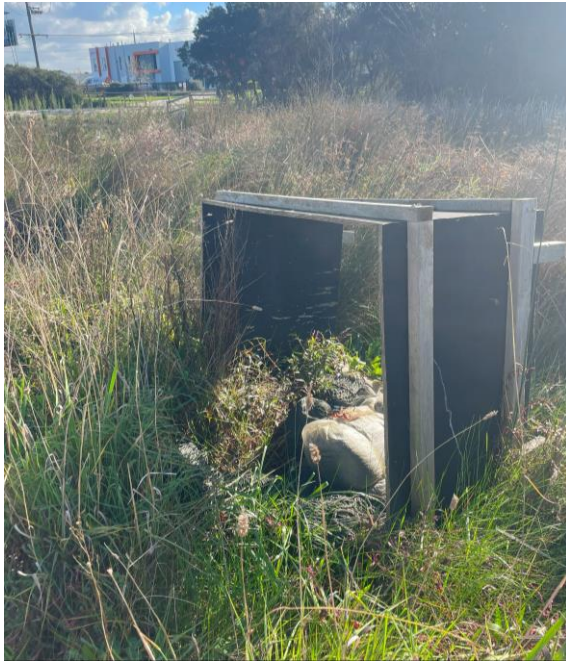
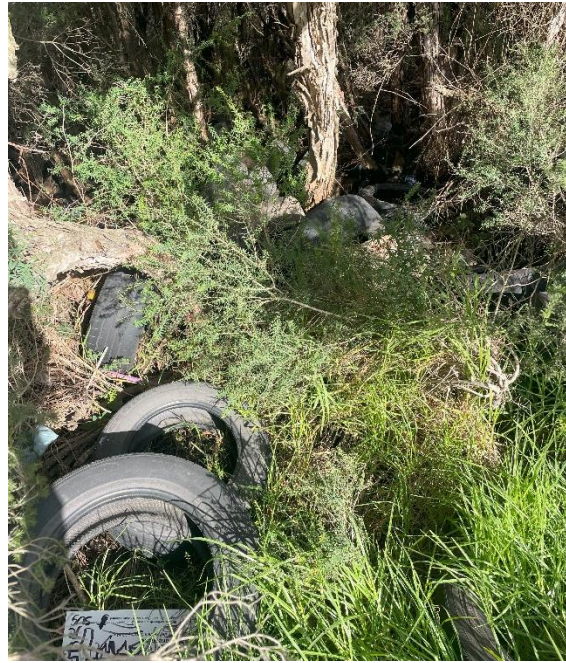
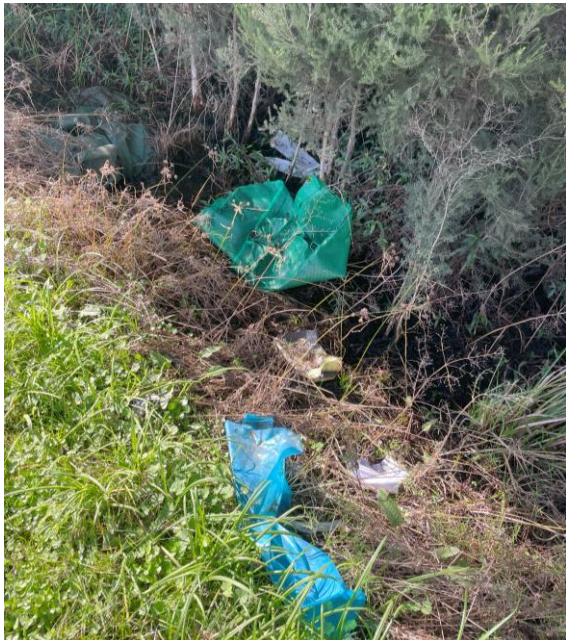
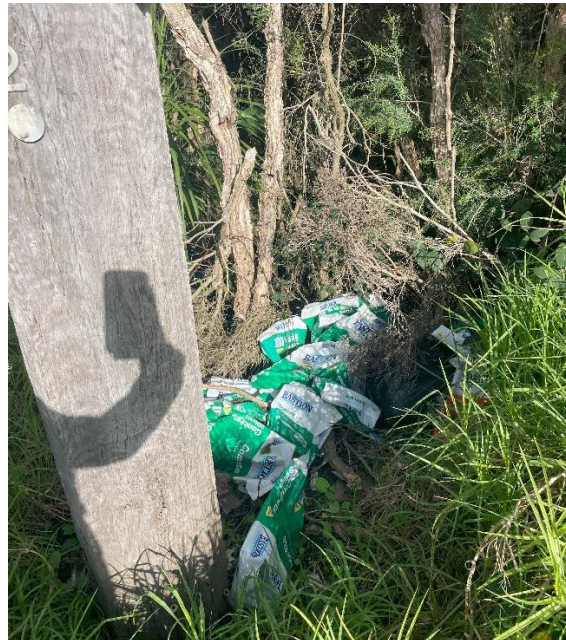
Some rubbish was also found near this fencing, at the edge of the Swamp Scrub along Centre Road (Figure 1). More rubbish (such as car tyres) was found along Centre Road, in or near the Swamp Scrub along this road. Unfortunately, this Swamp Scrub can be easily accessed by members of the public from Centre Road. Additional rubbish has also been found inside the offset site (see below). Clean-up of litter or dumped waste within the site is the responsibility of the proponent, but not along roadsides, this is required to be addressed by council.

Photos 16-19. Litter inside the offset site and dumped tyres in the Swamp Scrub along Centre Road.

- Remove litter and dumped rubbish inside the offset site.
- It is the council's responsibility to address littering and illegal waste dumping on public land, such as the roadsides of Centre Road and Hallam Road. The Proponent should report incidences of littering and waste dumping along these roads to council.

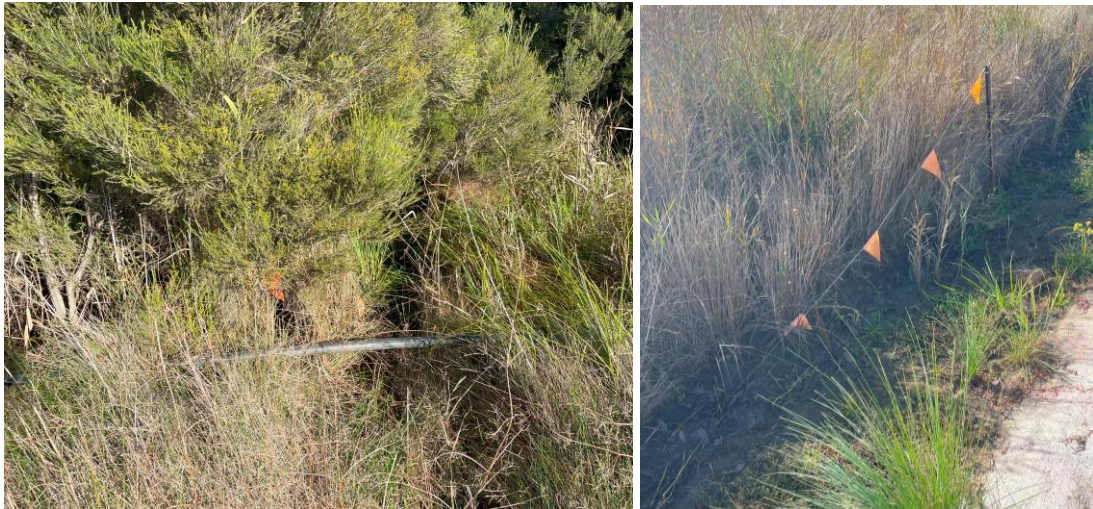
Some roped bunting was observed along the interface of the existing wetland vegetation and the revegetation track, in the southern part of the offset site (Figure 1). This was evidently used to prevent accidental encroachment into the vegetation during construction of the revegetation track, however it currently does not appear to serve a purpose and some sections had fallen. The rope bunting should now become part of the rubbish removal effort.

Photo 20-21. Rope bunting along the southern portion of the revegetation track.

- Remove all roped bunting (and stakes) at the southern part of the offset site as they have become rubbish in the site. It will become harder to removed as the vegetation becomes more overgrown.

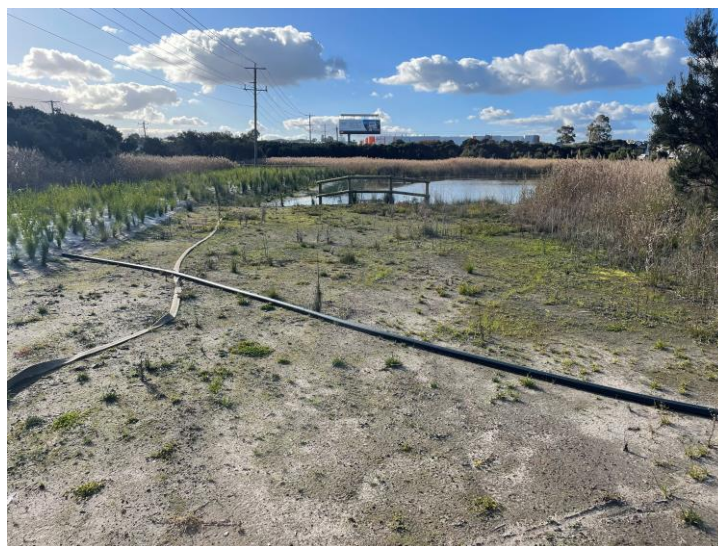
The current monitoring found an area at the southwestern part of the offset site that was generally devoid of vegetation, except for recolonising small plants and weed species (see photo below and Figure 1). This area appeared associated with access to the southern refuge pool from the entryway at the south-west corner of the site. It is currently not known what the intention for this area is, i.e. whether it is for maintenance vehicle access or if it will be left to become wetland vegetation naturally. As weeds have begun colonising this area, there is increasing threat of invasion to the adjacent existing native wetland vegetation and revegetation works.

Photo 22. Non-vegetated area at the southwestern part of the offset site.

- Future use of the non-revegetation area is to be confirmed. If this area is to be a permanent area set aside for maintenance and access, soil erosion may become an issue and this area may require works to provide a proper foundation. If this area will not serve a maintenance purpose and is intended to become part of the wetland vegetation on site, it is recommended that revegetation treatment be undertaken here to rapidly provide native vegetation cover and manage soil erosion. This area might be revegetated with Common Reed or native Rushes, for example.

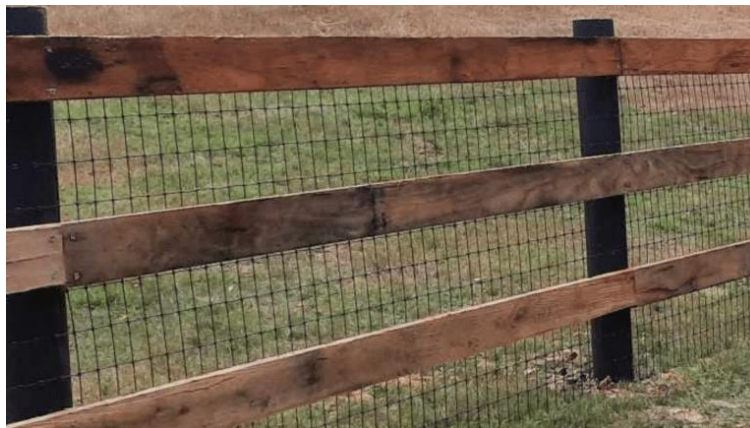
Image 1. Example photo of mesh fencing.
