**96-166 Centre Road,
Narre Warren**

Offset Site Monitoring for
Revegetation and Weeds –
12 Months Post-construction

**Prepared for
Narre Warren Central Pty Ltd
c/- The Fidus Group**

December 2024
Report No. 14090.7 (3.0)

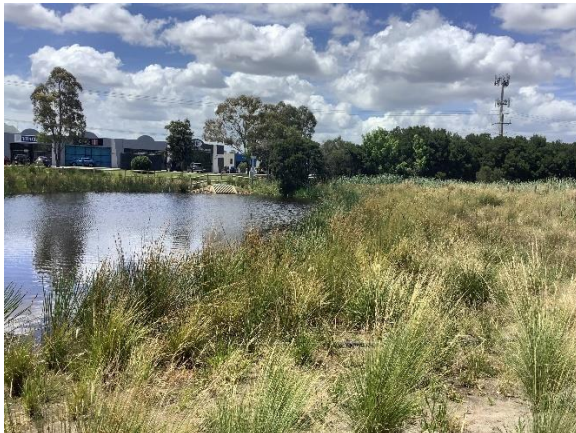
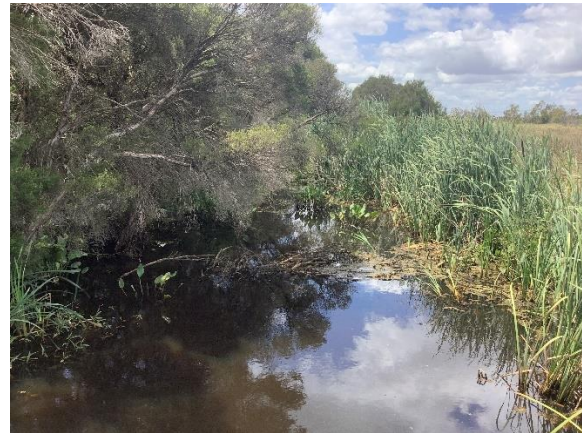
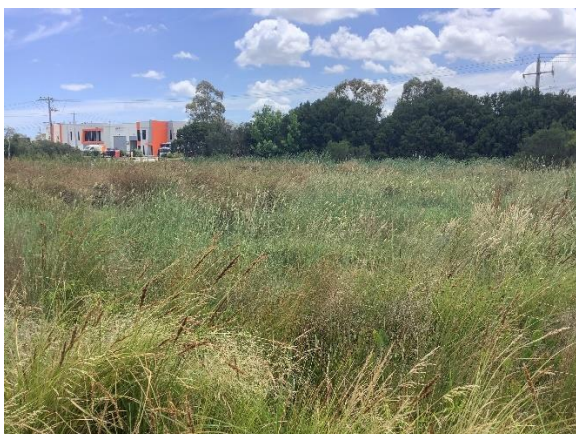
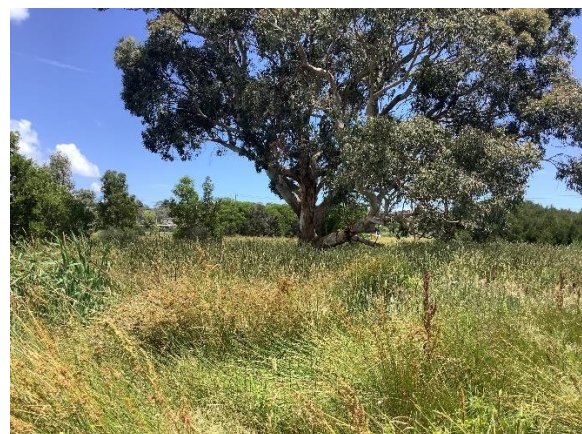
Photos 1-4. Native wetland vegetation in the offset site, including open wetlands and dense Common Reed (top and bottom left), with Swamp Scrub along the northern and western boundaries (top and bottom right).

Tall Marsh within the offset site was largely dominated by Common Reed, except where Cattail dominated the drainage line along the northern boundary of offset site. Areas of Plains Grassy Wetland occurred at the northern part of the site, often dominated by dense Tall Sedge with a variety of native plants such as Common Blown-grass, Common Spike-sedge, Small Loosestrife, Mat-rushes, Jointed Rush and other Rushes.

Stands of Swamp Scrub dominated by Swamp Paperbark and Woolly Tea-tree were observed along the northern, southern and western fringes of the offset site. There were also scattered Swamp Paperbark trees throughout the offset site. Swamp Scrub along the northern and western boundaries had an understory comprising indigenous Slender Knotweed and Rushes.

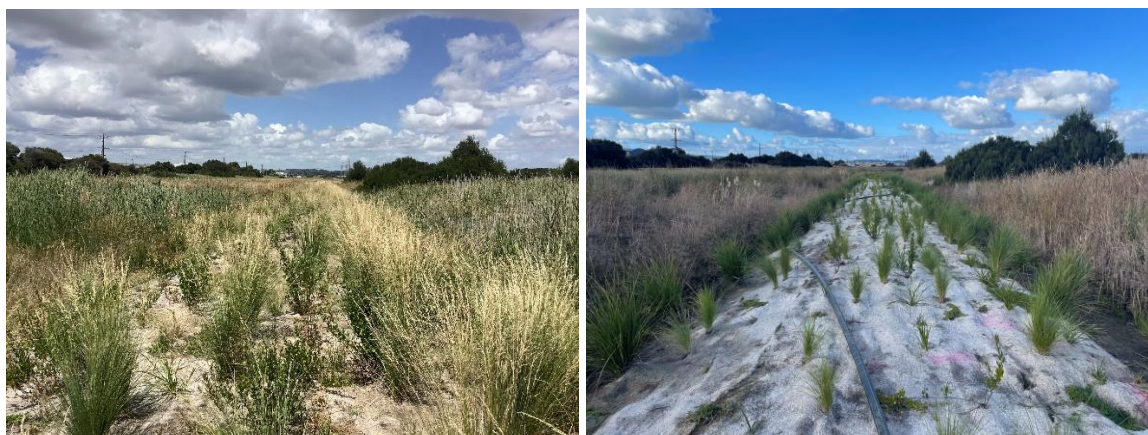
Photo 5 & 6. A comparison between December 2024 (left) and June 2024 (right) surveys to show a clear increase in revegetation biomass

Total mortality of plantings within the matting was estimated to be about 5-10% overall. Biomass from the revegetation works has increased dramatically from the previous monitoring assessment in June. Hop Goodenia, Mat Rushes, Spear Grass and Common Blown Grass remained successful in establishment. Furthermore, planted Flax Lilies, Goodenia and Wallaby Grasses were observed to be flowering.

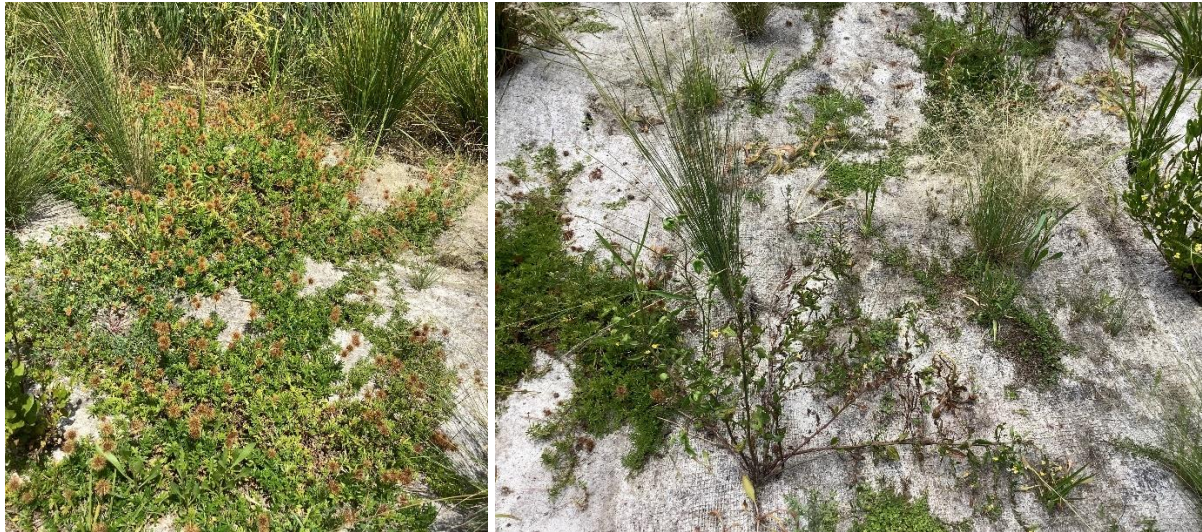
Photo 7 & 8. Bidjee-widgee forming mats in open space of the jut matting (left) and Kidneyweed under stress in drier areas of the revegetation path (right)

In addition, planted Bidgee-widgee has established to the extent that it dominated the ground cover in certain areas (see photos below), forming mats of native vegetation cover in the inter-tussock space.

The planted species that appeared to be struggling the most is the herbaceous Kidneyweed. Its patchy establishment is limited to moist areas (wet depressions and/or path edges) and struggling individuals on the edges of the revegetation path. This accounted for most of the revegetation plant mortality.

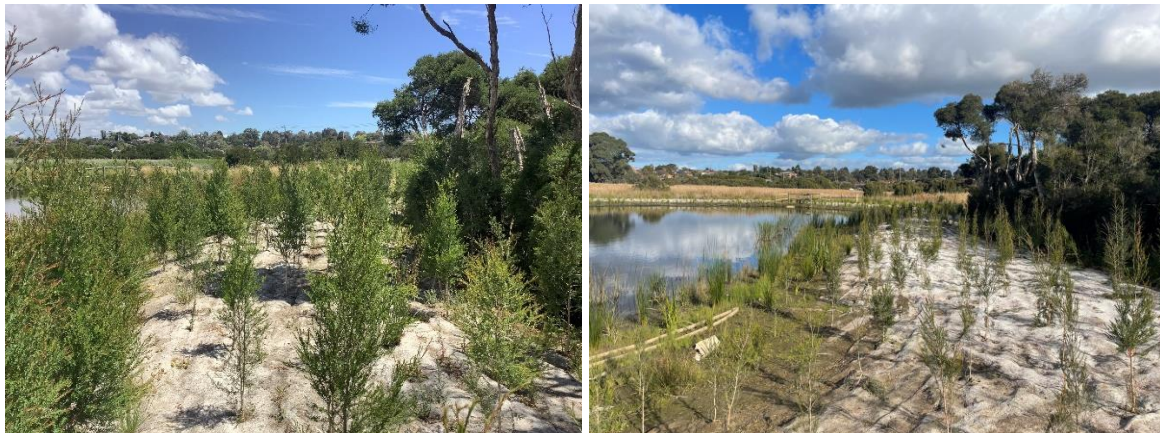
Photos 9 & 10. Increase in biomass of planted Woolly Tea-tree and Swamp Paperbark in December 2024 (left) to June 2024 (Right).

Planted Swamp Paperbark and Woolly Tea-tree in the western and northern entrance have mostly survived and grown considerably (see photos below), except the fallen individuals in the western entrance noted in the last survey which have since died.

- The planted Swamp Paperbark and Woolly Tea-trees that have fallen over and died will need to be replaced.
- Most of the tree guards have been removed from site. A small collection of planted shrubs along the border of the southern dam still have tree guards. These will need to be removed and disposed of appropriately (offsite), when no longer required.

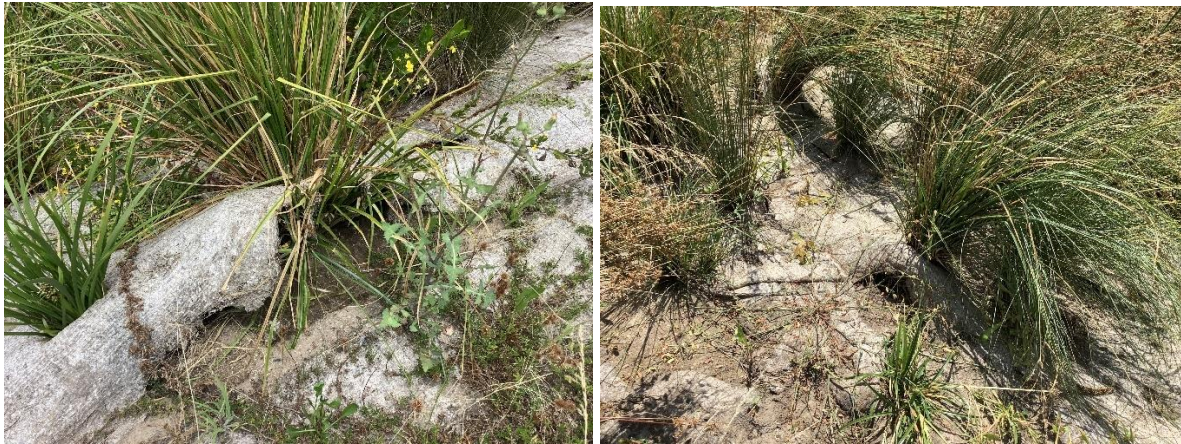
Some areas of the erosion matting had become unpinned and damaged (see photo below). The damage is most likely due to erosion over time and plants outgrowing the holes in the matting. Locations of the most damaged mat areas are shown in Figure 1.

Photo 11 & 12. Representative unpinning of matting caused by plants outgrowing the holes

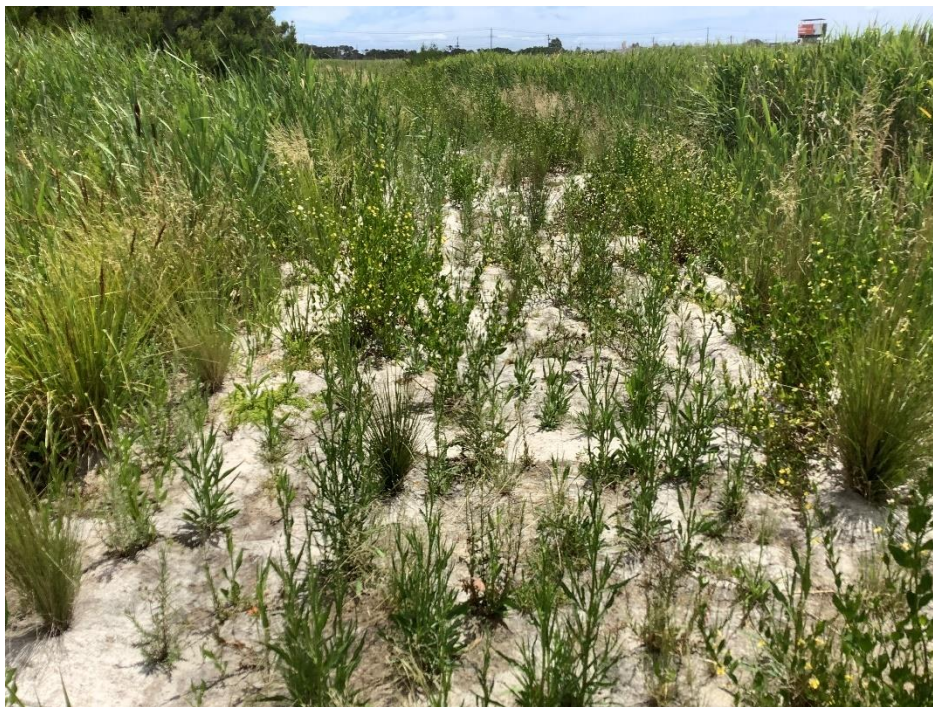
Photo 13. Fleabane and Common Sow Thistle in Figure 1. Photo shows lack of success of planted vegetation and the potential for fleabane to outgrow remaining native vegetation

- Although a high percentage of the revegetation works has been successful, one particular area has been identified in Figure 1 (photo below) which will require further weed management and replanting with similar plants used in the rest of the revegetation path. It is likely that planted individuals have not been as successful in establishing, hence weeds like Fleabane have established instead and the Fleabane could become a high threat weed if left unmanaged.

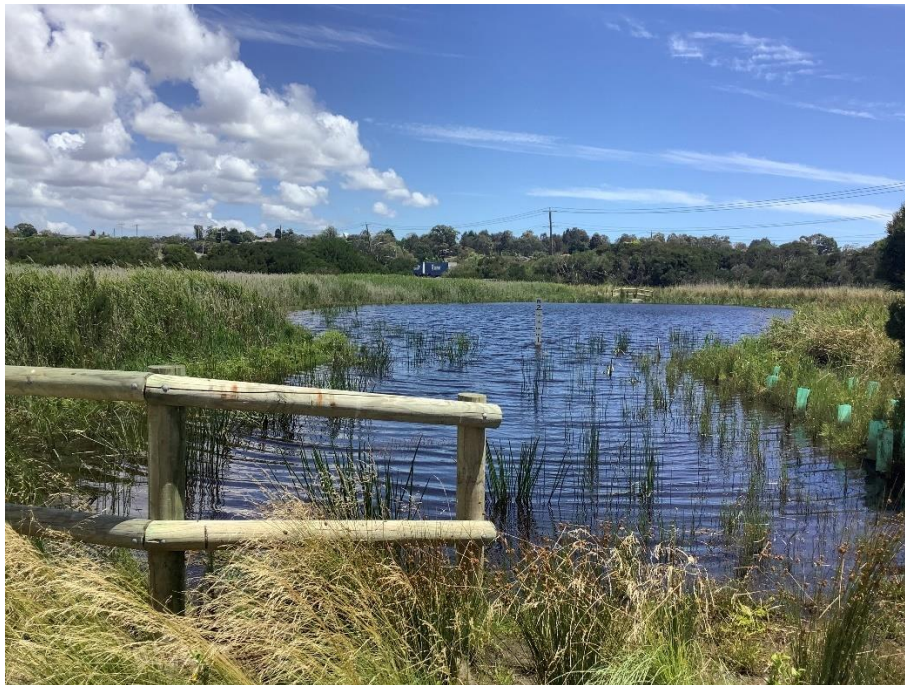
Photo 16. Tree guards surrounding the southern dam to the right of the photo

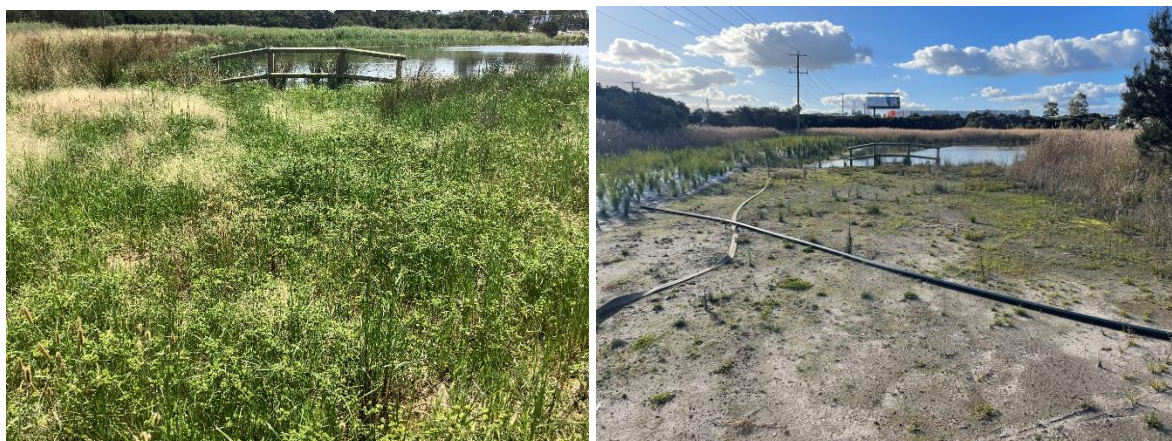
The previous survey identified an area in the southwest of the offset site that was generally devoid of vegetation. It was noted that the purpose of this area was unknown, but the current survey found weeds are colonising that area. This area is now densely dominated by Drain Flat-sedge, Couch Grass, and Fleabane (see photos below and Figure 1). These weeds are likely to invade the adjacent native wetland and revegetation works if left managed, therefore these weeds should be removed and it is recommended that native species be seeded or planted here.

Photo 22. Southwest of the offset site, previously non-vegetated (right) is now dominated by Fleabane, Couch grass, and Drain Flat-sedge (left).

- Future use of the non-revegetated area (now colonised by dense weeds) is yet to be confirmed. If this area is to be a permanent area set aside for maintenance and access, the area will require works to provide proper foundation. If this area will not serve as a maintenance purpose and has another intended purpose, it needs to be managed as to limit the continued establishment of high threat weeds. It is recommended that this area undergoes a revegetation treatment and done so rapidly as to provide additional native vegetation, mitigate weed establishment and soil erosion.

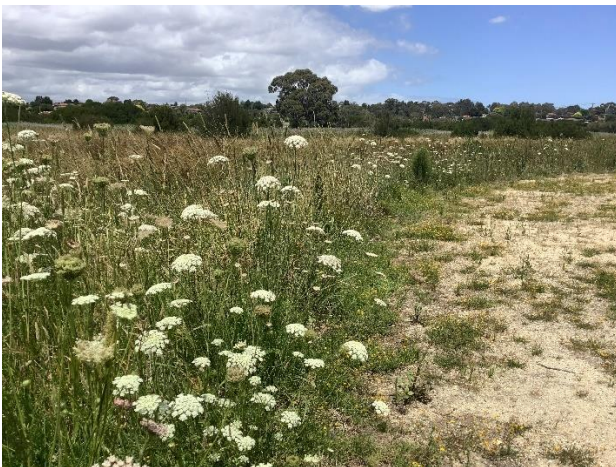
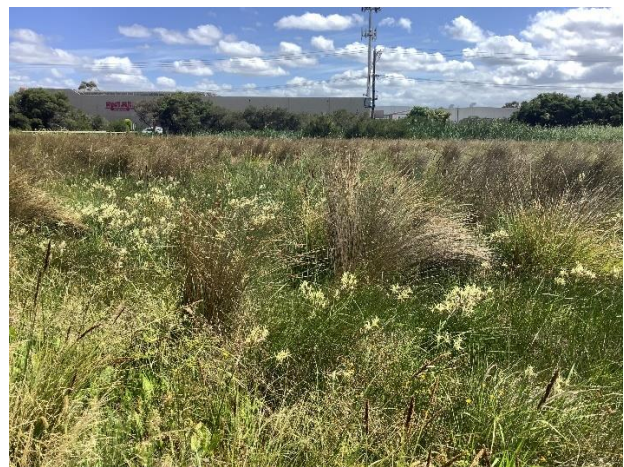
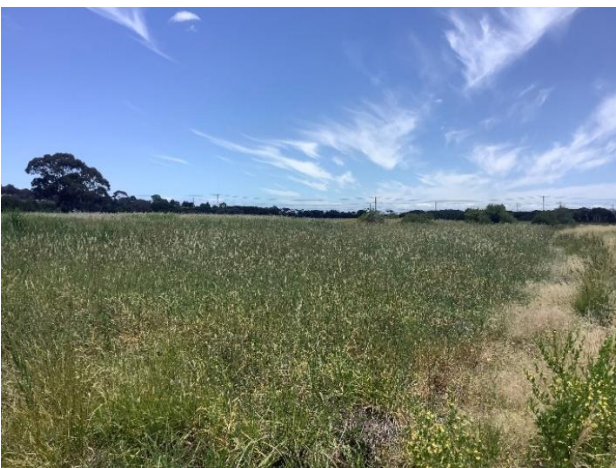
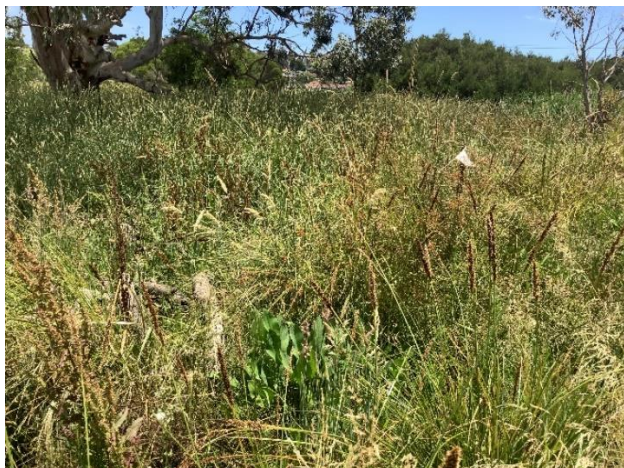
Photos 19-23. Top left – Weedy area along the dirt track. Top right – Wild Gladiolus in the northeast of the offset site. Bottom left – example of Toowoomba Canary-grass dominated area. Bottom right – weeds along the revegetation track in the southern part of the site.

- Continued weed control should aim for the following:
 - While all weeds should be removed or reduced as much as possible, the high-threat weed species (listed above) are to be prioritised.
 - Reduce weed cover in the Weed Areas mapped on Figure 1.
 - Reduce weed cover along the dirt track in the northern part of the site and in the areas of Swamp Scrub. All woody weeds (Blackberry, Gorse, Sweet Briar, Sweet Pittosporum and Yucca) are to be completely removed.
- Continued weed control actions should include the following:
 - Weed control should mostly occur during the times of the year when herbaceous and grassy weeds are actively growing and prior to flowering/seed set (generally in late spring), so treatment is most effective.

- Spot-spray using a herbicide that is appropriate for use in environmentally sensitive areas, such as Roundup Biactive® (Glyphosate). Spot-spray on target grassy and herbaceous weeds, with care to avoid off-target damage to revegetation works and native plants in the existing wetland vegetation.
- For areas containing significant infestations of Toowoomba Canary-grass (as shown in Figure 1), it is strongly recommended that the Toowoomba Canary-grass be regularly slashed every 3 months, including in late spring. Slashing prior to seed set in late spring will help prevent their spread and recruitment. Slashing also reduces biomass, enhancing visibility for weed treatment.
- Woody weeds can be removed using the cut-and-paint method, at any time of the year.
- Spot-spraying of Wild Gladiolus should occur in summer when it is flowering and therefore easily visible.

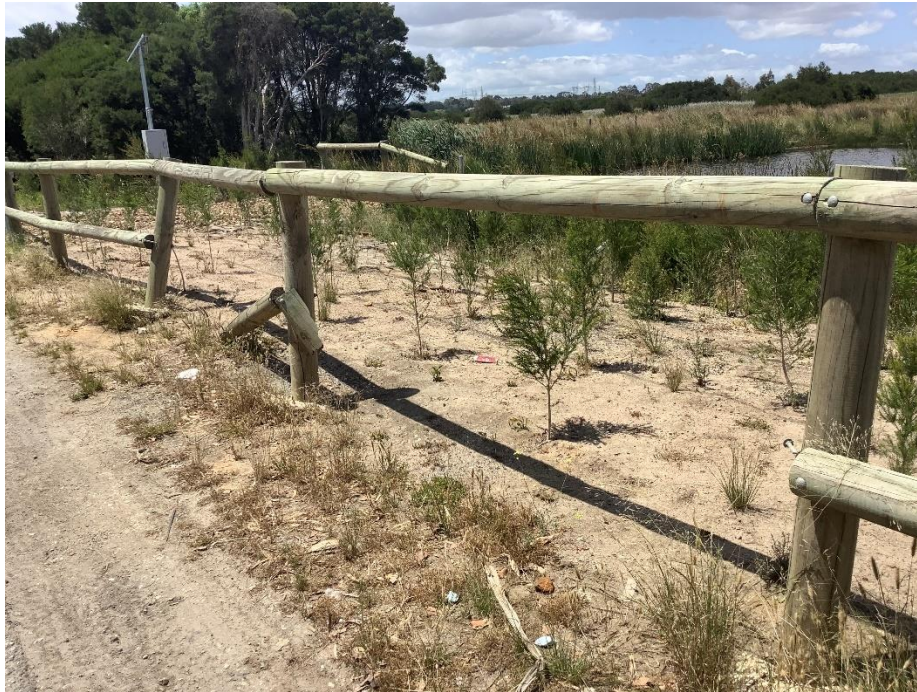
Permanent fencing was installed at the two refuge pools as indicated on Figure 1. The current perimeter fencing along the northern boundary does not prevent members of the public from accessing the offset site (this appears to be intentional as there is an open entryway incorporated into the fence). However, this leaves the revegetation works vulnerable to vandalism and damage as shown by the dumping of rubbish within the offset site. This survey found that the northern fencing remains damaged (see photo below).

Photos 24. Damaged perimeter fencing next to the entryway at the northern boundary.

- The damaged section of the northern fencing will require repair.
- Although the intention may be to enable public access to the offset site in the long-term, it is recommended that the fencing along Centre Road include wire mesh (Image 1 below) and that the entry ways be locked off outside of maintenance activities, to limit revegetation works from damage. Revegetation sites and reserves tend to be vulnerable to vandalism and other disturbances like dumping of garden waste as shown by the continued presence of rubbish 12-months post construction.

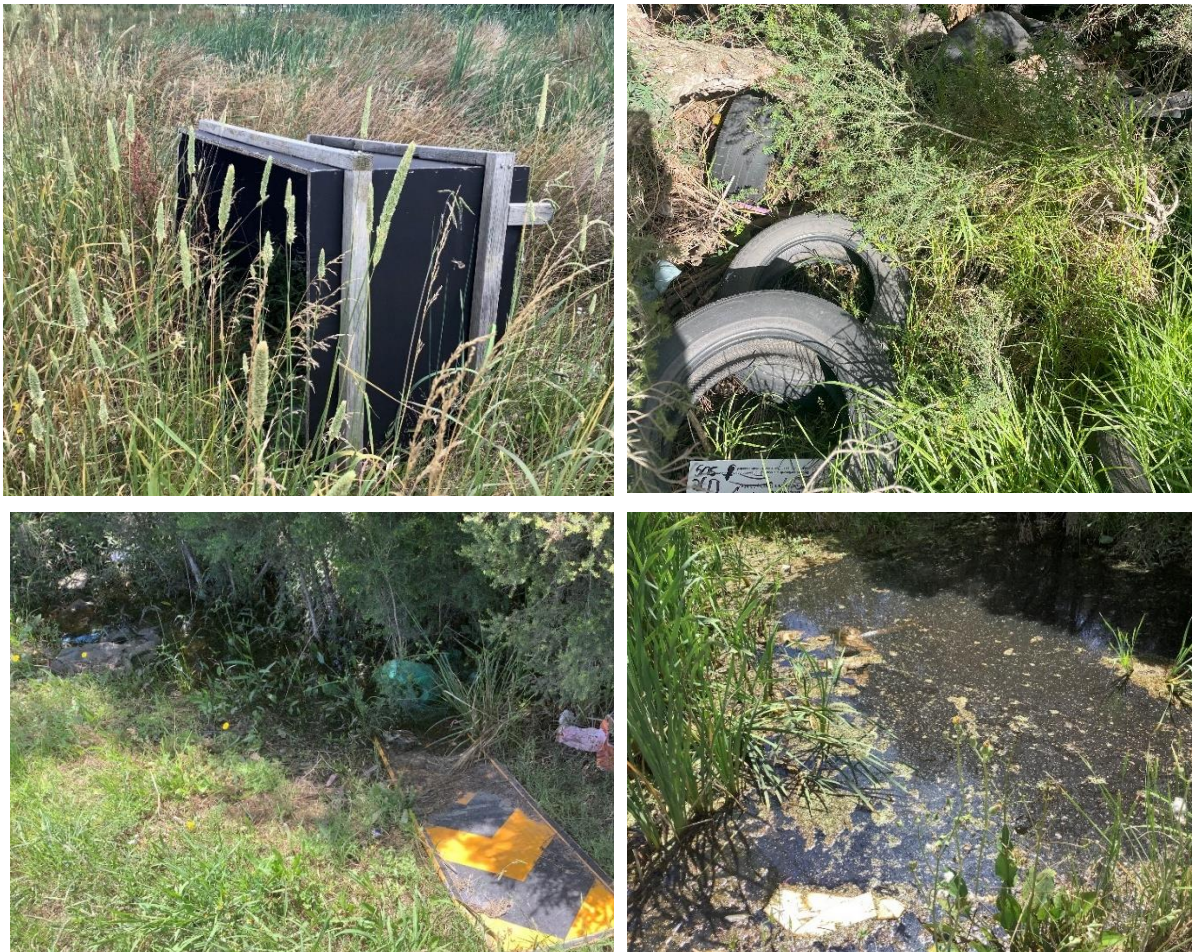
There was rubbish present in the offset site during this survey, including along the edge of the wetland pools (Figure 1). Swamp Scrub along Centre Road also still contains some rubbish dumping. Unfortunately, this Swamp Scrub can be easily accessed by members of the public from Centre Road. Clean up of litter or dumped waste within the site is the responsibility of the proponent. but not along roadsides which is required to be addressed by council.

Photos 25-29. Litter inside the offset site and dumped tyres in the Swamp Scrub along Centre Road.

- Remove litter and dumped rubbish inside the offset site. (Note: It is the council's responsibility to address littering and illegal waste dumping on public land, such as the roadsides of Centre Road and Hallam Road.)

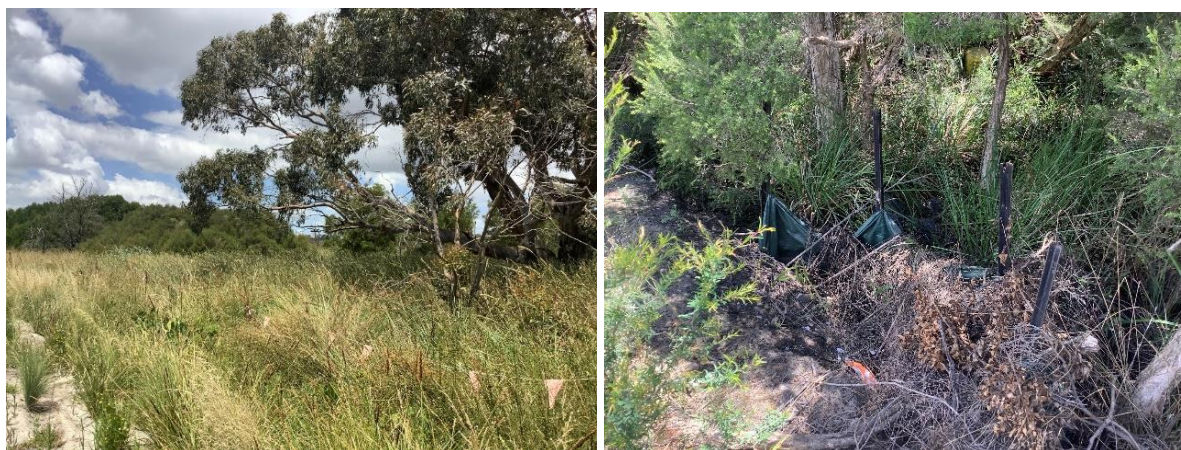
Rope bunting was observed along the interface of the existing wetland vegetation and the revegetation track, in the southern part of the offset site (Figure 1). This was evidently used to prevent accidental encroachment into the vegetation during construction of the revegetation track, however it currently does not serve a purpose and most of it has fallen. Similarly, broken sediment fencing was identified to the west of the most northern dam (Figure 1). The majority of the revegetation efforts have finished, and it is unlikely needed for sediment protection purposes, as such it and the rope bunting should now become part of the rubbish removal effort.

Photo 30-31. Rope bunting along the southern portion of the revegetation track (left) and broken sediment fencing (right).

- Remove all roped bunting (and stakes) at the southern part of the offset site as they have become rubbish in the site. Vegetation in these areas is becoming overgrown and if delayed it will become harder to be removed.

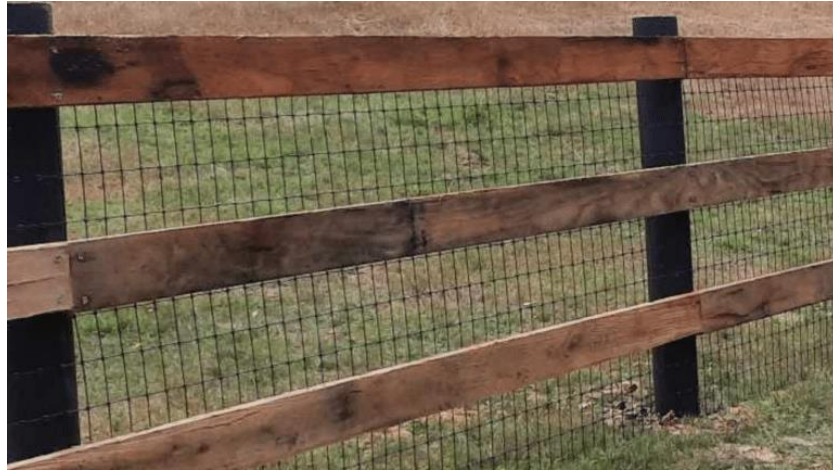
Image 1. Example photo of mesh fencing.

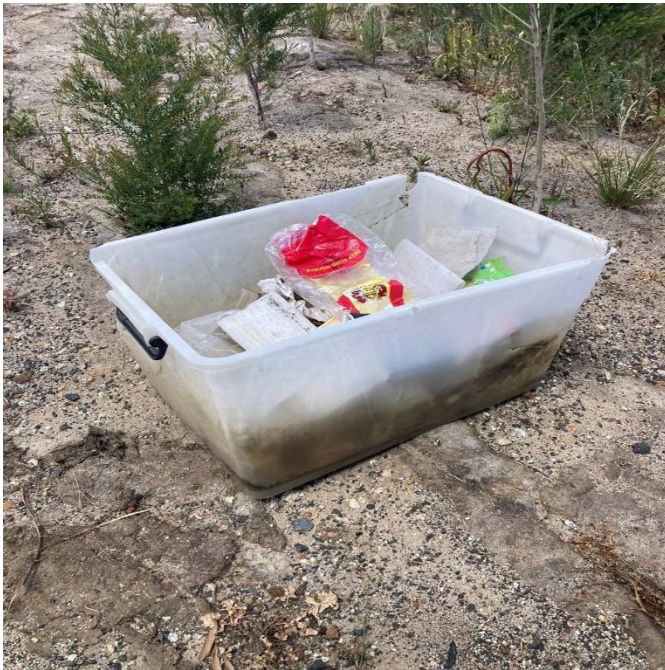
Rubbish collected

Project Name - Number	CASEY GREEN - DWARF GALAXIA HABITAT - SPM001804
Date:	13 Dec 2024
Crew:	Alex Vaudeau
Site Condition:	Moderate rubbish loads on the northern fringe of the inlet pond.
Weed Cover:	Seeing positive dieback of weeds treated last visit.
Infill Required:	Aquatic infill to be undertaken around the galaxia pond.
Works Undertaken:	Sprayed out the MW access track. Picked up rubbish from the northern fringe of the inlet pond.

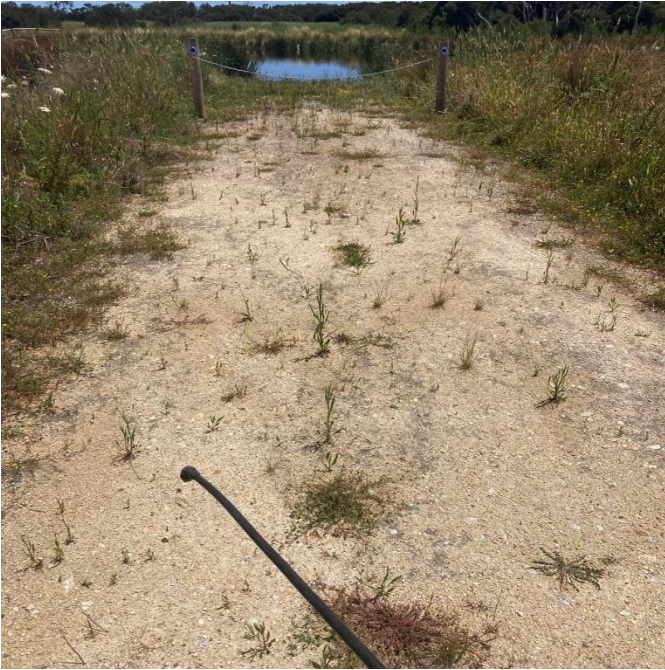
Track sprayed out
