96-166 Centre Road, Narre Warren – Dwarf Galaxias habitat buffer

Year 5 Vegetation Monitoring

Prepared for Narre Warren Central Pty Ltd c/- The Fidus Group

December 2022 Report No. 14090.8 (17.0)

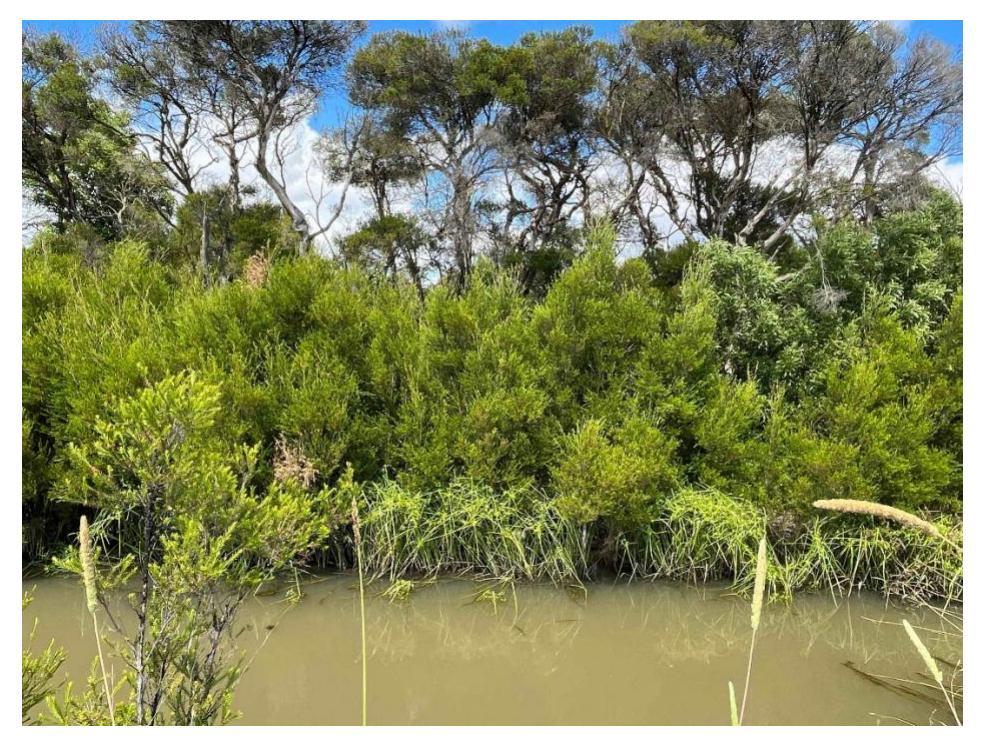
Photo 1. Swale drain with deep water (foreground) preventing access to the habitat buffer between Centre Road and the Packenham Railway line, which supported quadrats 11, 13, 15, 16 & 17.

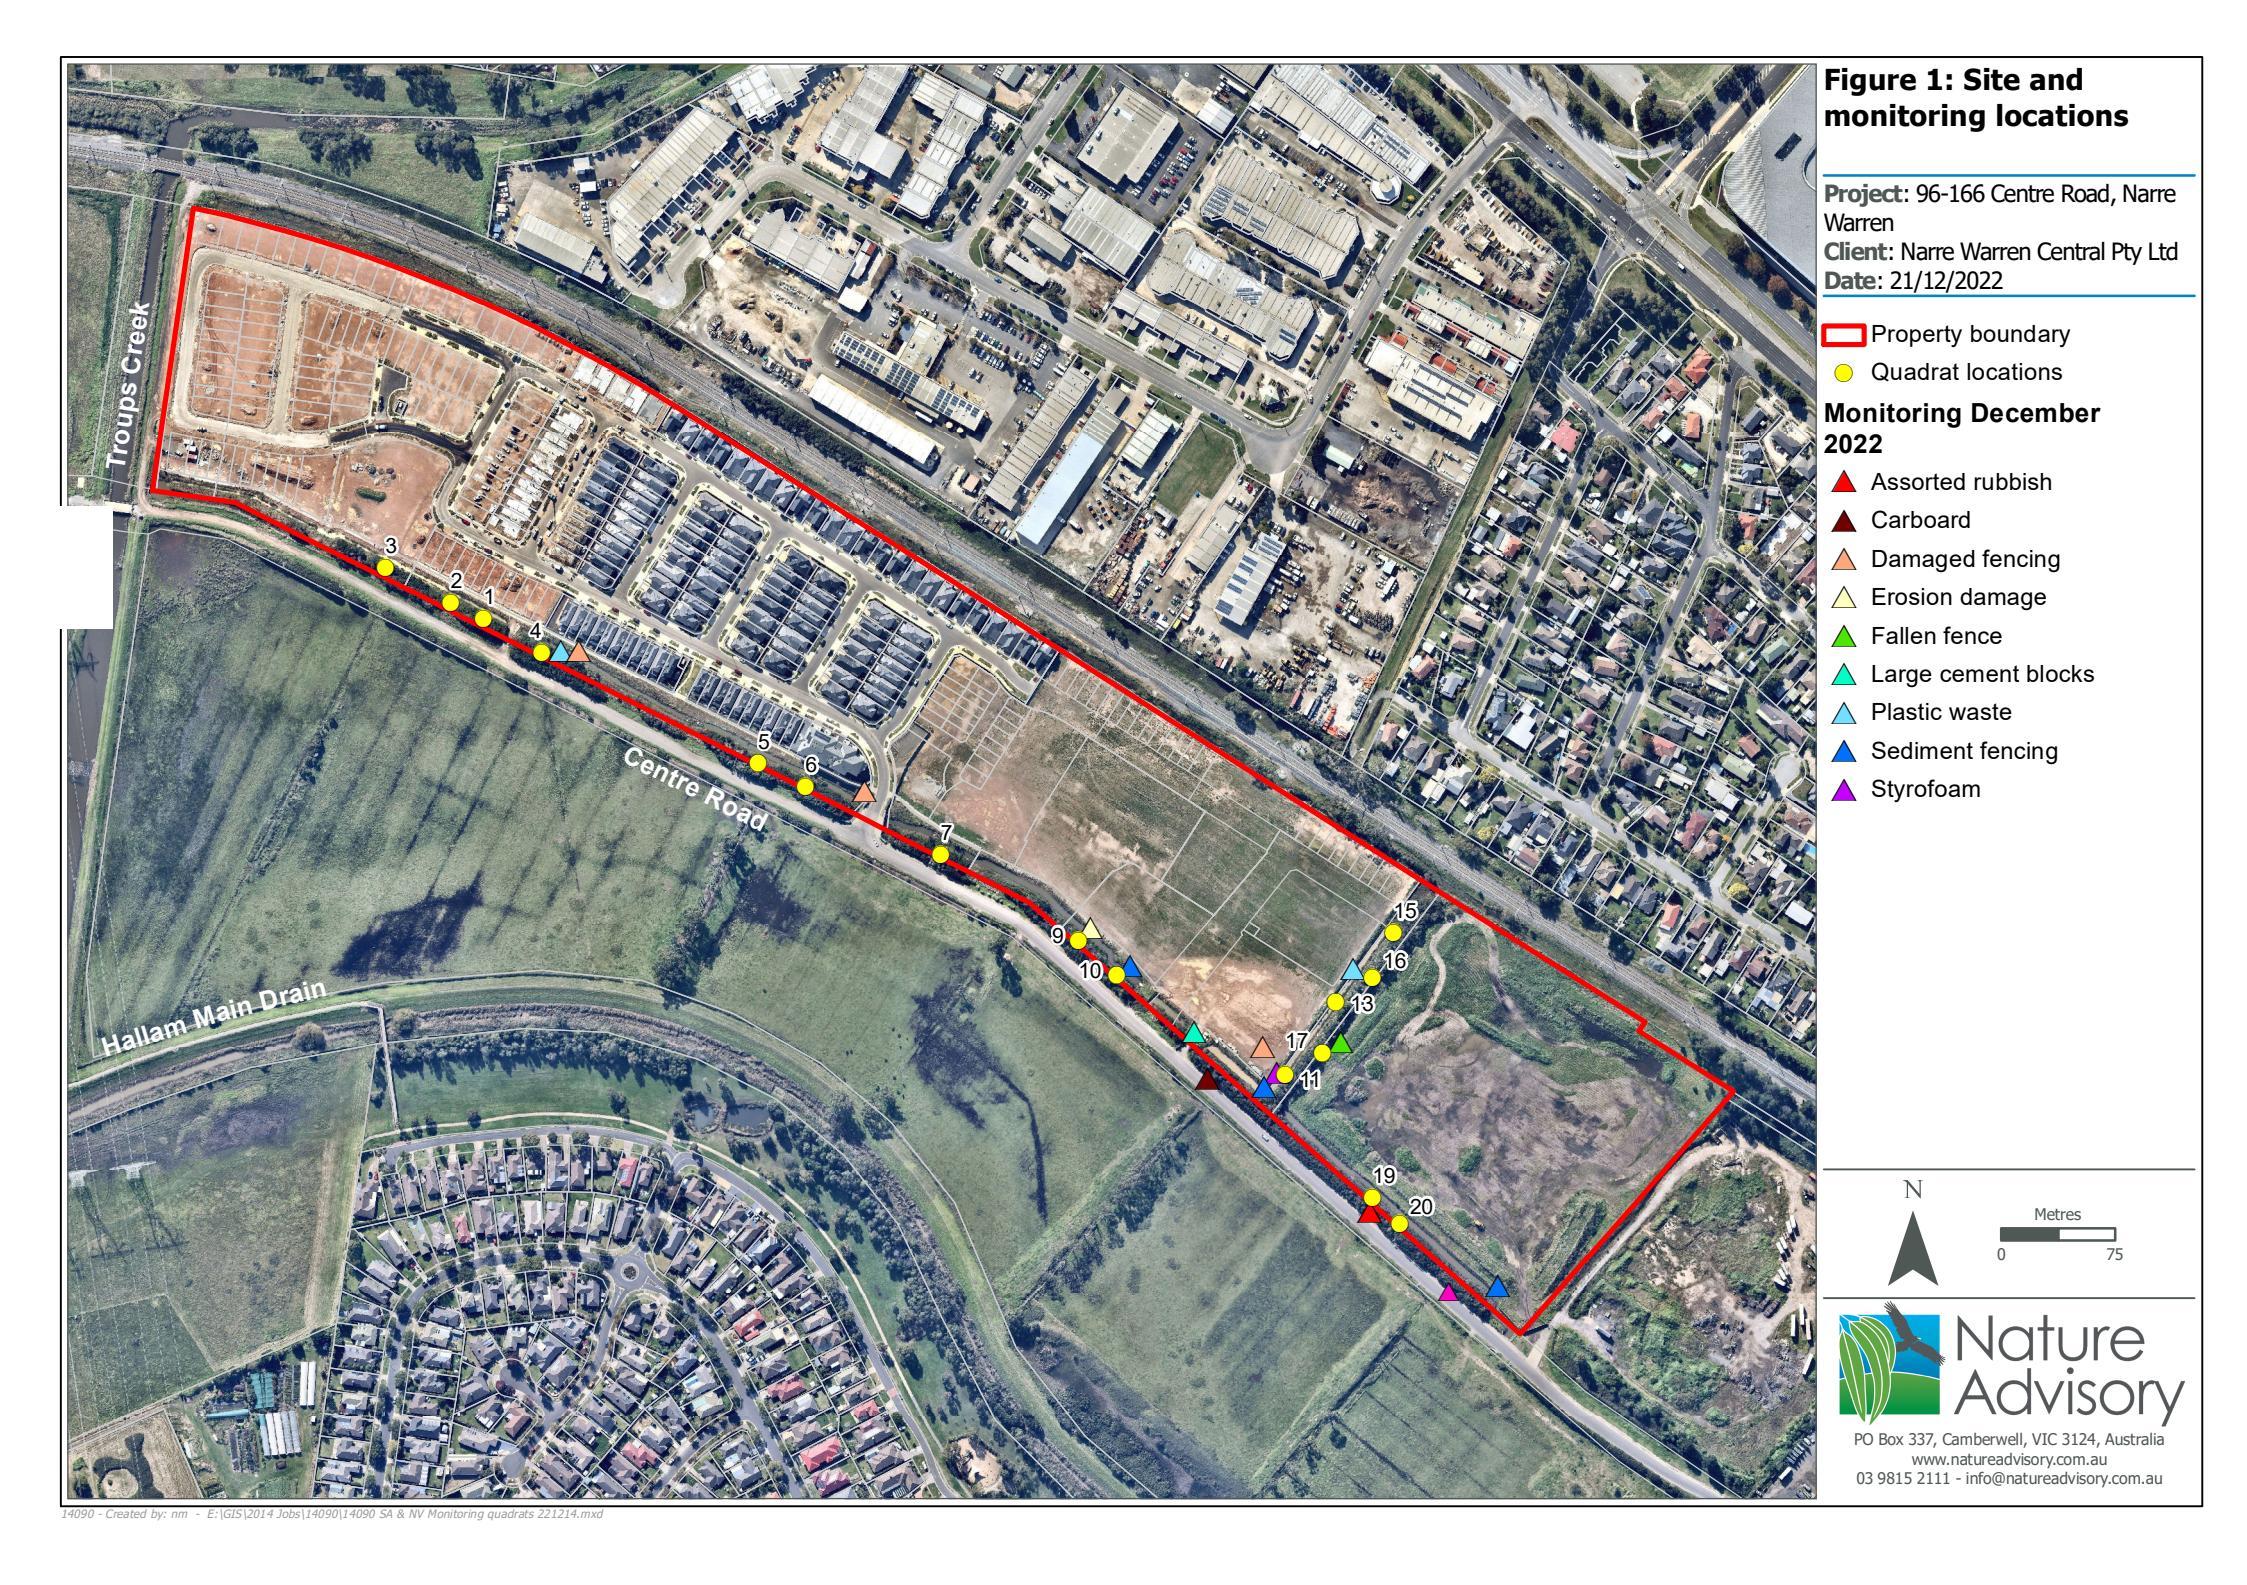
Figure 1: Study	v area and mon	toring locations	8	२
inguic I. Oluu	y area ana mon			•

Sediment fencing between the habitat buffers and swales/drains was in generally good condition across the study area. A few areas of sediment fencing had collapsed or been damaged, as mapped in Figure 1. The previous monitoring had reported collapsed fencing with erosion channelling occurring in the central part of the study area; the current monitoring found this has been rectified with intact fencing and the erosion was addressed with some rock fill, hay bales and sandbags.

Collapsed or damaged sediment fencing (as mapped on Figure 1) should be rectified to prevent further sedimentation and run-off into the swales/drains. It is strongly recommended that all sediment fencing surrounding the habitat buffers are regularly checked and any collapsed/damaged fencing rectified in a timely manner, as part of routine on-ground works. Any sediment fencing that is no longer serving its purpose is to be removed to avoid the fencing becoming litter.

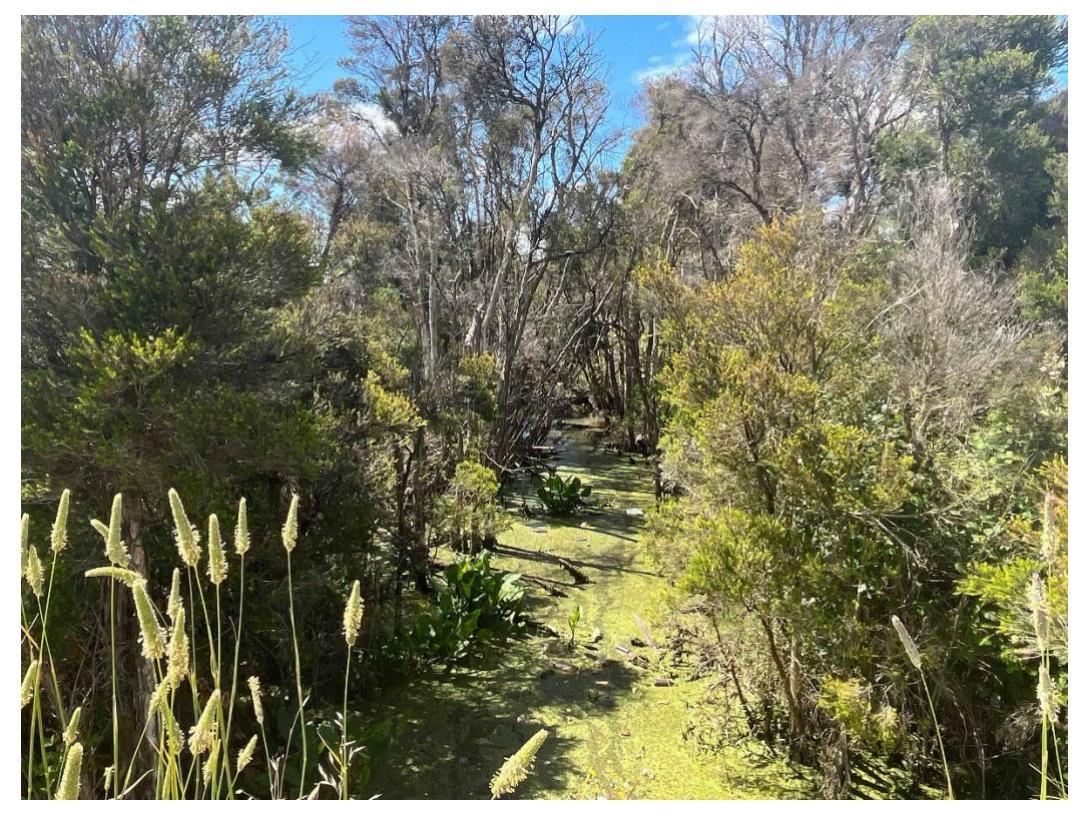
The drainage channel along Centre Road was full of water and contained algal bloom.

Algal blooms are an indicator of excess nitrogen and phosphorus in the water, and the algal blooms may impact on native aquatic plants (and therefore the quality of Dwarf Galaxias habitat) by consuming oxygen and blocking sunlight. Preventing soil erosion and run-off into the habitat buffers, as well as maintaining vegetation cover, will help to reduce algal blooms. In particular, sediment fencing around the habitat buffers will be required to be effective in controlling soil erosion and run-off (discussed above). Rubbish management will also support reduction of algal blooms.

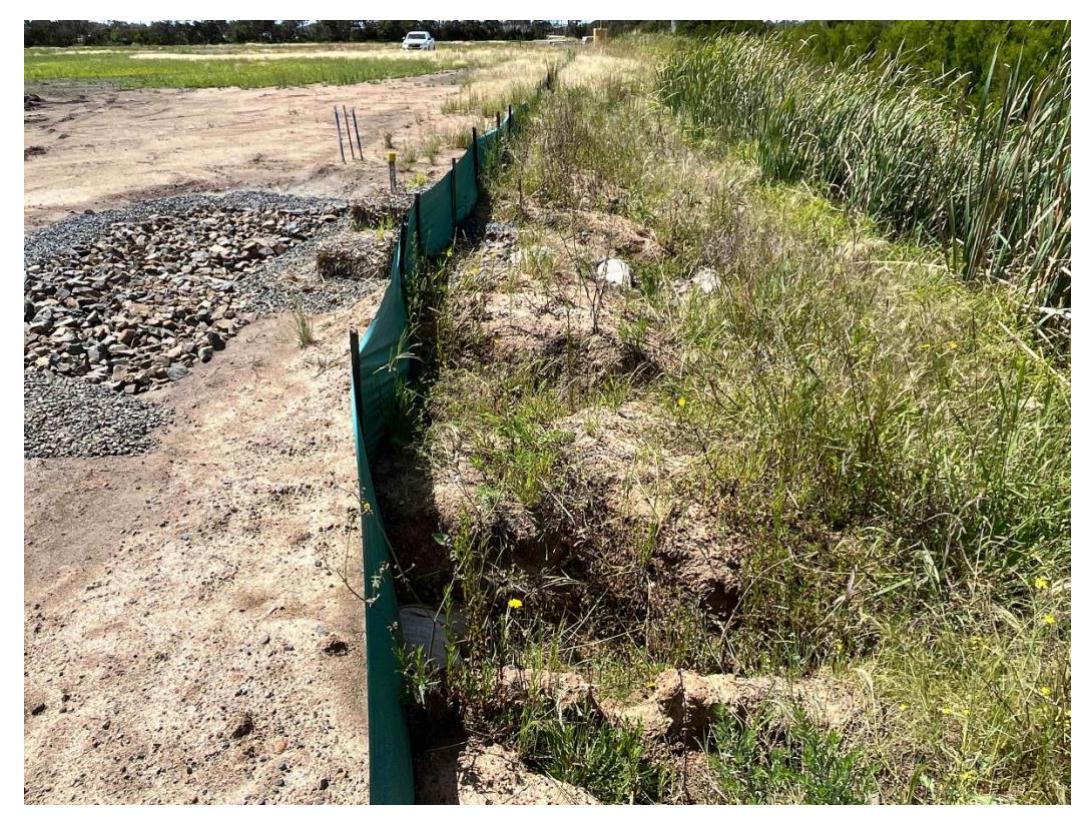
Sediment fencing in good condition, with efforts to control erosion through the use of rock fill, hay bales and sandbags along the northern edge of the swale in the central part of the study area.

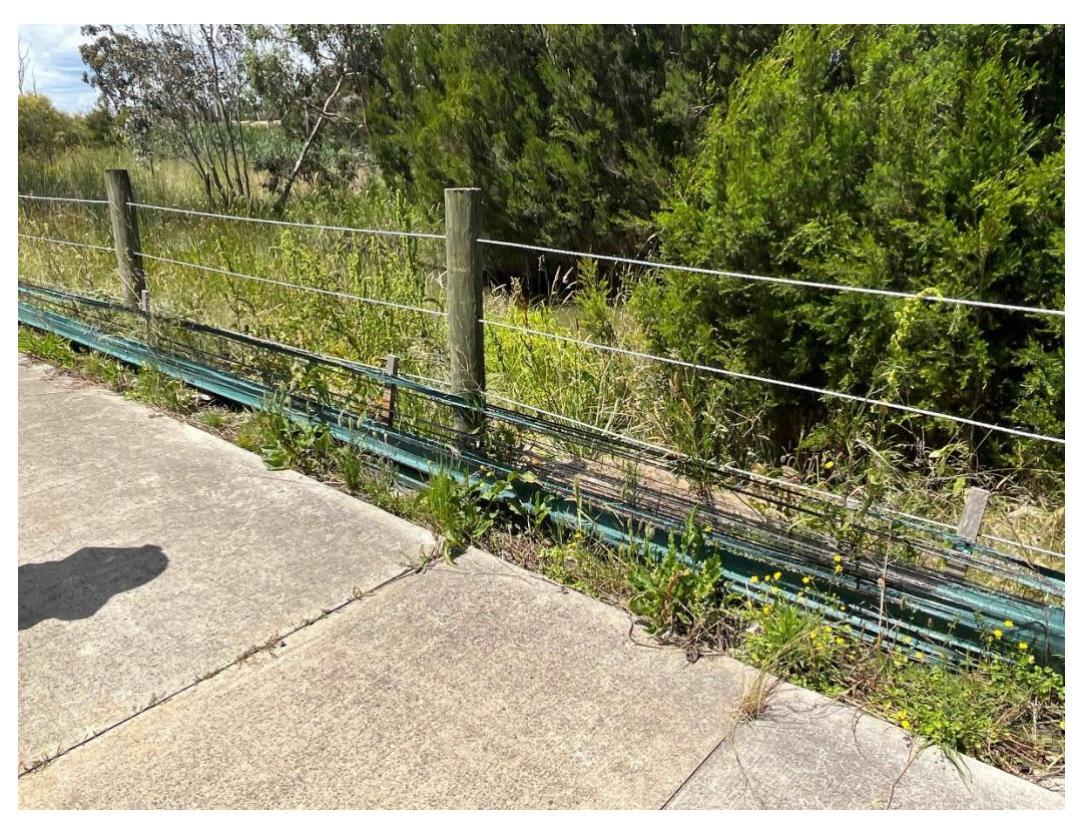
Sediment fencing along the path south of Billy Buttons Drive was generally intact but portions of it had begun to break down. The broken-down fencing must be rectified as soon as possible.

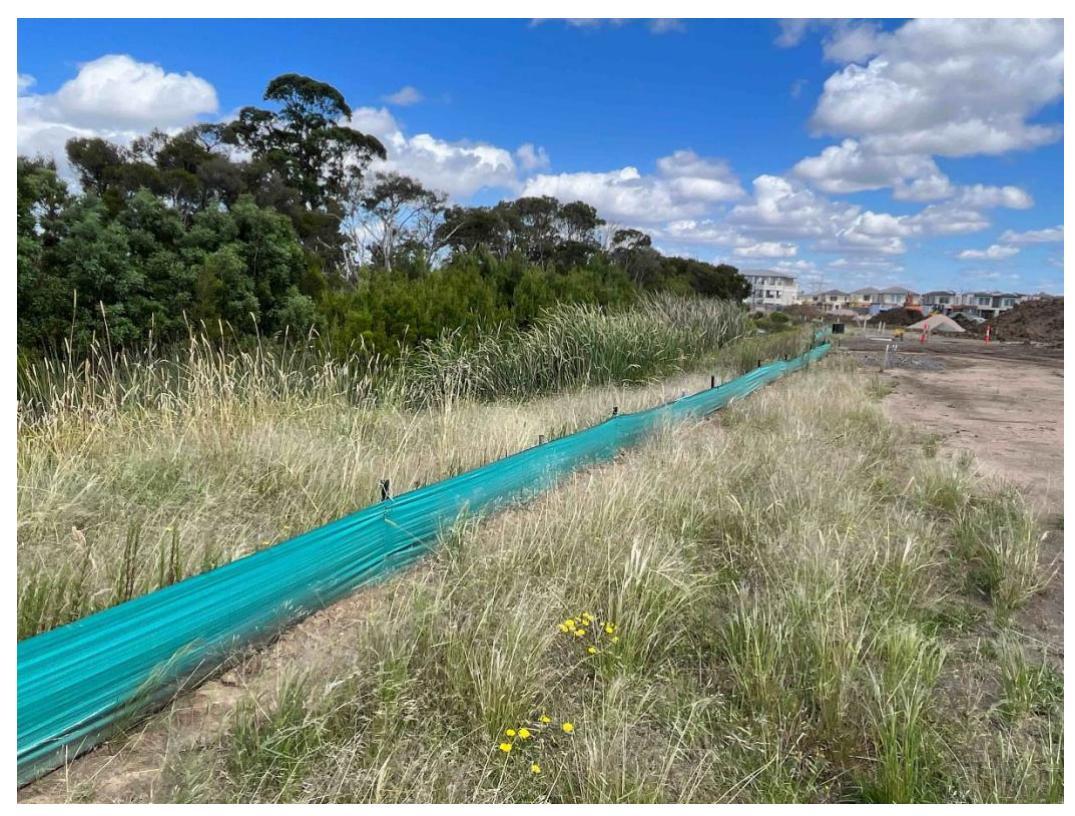
Example of sediment fencing in good condition along the northern edge of the swale in the eastern part of the study area.
